# TECHNICAL SERVICE BULLETIN

<b>ISSUE DATE:</b>	10-6-2021
<b>SERVICE BULLETIN SUBJECT:</b>	Ancillary Bay Battery Pack Ground Screw Replacement
<b>VINs or MODELS AFFECTED:</b>	Service Specified Buses
<b>COMPLETE BY:</b>	Next Service Opportunity
<b>SERVICE BULLETIN #:</b>	SC-21-174
<b>Labor Operation Code:</b>	HB45Z

## ANCILLARY BAY GROUND SCREW RETROFIT

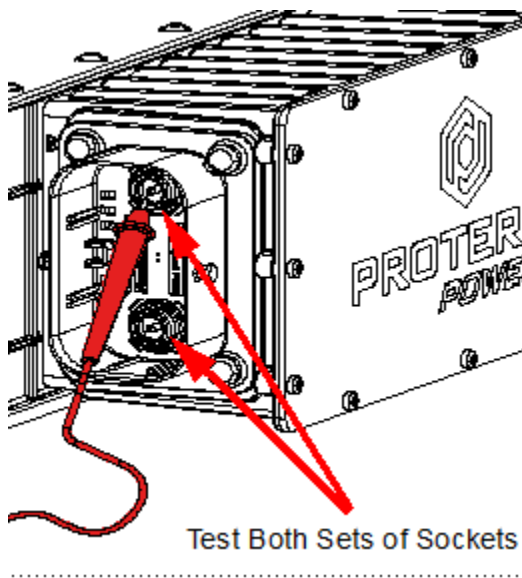
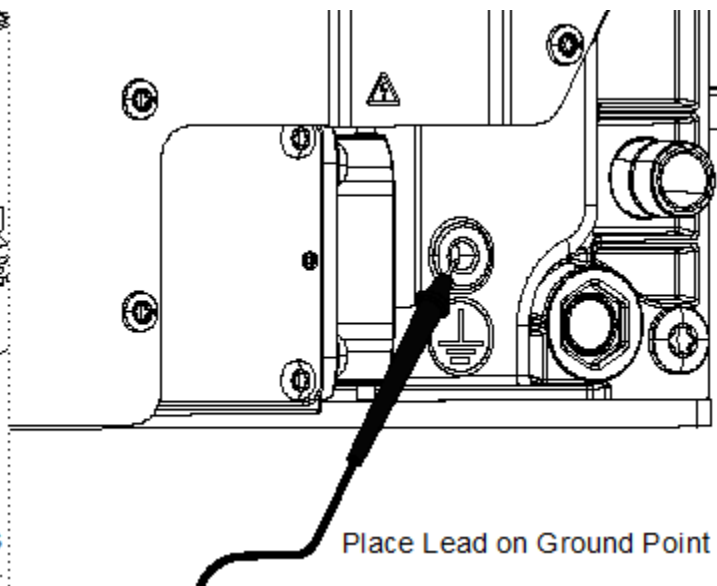
**NOTE:** If any values measure less than 225 kilohms or greater than 50 megohms, an Isolation Fault is indicated. Please contact Proterra Service for assistance with Isolation Faults.

- Using the Fluke 1587 FC Insulation Meter, check the MSD connector pins for Isolation Faults. Test the resistance of the pins to the chassis of the Ancillary Bay. The measurement should be between 225 kilohms and 50 megohms.
