SERVICE BULLETIN

APPLICABILITY: 2022-25MY BRZ Models **NUMBER:** 15-297-22R
SUBJECT: Reprogramming File Availability for Optimization of Gen 4 Denso CP1 Infotainment Systems **DATE:** 07/01/22
REVISED: 01/13/25

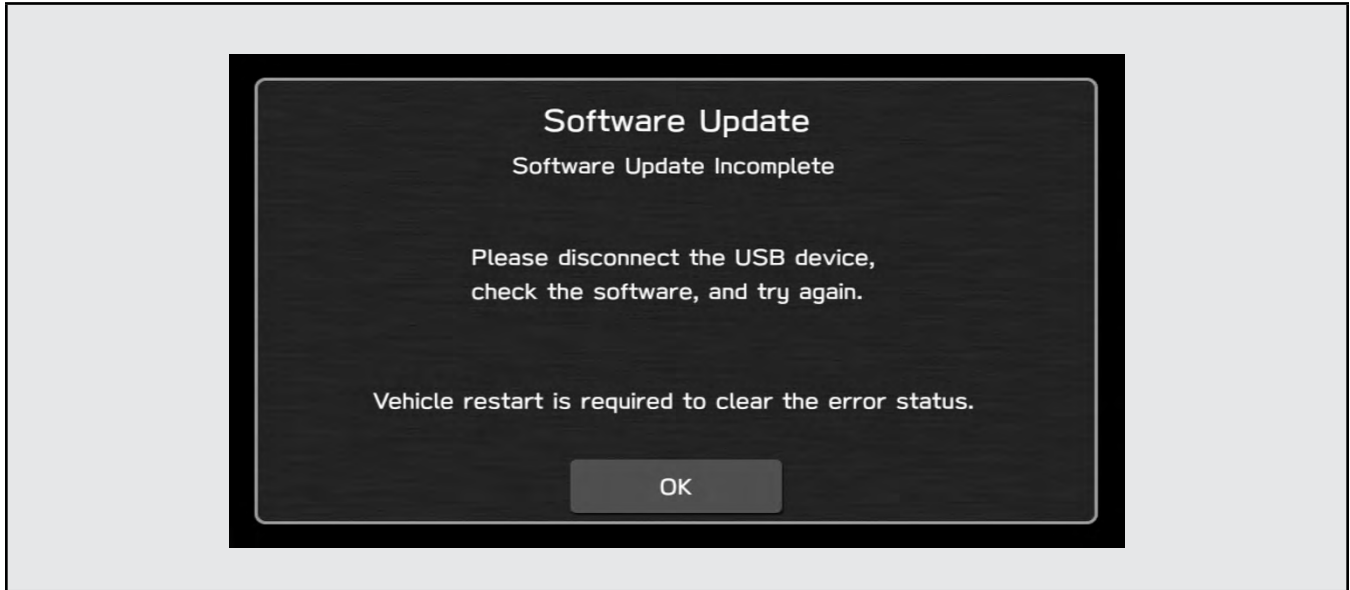
In case of retrying the software update after the first attempt of update fails.

- If the first attempt of update fails with the message below, please perform procedures 1-2 to 1-8 before retrying the software update.

1-1. Select OK in the screen below

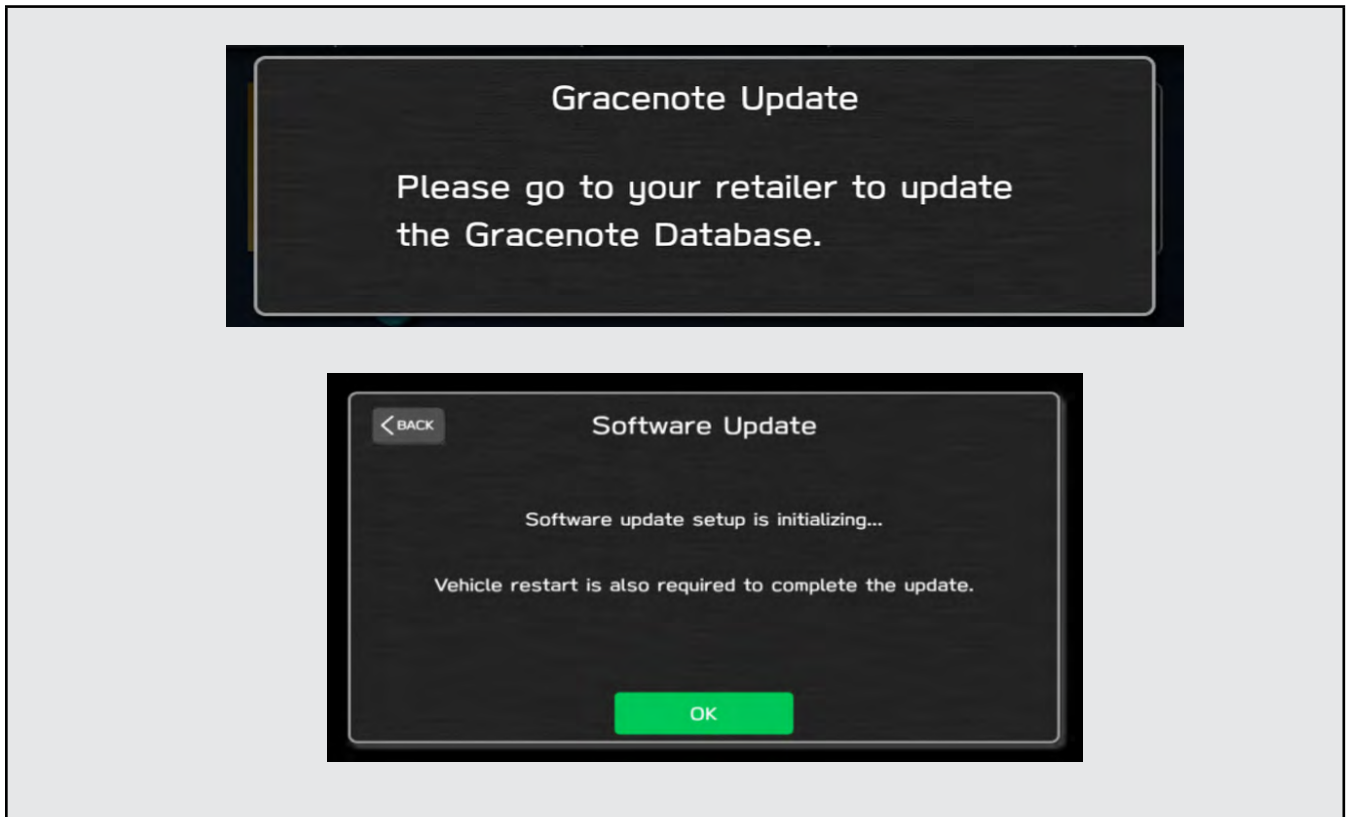
In case the Gracernote update popup screen appears or software initializing screen does not go away for more than 20 minutes, please perform procedures 2-1 to 2-11.

2-1. Select “Settings” in the Dealership Mode diagnostics screen.

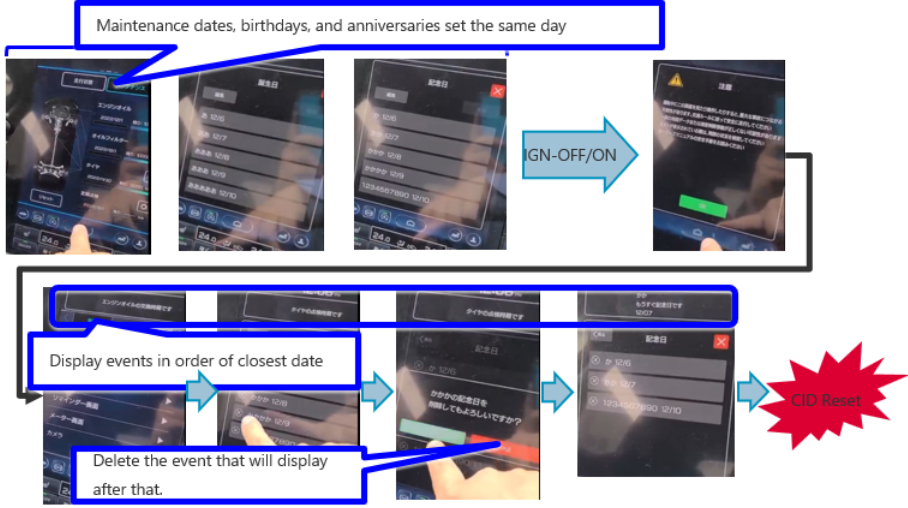
The CID screen may reset within 3 minutes after engine starts.
	The CID screen may reset within 3 minutes after engine starts. No sound is heard from the speaker and ""No Audio Playing"" is displayed on the CID screen.
	When maintenance dates, birthdays, and anniversaries are set on the same day, pop-ups will appear in sequence on the top of the CID after engine starts when their dates are close. At this time, if an operation is performed to delete the maintenance date or birthdays or anniversary date registration within a few seconds immediately before the display, the CID screen will reset. However, the BRZ screen configuration does not allow the delete operation to be performed before the display, so this event does not occur actually.

<p>Maintenance dates, birthdays, and anniversaries set the same day</p> <p>IGN-OFF/ON</p> <p>注意</p> <p>Display events in order of closest date</p> <p>Delete the event that will display after that.</p> <p>CID Reset</p>

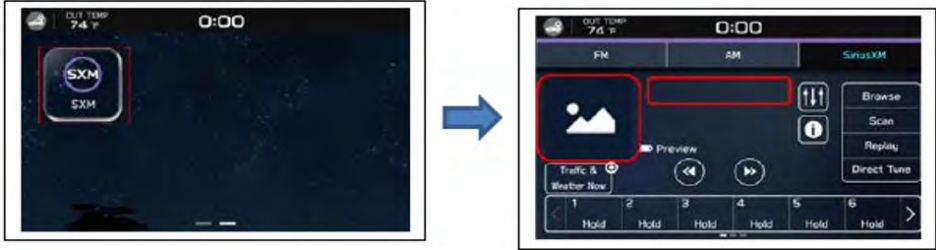
Number	Symptoms to be Improved:
19	<p>In USB music mode, some music is skipped and the music in the next folder is started. Under following condition</p> <ol style="list-style-type: none"> 1. Play USB music in “Folder” mode with repeat mode setting “Repeat All.” 2. Turn Ignition Switch off then open/close door and keep it locked for more than 5 minutes. 3. Turn Ignition Switch on and operate “Track Up/Down” on the audio system.
20	The mode does not switch to Media, after “Media” icon is selected.
21	<p>When selecting shortcut for SXM channel on “Home” screen, the screen is changed to SXM but no sound is coming or no channel name is displayed.</p>

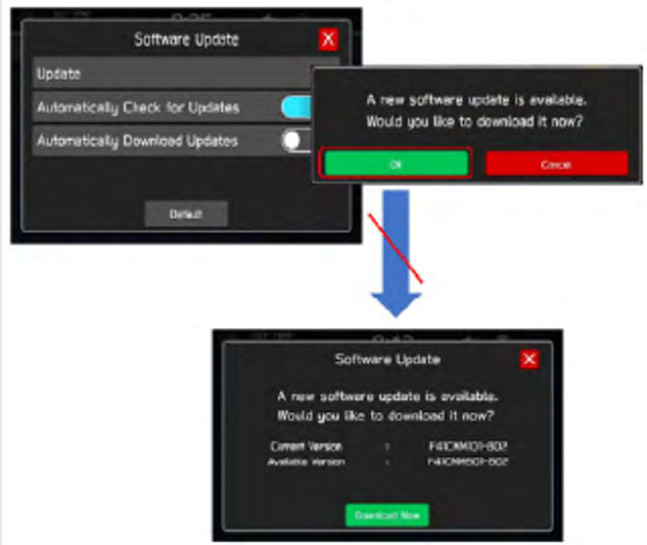
22	<p>When using FOTA service to update the software by selecting “Setting” > “Software Update,” a message of “A new software update is available. Would you like to download it now?” is displayed but the downloading does not start after pressing “OK.” When this symptom occurs, it comes back to the “Software Update” screen. The downloading can be started by pressing the “Update” on the “Software Update” screen. (Temporary solution.)</p>

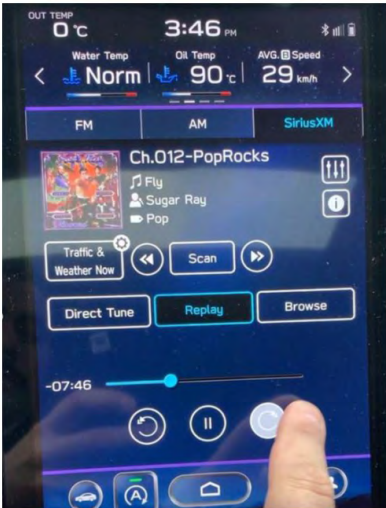
28	SXM has blank screen and no sound when the audio source is change to SXM.
29	<p>“Fast forward” does not work in SXM replay function. (Fast Rewind works.)</p>

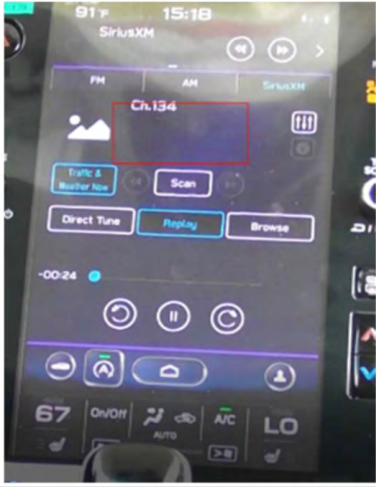
Number	Symptoms to be Improved:
30	<p>The channel information becomes blank when the seek button (<< / >>) of the steering satellite switches is pressed continuously to control the Traffic & Weather Now (TWN) in SXM.</p>

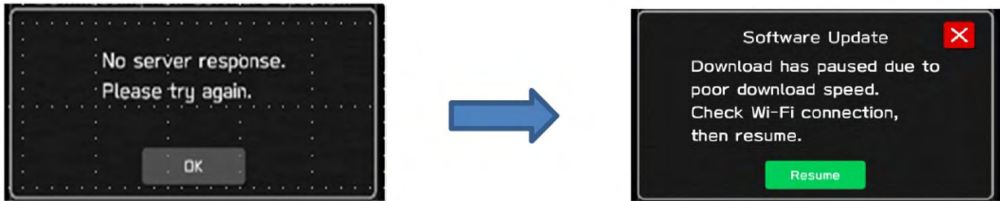
Number	New Functions and Enhancements:
1	Icons of home screen change to those of the US specifications even though the original specification is not of the US.
2	Two ways of MOTA operations, i.e., by connect CCM to Wi-Fi or by transferring the downloaded map data to CCM via smart phone are executed simultaneously by error.
3	<p data-bbox="337 348 1464 457">One of the Pop-up Error Messages displayed during the FOTA operation in case of weak Wi-Fi signal is not intuitive. Even if the customer tap “OK,” it does not transit to another screen.</p> <div data-bbox="404 485 1398 684" style="text-align: center;">

</div> <p data-bbox="337 726 1464 911">As the improvement for this inconvenience, the message is changed so that the customer finds the reason why the FOTA operation has been paused. Also a “Resume” button is prepared so that the customer can do the rest of operations after necessary action (moving the vehicle to another place with better Wi-Fi connection**, or tethering the CP1 to a mobile phone, etc.)</p> <p data-bbox="337 928 1464 999">Note** The FOTA operation can be paused when the Wi-Fi indicator at the upper right corner of the CID is not in “Good” or “Excellent” as shown below.</p> <div data-bbox="534 1031 1261 1199" style="text-align: center;">

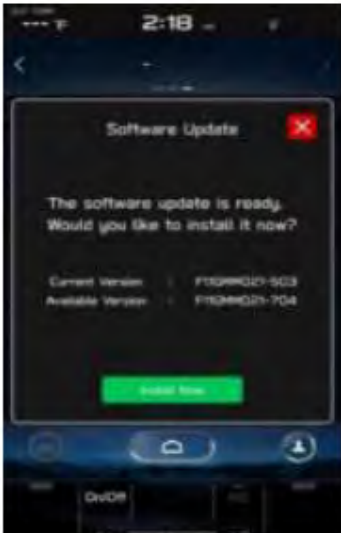
<p>Note* Even if this symptom occurs, after approximately 2 minutes, the system resumes, and the CID comes back to the below screen. Customer can then push the “Install Now” to proceed with the installation.</p>
