## SERVICE BULLETIN

**NUMBER:** 15-305-22R

**DATE:** 11/15/22

**SUBJECT:** Reprogramming File Availability for Optimization of Gen 4.5 Denso CP1.5 Infotainment Systems

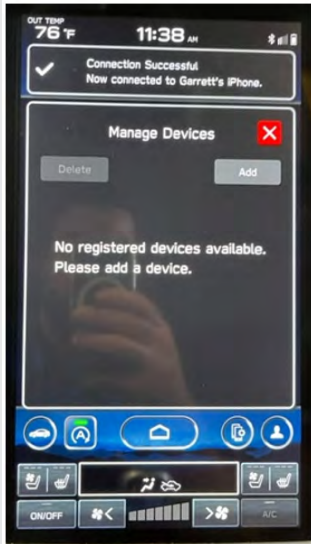
| Number | Category | Symptoms to be Improved: |
|---|---|---|
| 6 | Display | <p>The registered mobile device information is not displayed on the Manage Devices screen.</p> <p>(This occurs when the name or device ID of a mobile device contains a character code that cannot be displayed.)</p> <p>(only applicable to HIGH and MID trim)</p> |

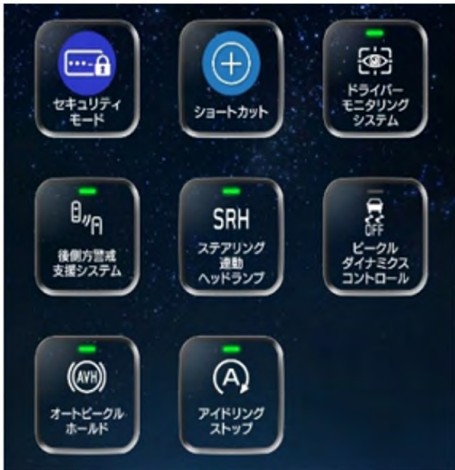
| Number | Category | Symptoms to be Improved: |
|---|---|---|
| | | <p>When turning off and on while two or more shortcuts of DMS/SRH/SRVD icons are set on the Home screen, the order of icons changes from DMS to SRVD, SRH, VDC, AVH, and ISS.</p> |

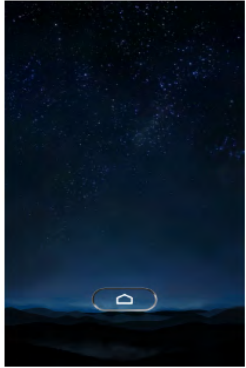
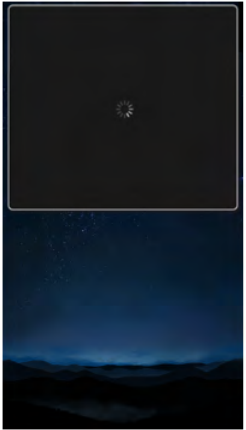
| Number | Category | Symptoms to be Improved: |
|---|---|---|
| | | -Right after starting up, the CID displays only background without icons and no further operation can be done (not applicable to WRX) |
| | | <p>After engine starts, only the black frame of the Caution screen display may remain on the CID screen.</p> <p>The rear view camera can be displayed by shifting to shift R.</p> |

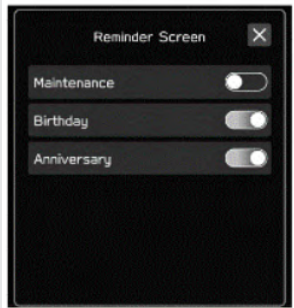
| Number | Category | Symptoms to be Improved: |
|---|---|---|
| | | <ul style="list-style-type: none"> <li>- When multiple reminders for maintenance dates, birthdays, and anniversaries are set and nearing, a series of pop-up notifications appear on the CID screen after starting the engine. If you try to delete a reminder right before it switches to the next one, the CID screen may reboot (not applicable to WRX)</li> </ul> |

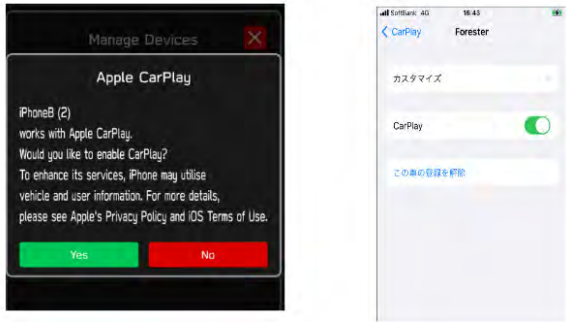
| Number | Category | Symptoms to be Improved: |
|---|---|---|
| 7 | Bluetooth | <p>- Bluetooth connection may not become active, and it may become impossible to switch Bluetooth-connected devices, when following steps below (turning on/off the connection)(not applicable to WRX):</p> <p>With the CarPlay usage confirmation screen displayed on the CCU, press the 'Yes' button. Almost simultaneously, on the iPhone's settings screen, turn off the CarPlay toggle switch.</p> |

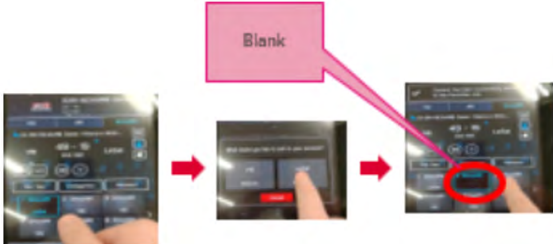
| Number | Category | Symptoms to be Improved: |
|---|---|---|
| | | <p>- When registering SXM sports team channels to the radio preset buttons if a team for which logo image cannot be captured is registered, the channel short name will not be displayed on the registered button and the button will be blank (not applicable to BASE trim)</p> |

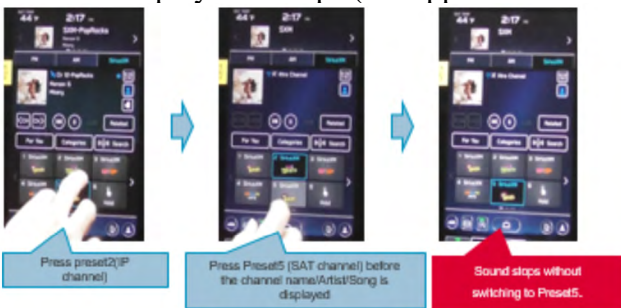
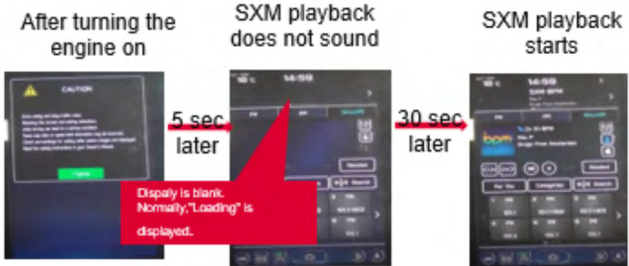
| Number | Category | Symptoms to be Improved: |
|---|---|---|
| 9 | SXM | <p>- When switching to the SAT channel (satellite channel) immediately after selecting the IP channel (Internet channel) on the SXM360, song information is not displayed and audio playback stops (not applicable to BASE trim)</p> <p>Press preset(2)(IP channel) → Press Preset5 (SAT channel) before the channel name/Artist/Song is displayed → Sound stops without switching to Preset5.</p> <p>- If the ignition-off/on operation is performed quickly immediately after ignition-on, the previously viewed channel in SXM may not start playing automatically (It will play by switching the audio source) (not applicable to BASE trim)</p> <p>- When the contract status is Demo, "Your Trial Expires in 0 Days" is displayed on the SXM Setiing screen. The display will be removed when the contract status is Demo (not applicable to BASE trim)</p> <p>- Gametime (1st Period, etc.) is not displayed on the pop-up screen of SXM Sports channel when a game starts</p> <p>- Registering a channel with blank information in presets results in a preset button with a blank label, and the channel logo is not displayed. Additionally, pressing the preset button with the blank label does not initiate playback of the channel.</p> <p>- After turning the engine on, "Loading" should appear on the channel information screen until SXM playback starts, but it does not appear and remains blank</p> <p>After turning the engine on → 5 sec later → 30 sec later → SXM playback starts</p> <p>Display is blank. Normally, "Loading" is displayed.</p> |

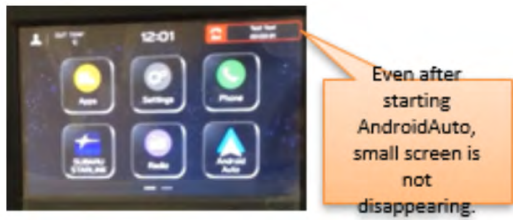
| Number | Category | Symptoms to be Improved: |
|---|---|---|
| 11 | Display Appearance | <p>- The call screen reduction appears in the Status Bar while connected to Android Auto. Originally, when Android Auto is activated during a hands-free call, the call screen reduction should disappear (only applicable to BASE trim).</p> |

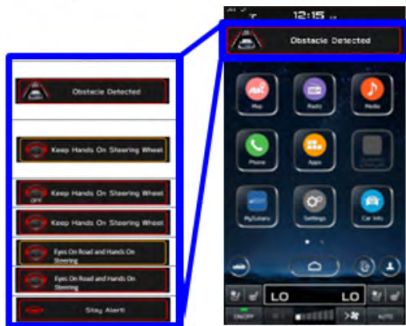
| Number | Category | Symptoms to be Improved: |
|---|---|---|
| | | <p>- If the language setting of the CID is changed while an alarm message by the Driver Monitoring System(DMS) is displayed on the CID, the alarm will be hidden (not applicable to BASE trim)</p> |

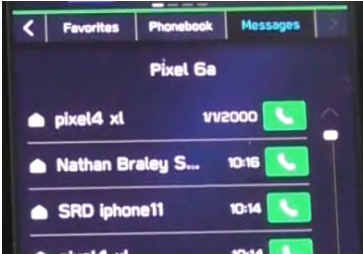
| Number | Category | Symptoms to be Improved: |
|---|---|---|
| | | <p>- The date for the message is displayed as 1/1/2000 instead of the correct date. This occurs on some models of phones with Android OS 13 or later.</p> |

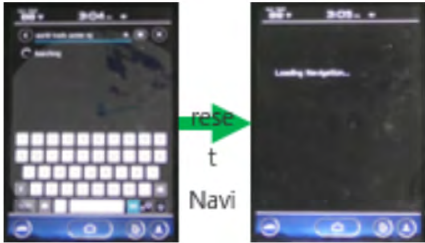
| Number | Category | Symptoms to be Improved: |
|---|---|---|
| 13 | Navi Operation | <p>- When repeatedly entering text on the destination search screen, the screen may freeze, and the navigation application restarts (only applicable to HIGH trim)</p> <div style="text-align: center;"> </div> |

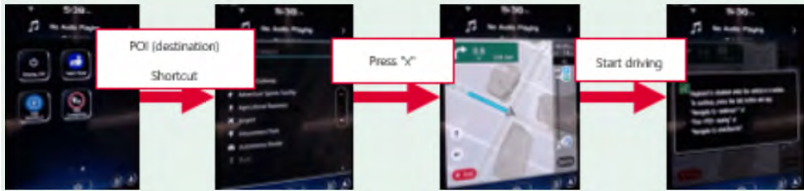
| Number | Category | Symptoms to be Improved: |
|---|---|---|
| 13 | Navi<br>Operation | <p>- "Keyboard is disable while the vehile is in motion"" is displayed on the screen when performing the steps below (only applicable to HIGH trim) :</p> <ol style="list-style-type: none"> <li>1. Press the POI (destination) Shortcut on the home screen to display the list of destinations.</li> <li>2. Press "x" to clear the list.</li> <li>3. Start driving with the Map screen displayed.</li> </ol> |

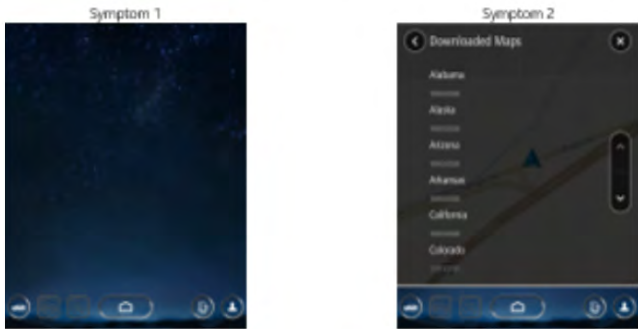
| Number | Category | Symptoms to be Improved: |
|---|---|---|
| 13 | Navi<br>Operation | <p>- When you set a navigation destination and drive repeatedly triggering rerouting by deviating from the route and start a map update via Wi-Fi, then wait for about 30 minutes on a screen other than the navigation screen (like the HOME screen) before transitioning back to the navigation screen the following symptom occur (only applicable to HIGH trim):</p> <p>symptom 1: The map is not displayed.</p> <p>symptom 2: The download start button is not displayed on the map update screen.</p> <div data-bbox="683 457 1317 783"> </div> |

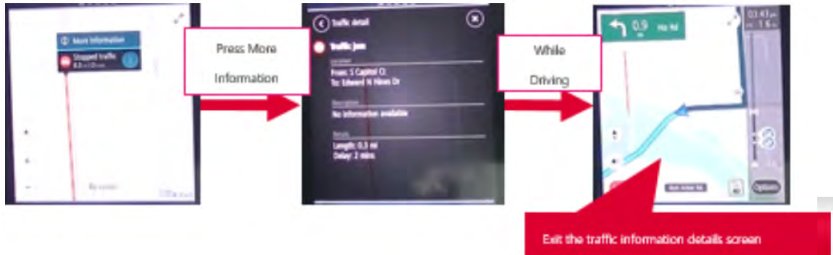
| Number | Category | Symptoms to be Improved: |
|---|---|---|
| | | <p>- While parked or driving, touch the traffic information icon on the map or the traffic information icon on the route bar and display the traffic information details screen. If you start driving with this screen displayed, it will exit the traffic information details screen and transitions back to the map screen (only applicable to HIGH trim)</p> <div data-bbox="586 1199 1414 1451"> </div> |

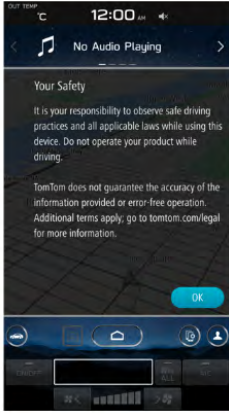
| Number | Category | Symptoms to be Improved: |
|---|---|---|
| 13 | Navi<br>Operation | <p>- The requirement to press ""OK"" on the Your Safety screen during the initial navigation launch sometimes wasn't displayed (only applicable to HIGH trim).</p> <p>Before the change:<br/>If the navigation app was launched for the first time from any icon other than the Map icon on the Home screen (e.g., through a rest suggestion feature) the Your Safety screen would not appear and navigation functionality could not be initiated.</p> <p>After the change:<br/>Even if the navigation app is launched for the first time from an icon other than the Map icon on the Home screen, the Your Safety screen will be displayed.</p> |

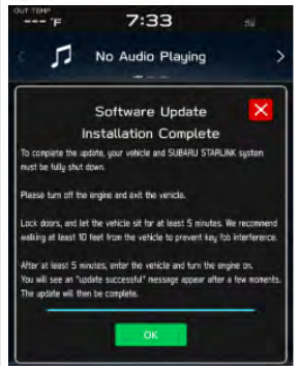
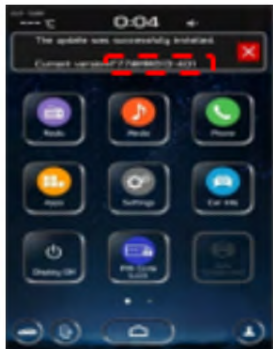
| Number | Category | Symptoms to be Improved: |
|---|---|---|
| 26 | Software Update | <p>- When the engine is turned off at a specific moment just before the completion of the CCU software update via FOTA, the expected completion notification screen does not appear when the engine is turned on next time (not applicable to BASE trim)</p> <p>- After the installation of software updates via OTA (Over-the-Air), the "Current Version" field in the popup screen that appears during the next IGN-ON may be blank or empty (not applicable to BASE trim)</p> |

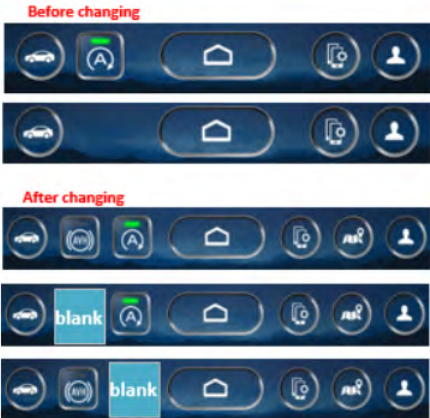
| Number | New Function or Enhancement |
|---|---|
| 9 | <p>- New shortcut button(s) are added in button bar of “Home” screen. AVH (Auto Vehicle Hold) ON/OFF Button for vehicle equipped with AVH (not applicable to BASE trim)</p> |

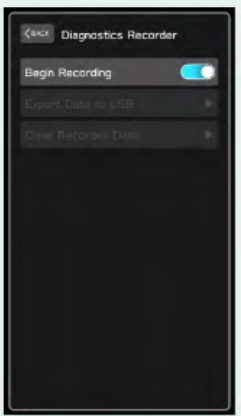
| Number | New Function or Enhancement |
|---|---|
| 11 | <p>When getting CCU USB logs at the Diagnostics Recorder screen in the Dealership Mode, it was necessary to turn off ""Begin Recording"" to ""Export Data to USB.""</p> <p>And after the log acquisition, it was necessary to turn ""Begin Recording"" ON again.</p> <p>The system interface is improved so that ""Begin Recording"" is automatically switched ON after log acquisition has been accomplished.</p> |

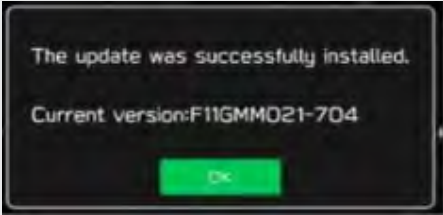
| Number | Symptoms to be Improved: |
|---|---|
| 15 | Popup of “The update was successfully installed” is not displayed after reboot (IG-OFF and ON) operation of FOTA (Firmware Over The Air) update.<br> |

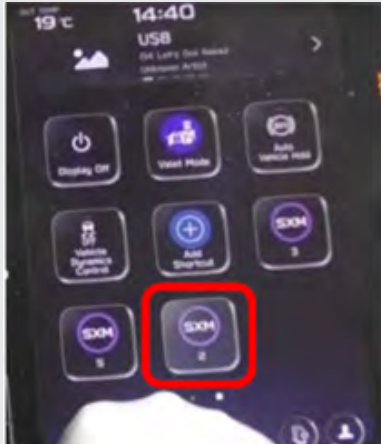
| Number | Symptoms to be Improved: |
|---|---|
| 6 | <p>SXM station shortcut created by the customer does not work when the SXM has not been used as audio source after the Ignition Switch was turned on in the ignition cycle.</p> |

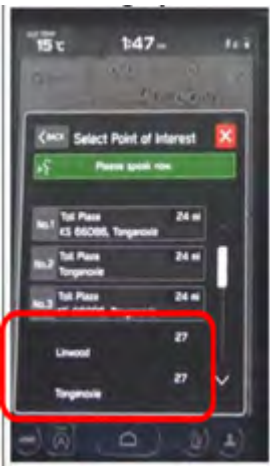
| Number | Symptoms to be Improved: |
|---|---|
| 9 | <p>POI Search Result shows only city names and distances (without unit) when voice recognition POI search with Category name like “Find toll gate” is used.</p> |

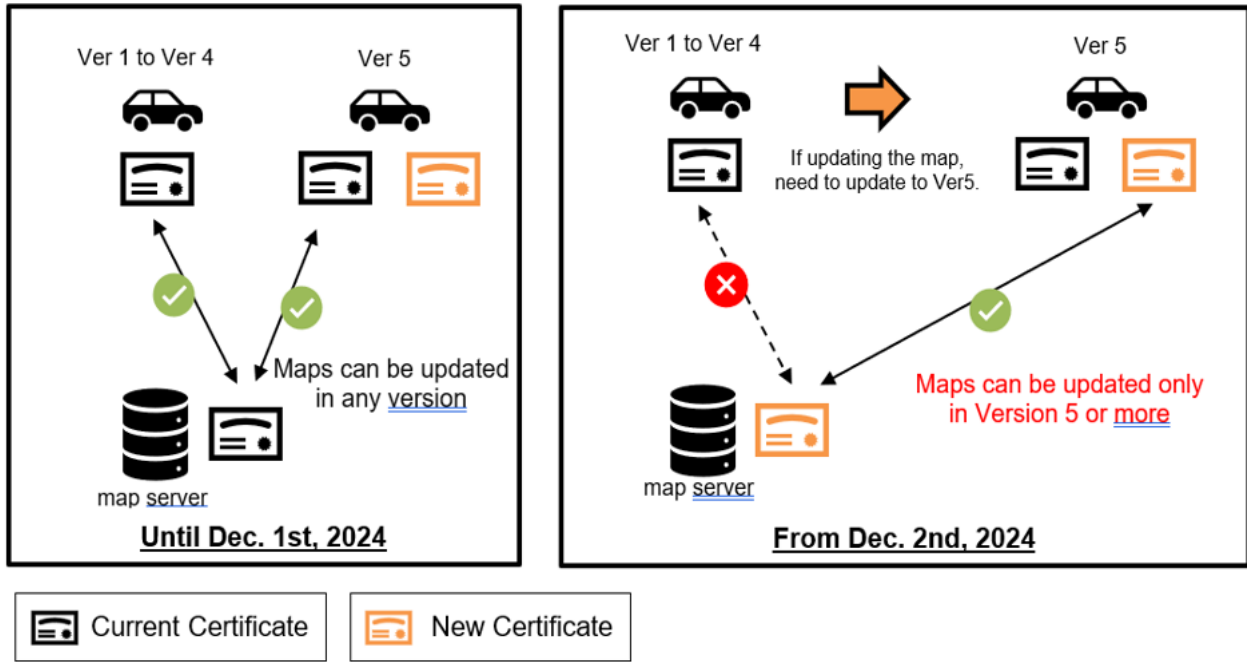
## APPENDIX 10

**IMPORTANT NOTE:** The certificate of the data distribution server for the map update service by Map OTA (MOTA) will be changed **from Dec 1<sup>st</sup>, 2024**, and the previous server certificate will no longer be eligible after **2<sup>nd</sup> December, 2024**. To get the MOTA service on and **after Dec 2<sup>nd</sup>, 2024, Ver. 5 software that includes new server certificate should be installed in advance.**
