# Service Bulletin

Bulletin No.: 22-NA-172

Date: January, 2025

**Subject: Trailer Tire Pressure Only Reading Up To 100 PSI (689 kPa), New Parts To Increase To 147 PSI (1013 kPa)**

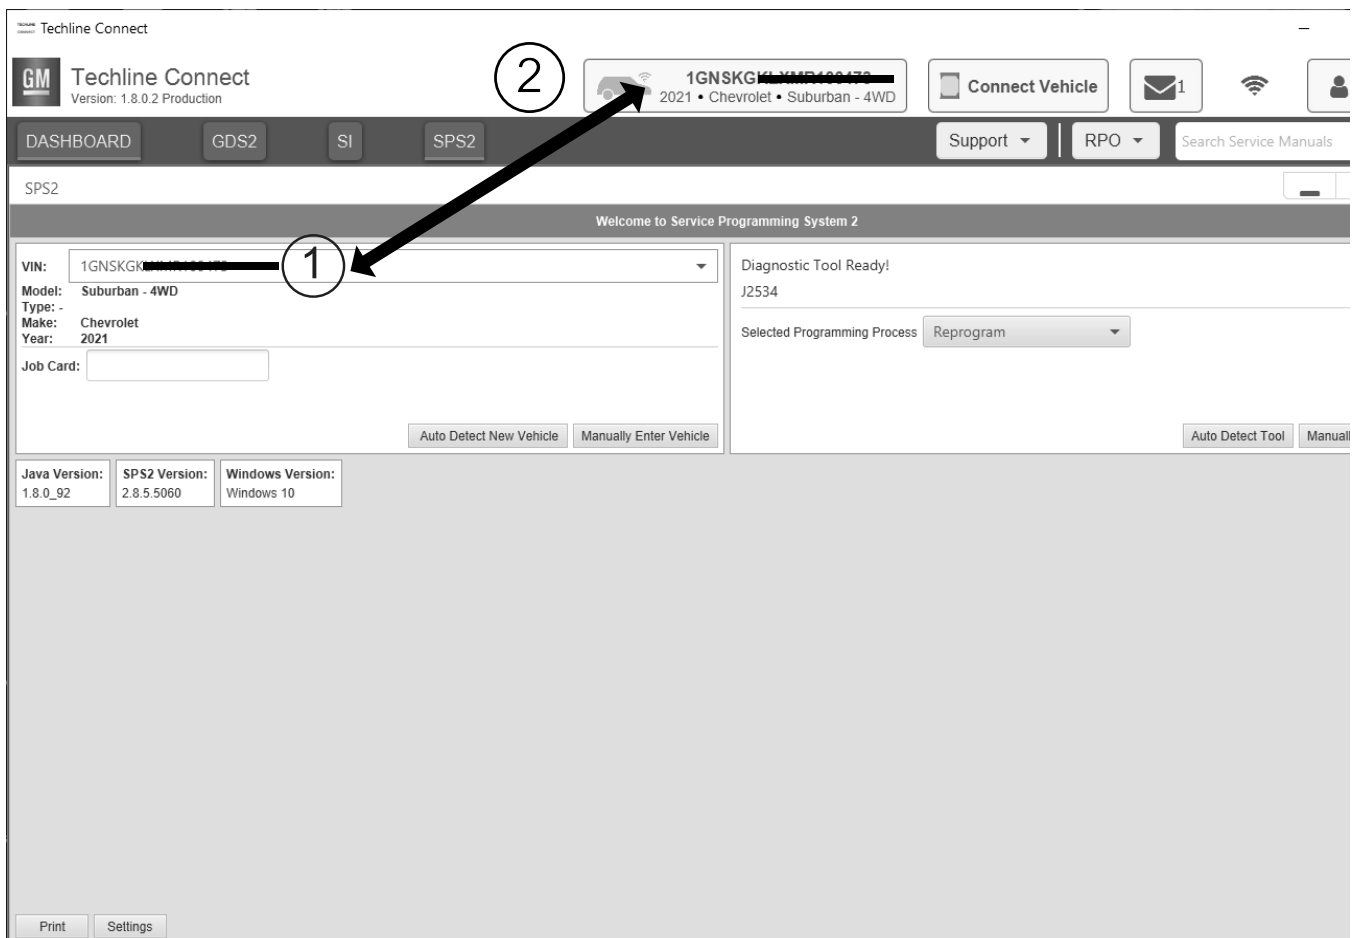
**Caution:** Be sure the VIN selected in the drop down menu (1) is the same as the vehicle connected (2) before beginning programming.
