91-25-01 - MIB Display Image Distorted

Release date: 1/9/2025

Applicable Vehicles					
Model(s)	Year	Eng. Code	Trans. Code	VIN Range From	VIN Range To
Atlas, Atlas Cross Sport	2024 - 2025	All	All	All	All

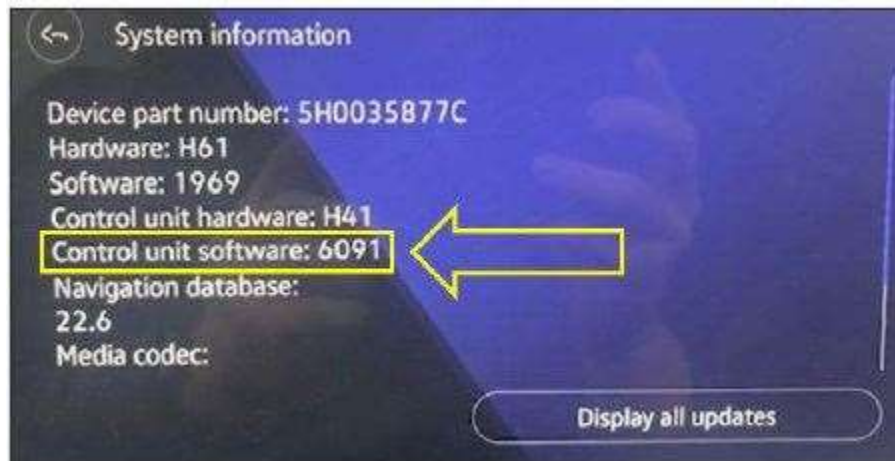
If the "Control unit software" is lower than **6098**, proceed with this Technical Bulletin.

If the "Control unit software" is greater than or equal to **6098**, this work procedure does not apply.

- Connect the MTRMSP0702 battery maintainer/charger to the vehicle's 12 volt battery.
- Switch the ignition to the ON position.
- Check the current software level by pressing the rounded square home key on the left side of the touchscreen menu.
- Select "Settings" on the touchscreen menu.
- Select "System Information" on the touchscreen menu.
