Service Bulletin

Bulletin No.: PIE0811A

Subject: Engineering Information - Service Engine Soon, Service Emission System, and/or Service Exhaust Fluid System Message on Driver Information Center (DIC), DTCs P249C, P20E8 Set

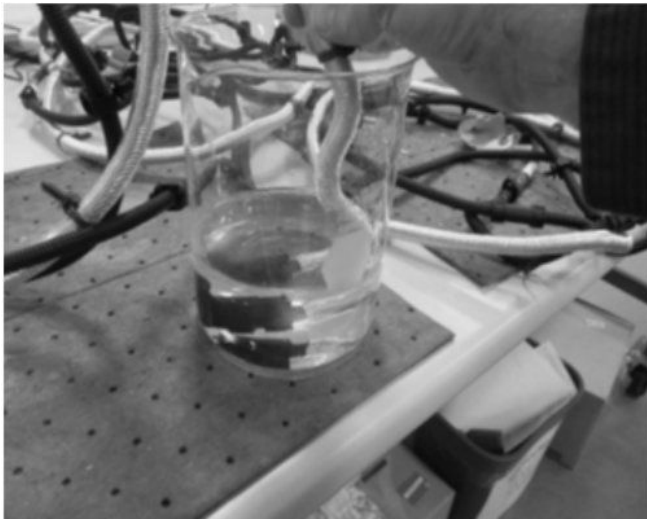
6793867

Note: This procedure cannot be performed if the Emission Reduction Fluid Exhaust Front Pipe Injector Supply Pipe connector is contaminated with other forms of contaminants such as frame wax or dirt inside the connector, as shown in the picture above. If this is the case, DO NOT perform the cleaning procedure as the Emission Reduction Fluid Exhaust Front Pipe Injector Supply Pipe will need to be replaced.

4. Submerge the Emission Reduction Fluid Exhaust Front Pipe Injector Supply Pipe connector end into the container filled with DEF, ensuring the open end of the connector is facing up, as shown in the picture above, and hold for 1 min. Swash around the connector while it is submerged in DEF for another minute to dislodge any crystals embedded inside the connector
5. Which side is the Emission Reduction Fluid Exhaust Front Pipe Injector Supply Pipe disconnected?
