Customer Satisfaction Program

N242478860 Heated Seat Icon Not Displayed on Virtual Cockpit Unit

Release Date: February 2025

Models: 2025 Chevrolet Blazer EV

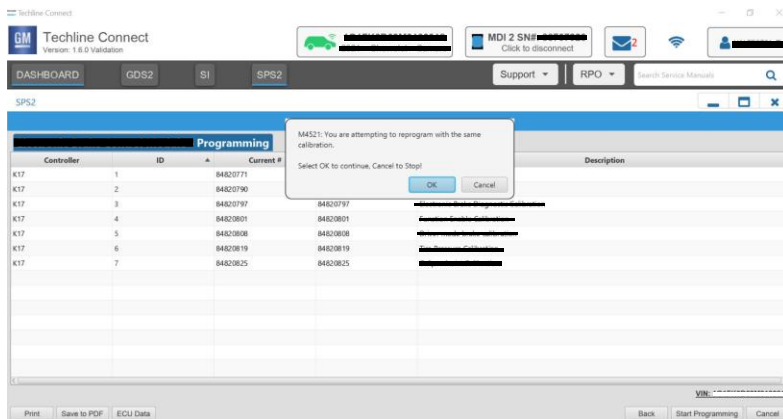
5644477

Important: Techline Connect screens shown above.

Important: If the same calibration/software warning is noted on the TLC Summary screen, select OK and follow screen instructions. After a successful programming event, the WCC is located in the Service Programming System dialogue box of the SPS Summary screen. No further action is required. Refer to the Warranty section of the bulletin.
