Technical Service Bulletin

GROUP FUEL SYSTEMS	NUMBER 25-FL-002G
DATE FEBRUARY 2025	MODEL(S) G70 (IK)

SUBJECT: HIGH PRESSURE FUEL PUMP REPLACEMENT
(WARRANTY EXTENSION Z05G)

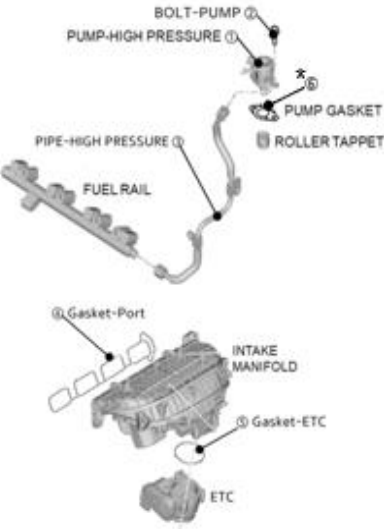
Pump – High Pressure 35320-2CTB1 (Figure 1: QTY 1)
			Bolt – Pump 11235-06226K (Figure 2: QTY 2)
			Pipe – High Pressure 35305-2CTA0 (Figure 3: QTY 1)
			Gasket – Port 28312-2CTA0 (Figure 4: QTY 1)
			Gasket – ETC 28313-2CTA0 (Figure 5: QTY 1)
	*Pump Gasket (Figure 6: Transfer from old and reuse. NOT included in kit.)		
	Pink Antifreeze (2 Quarts) 00232-19098WAR

NOTE: Above parts are for high pressure fuel pump replacement, only if the vehicle has **DTC P0088**. Please order the kit part number 35399-2C333QQH, not the individual parts.

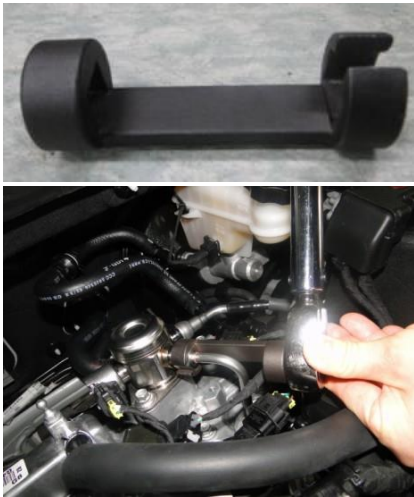
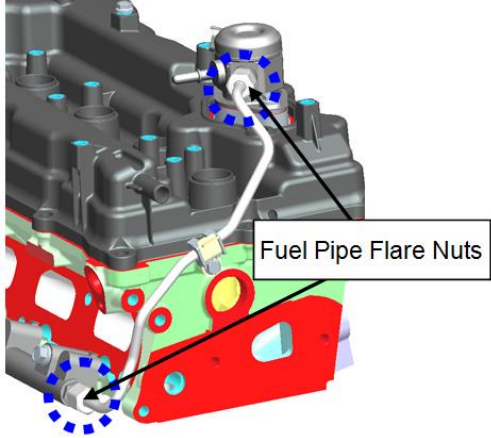
<p>Fuel Pipe Flare Nuts</p> <p>For tightening the flare nuts on both ends of the high pressure pipe.</p>
