STAR ONLINE PUBLICATION

Case Number: S2208000154 Rev. A

Symptom/Vehicle Issue: Service Hybrid Electric Vehicle System Message Displayed In The IPC. Vehicle Shakes During A Cold Start And Noise Is Heard Near The P2 Motor. DTC's U0287-00 And B273C-00

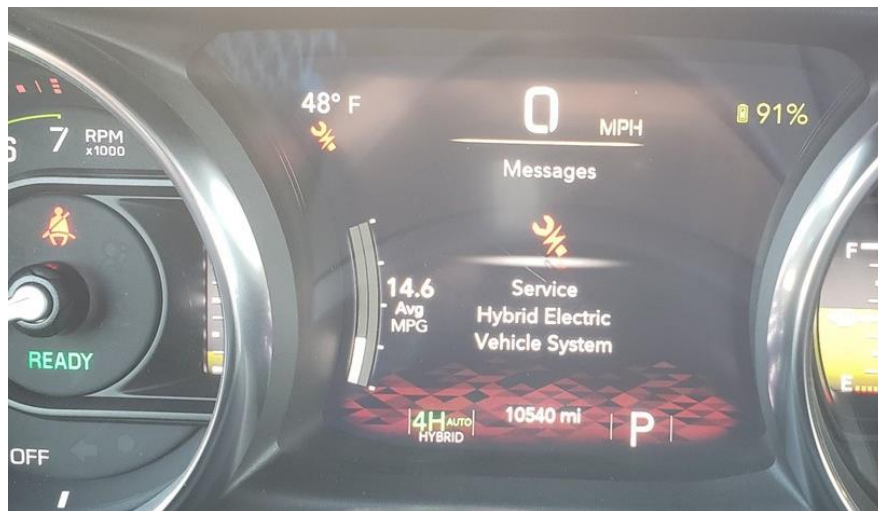
Diagnosis: The cluster may display the "Service Hybrid Electric Vehicle System" message. Upon scanning for DTCs, you may find U0287-00 – Lost Communication With Transmission Fluid Pump Set In The TCM. Along with B273C-00 – Digital Crash Input in the HCP. This may be caused by damage to the PIM to P2 High Voltage wiring harness. Or inductive noise from the damaged HV harness being transferred to the low voltage harness. You may also detect electrical noise on the R414 when using an oscilloscope to monitor the circuit.

Repair Procedure: If damage is found, replace the high voltage wiring harness. Follow all safety procedures for powering down and isolating the HV electrical system before removing any HV wiring.
