Technical Service Bulletin (TSB)
Telematics Box Module (TBM) Firmware Over The Air (FOTA) Software Updating from 4.37 to 4.38

REFERENCE:	TSB: 08-039-25 GROUP: 08 - Electrical	Date:	February 19, 2025	REVISION:	—
VEHICLES AFFECTED:	2021 - 2024 (RU) Chrysler Pacifica 2021 - 2024 (WD) Dodge Durango 2021 - 2024 (MP) Jeep Compass This bulletin applies to vehicles equipped with Global Telematics Box Module (Sales Code RDG).	MARKET APPLICABILITY:			
		<input checked="" type="checkbox"/> NA <input type="checkbox"/> MEA <input type="checkbox"/> SA <input type="checkbox"/> IAP <input type="checkbox"/> EE <input type="checkbox"/> CH			
CUSTOMER SYMPTOM:	Customers may not experience the following: <ul style="list-style-type: none"> Update URL's for ADA's whitelist – to collect data from ADAS customer. No customer impact. No customer symptoms. Other Software Enhancements included: <ul style="list-style-type: none"> Improves vehicle data communication with server for App data management performance. 				
CAUSE:	TBM Software

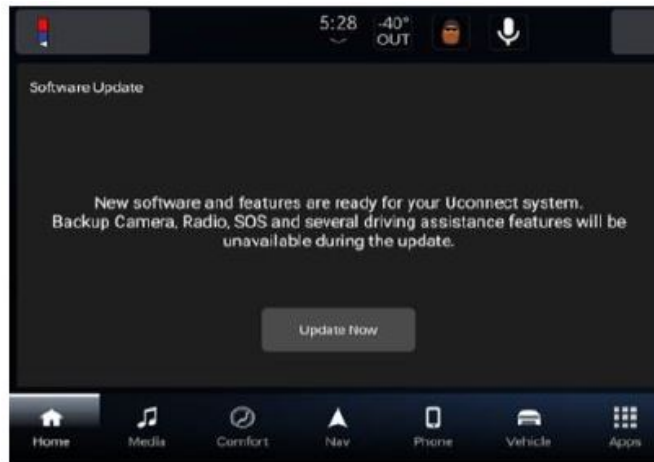
**Fig. 2**

Software Acceptance Screen

1. The vehicle needs to be in 'Park'. The ignition needs to be in the off position.
2. If the customer selects “Update Now” [Fig. 2](#) they can shut off the vehicle and leave. The update will be completed automatically.

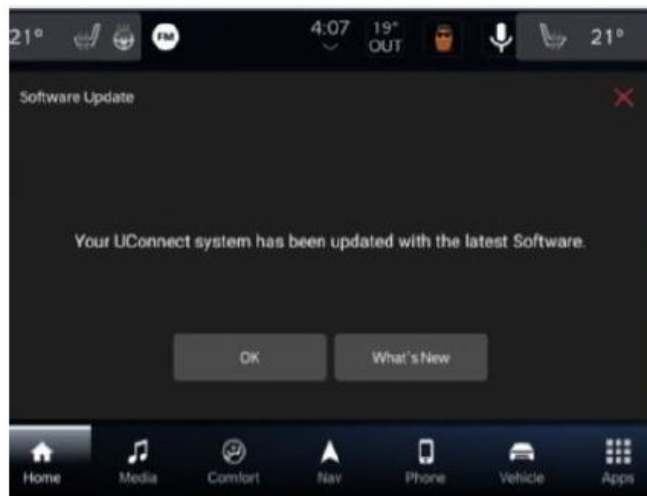
**Fig. 3**

3. Upon completion of update, the radio will display a confirmation message [Fig. 3](#).

Software Update Confirmation Screen
