**Location:** Hybrid / Electrical

**Topic:** McLaren Artura eMotor Overtemperature Diagnosis Guide

**Diagnostic Trouble Codes:** P0A2A29 P160068 P0A2A1C P0A2B98

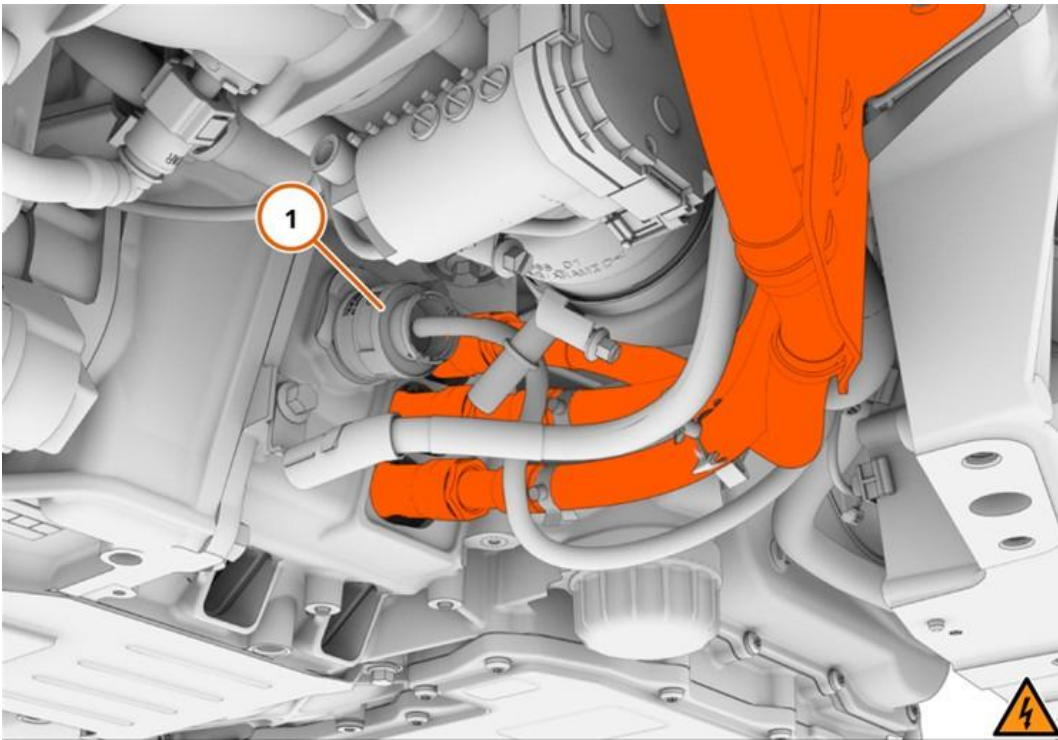
**Care Point:** During the following resistance checks, please wiggle wiring where possible at each tested connector to try and identify poor connections. Also check each connector for signs of water/corrosion and damaged/backed out pins.  
 For convenience it is recommended to start checking the round transmission connector first.

*transmissionexternal-to-transmissionhtm* Disconnect the round connector (1) in the image above.

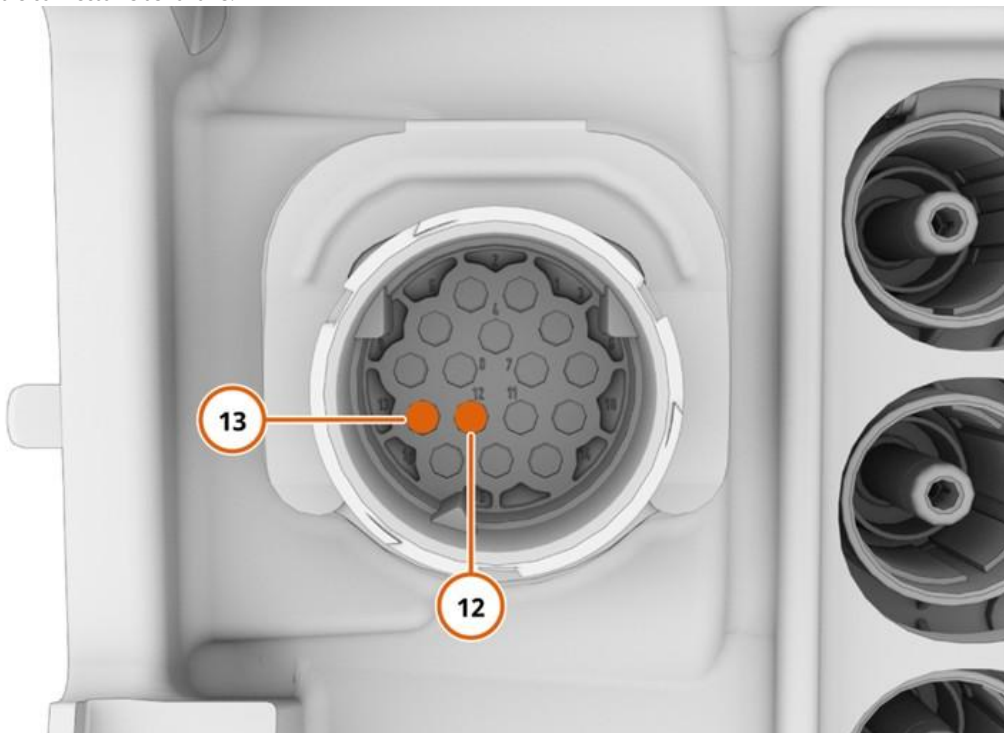
*transmissionexternal-to-transmissionhtm* (Round connector - male) Check connectors for:

- Connectors not fully engaged
- Corrosion
- Pins backed out from connectors

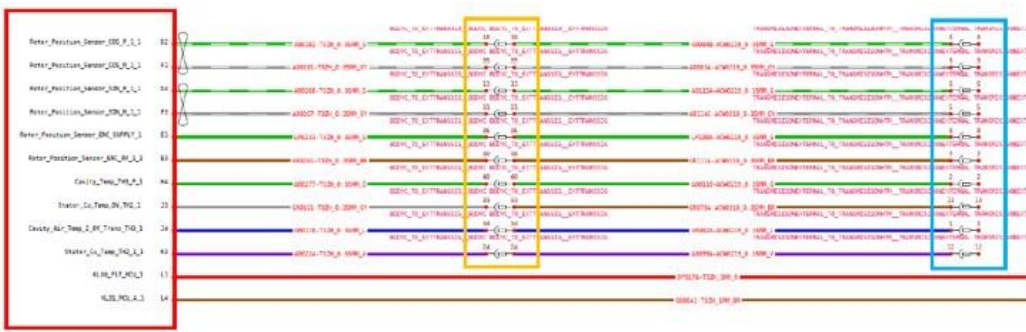
The Stator winding thermistor pins are 12 and 13 (blue section) as per the above schematic .  
 Locate pins 12 and 13 in the round connector as shown in the image above. Set  
 a multimeter in resistance mode as shown in the image below:

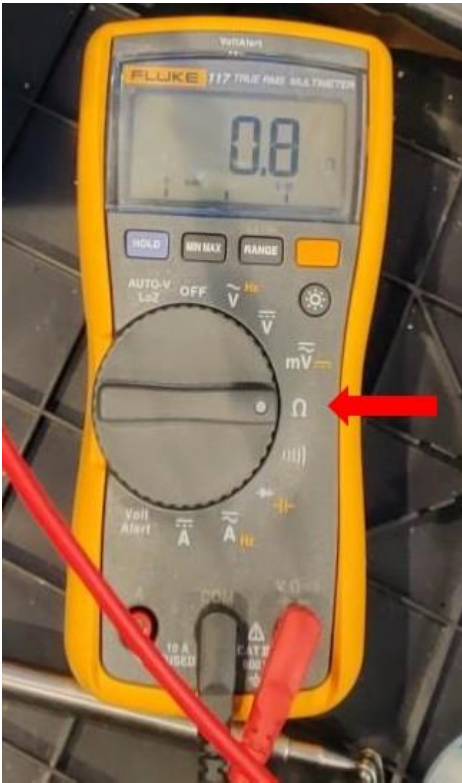
Connect the multimeter positive probe to pin 12.  
 Connect the multimeter negative probe to pin 13.

According to the specification, the resistance at ambient temperature should be between **1077.9 Ω** and **1155.4 Ω** as shown in the example below:

If the resistance value is not between the range specified above, please take a picture of the value and the measuring points on the connector, and attach your findings to the TR.

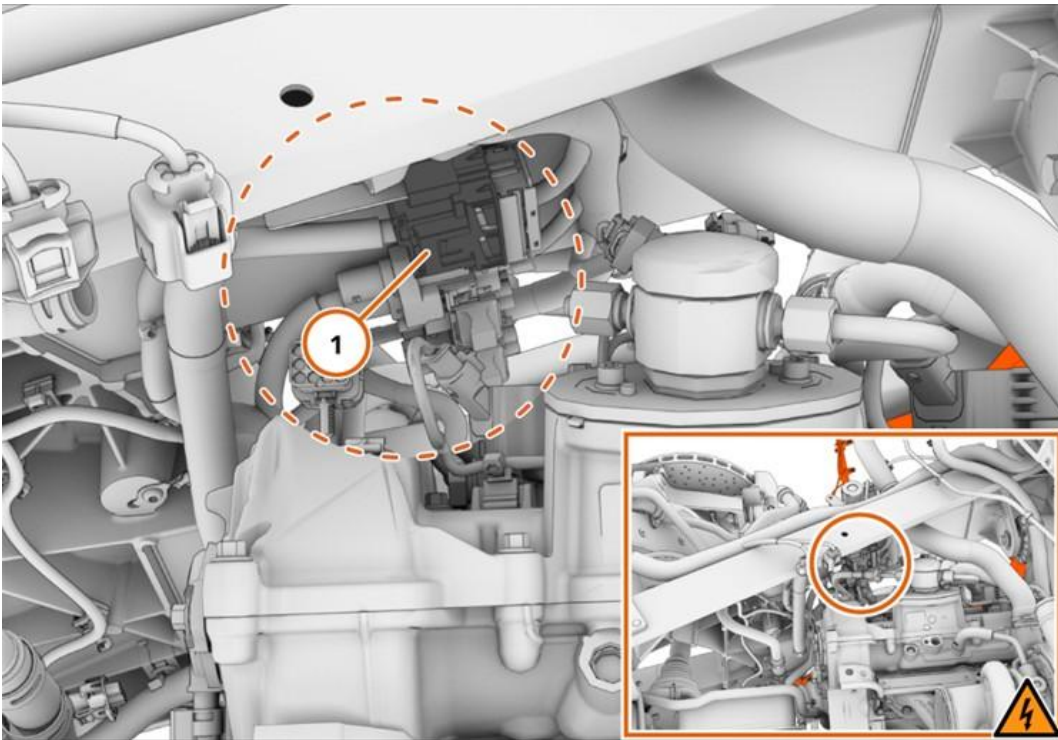
*Transmission in-line connector*

This connector is located in the left part of the rear subframe as shown in the picture below:

This connector can be accessed by removing the rear left wheel arch liner or through the top service hatch.

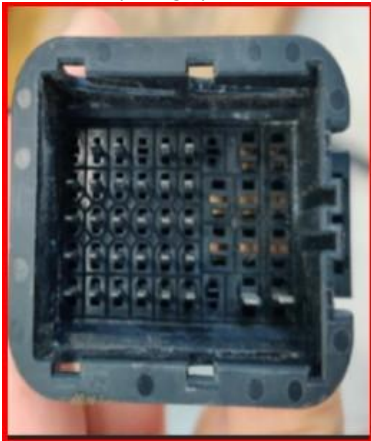
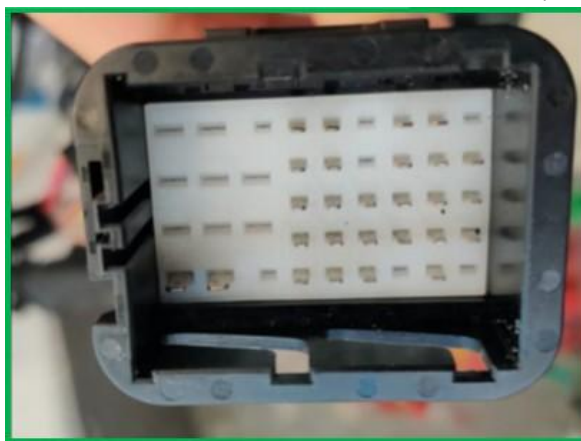
Please take a photograph of the male connector and comment in the TR if a white seal is fitted as shown in the picture below.

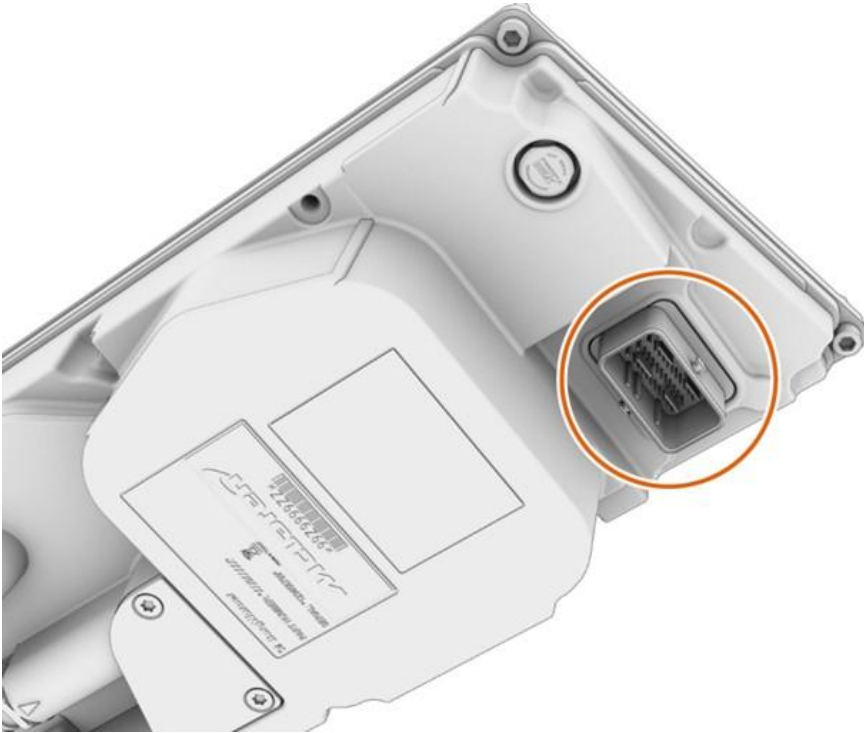
#### MCU connector location

To perform this check, it is required to have access to the low voltage (LV) connector on the MCU. For this reason, it will be necessary to remove the HV battery and the fuel tank. Once there is access to the MCU the steps are as follows:

Disconnect the LV connector in the MCU

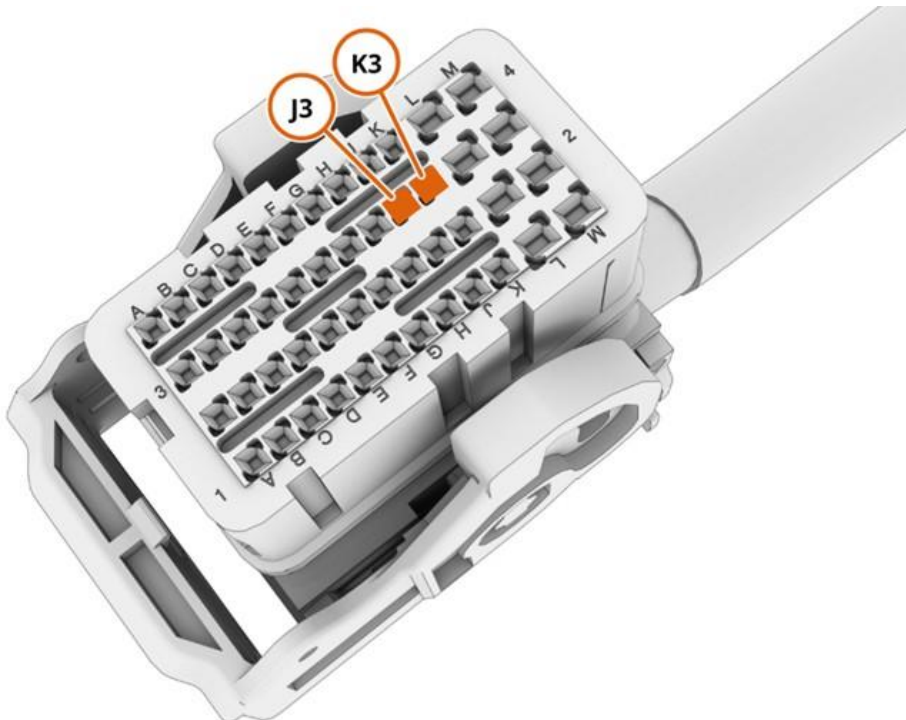
#### Winding thermistor pins K3 & J3 in the MCU female connector

The thermistor resistance can be read in the PINs K3 & J3 of the MCU female connector as per the electrical schematic:

As the pin holes are small, use a suitable piece of wire of a diameter no greater than 0.7mm to insert in the correct location as in the example below:

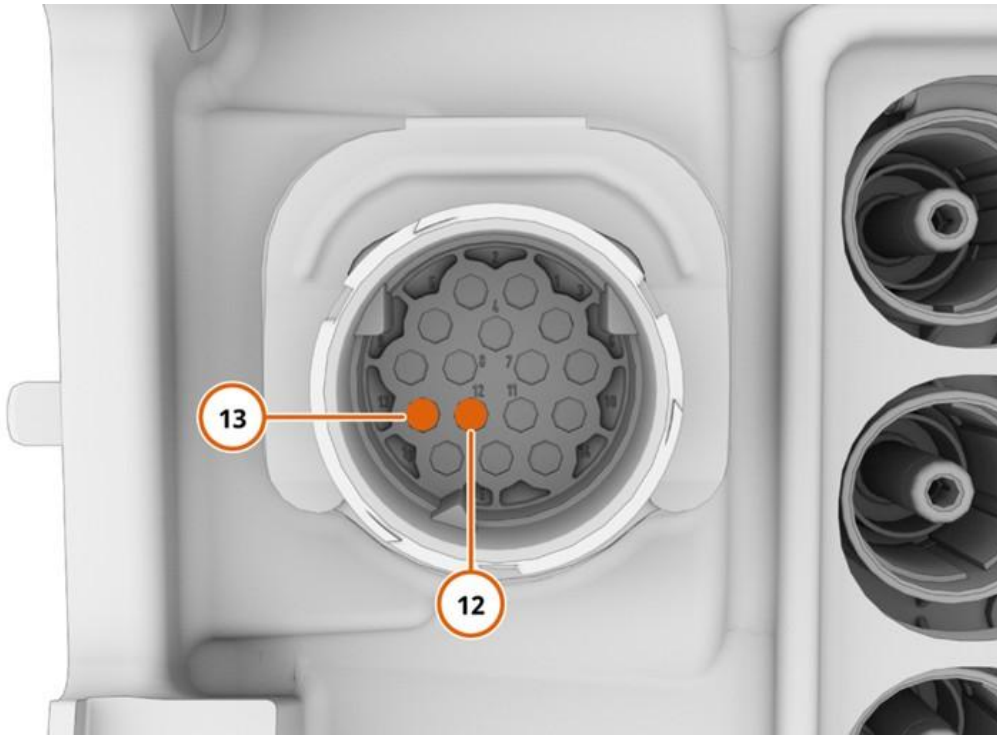
If advised through the TR to remove the transmission, please re-check the resistance at pins 12 and 13 again of the round connector. Check for resistance fluctuations while wiggling all transmission harness cables.
