Technical Service Bulletin

SUNROOF RATTLE NOISE

Bulletin No.: 09-010/25

2023-2025 CX-50

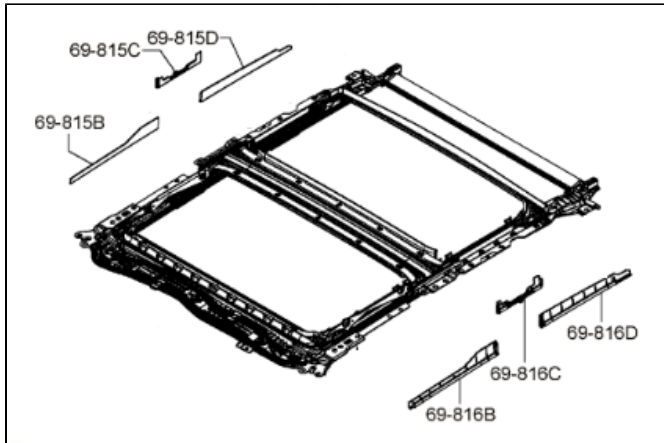
Do they have non-woven felt as shown in the image in step 3?

2. Order all 6 link covers and inspect them for non-woven felt.
