## SERVICE BULLETIN

**APPLICABILITY:** 2010-19MY Legacy and Outback  
 2014-19MY Forester  
 2012-19MY Impreza  
 2013-19MY Crosstrek (Exc. 19MY PHEV)  
 2015-19MY WRX  
 2019-20MY Ascent

**NUMBER:** 16-103-16R

**SUBJECT:** Transmission Fluid Seepage

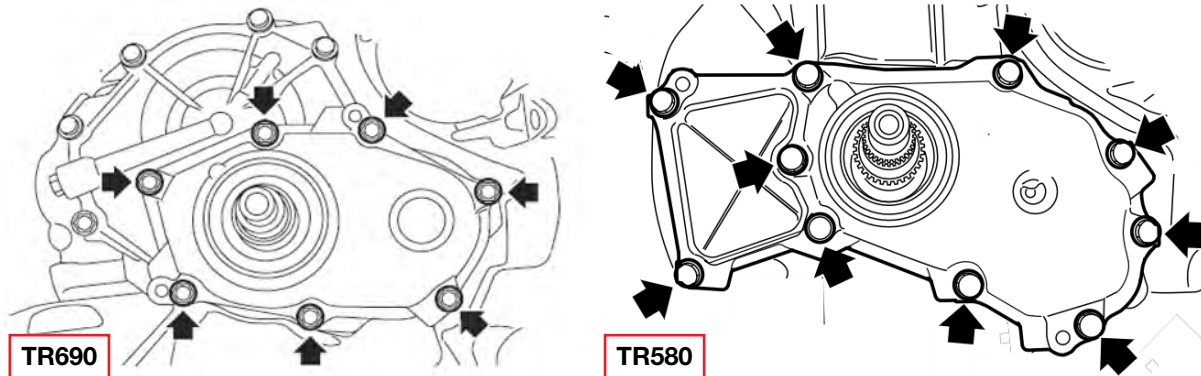
- Remove the 7- (TR690) or 10- (TR580) 12mm hex bolts securing the oil pump chain cover.

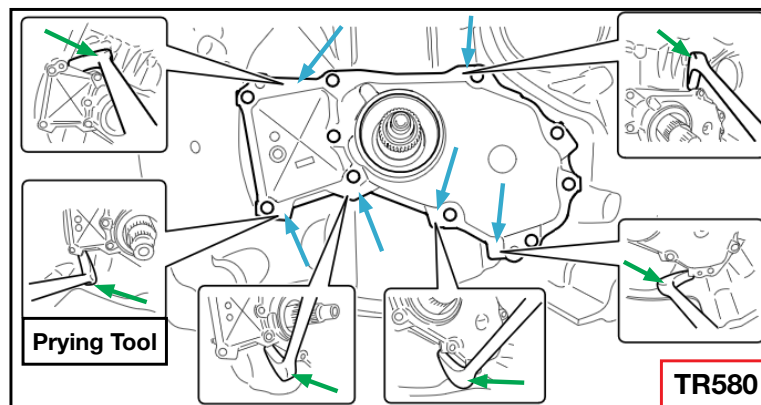
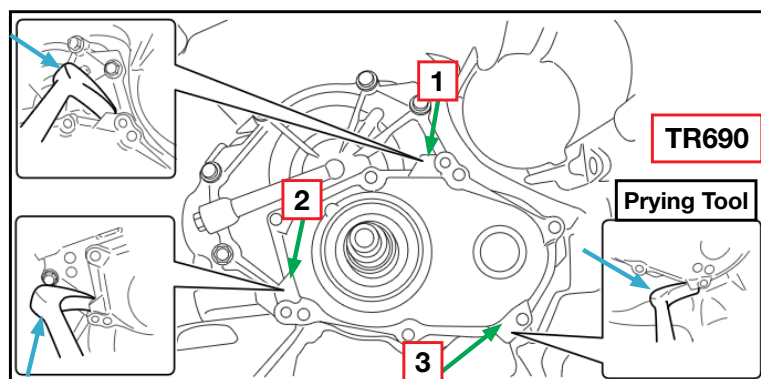
- Using a prying tool, **CAREFULLY** pry (GREEN arrows IN THE ORDER SHOWN for **TR690** model) the cover loose from the housing. Pry **ONLY** on the specific areas or “tabs” of the pump cover indicated by the BLUE arrows. When the cover starts to come loose, continue to pry **ONLY** on the tabs and not the machined sealing surface of the cover.

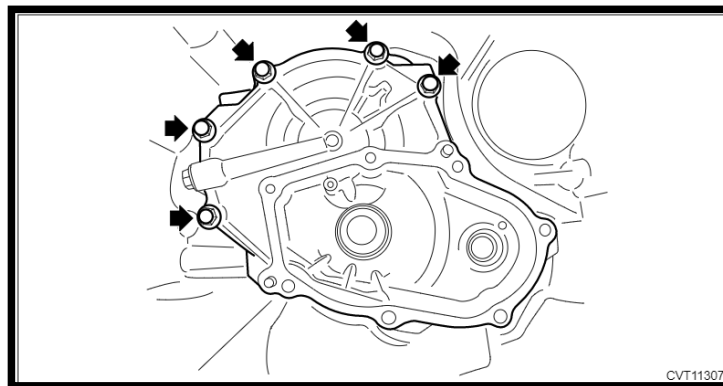
- Remove the 5 – 12mm hex bolts securing the converter case in a crossing pattern.

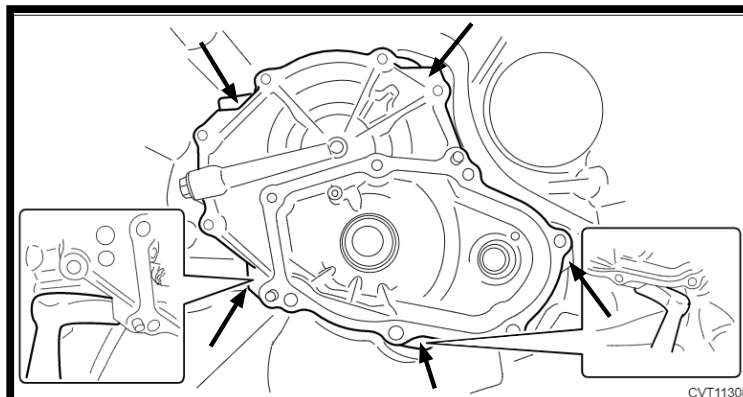
- Using a prying tool, **CAREFULLY** pry the cover loose. Pry **ONLY** on the specific areas or “tabs” of the converter case cover. Once the cover is loose, continue to pry only on the tabs and not the machined sealing surfaces.

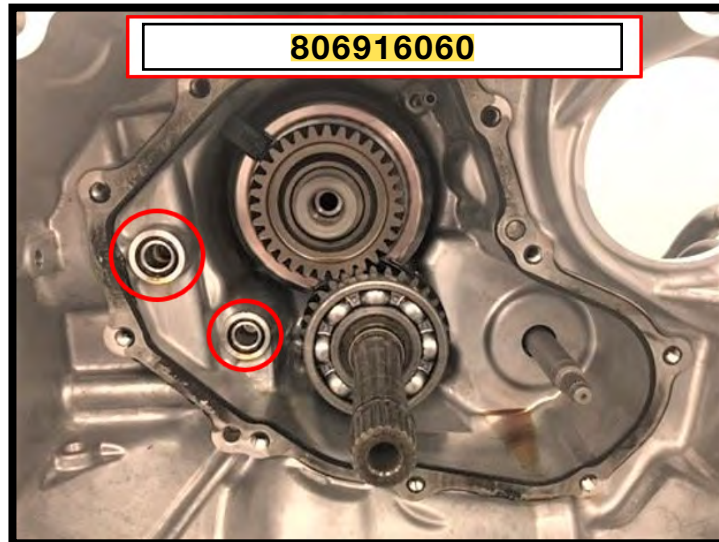
- Remove and replace the two **one-time use** o-rings (806916060).

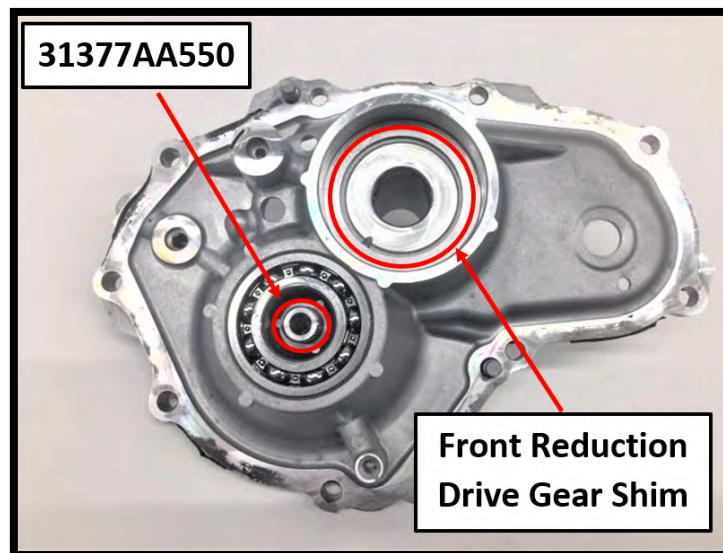
- IMPORTANT:** Always confirm the front reduction drive gear shim stays with the converter case cover when removing and prior to re-installation.

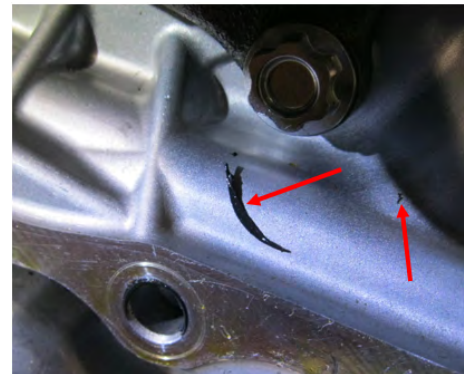
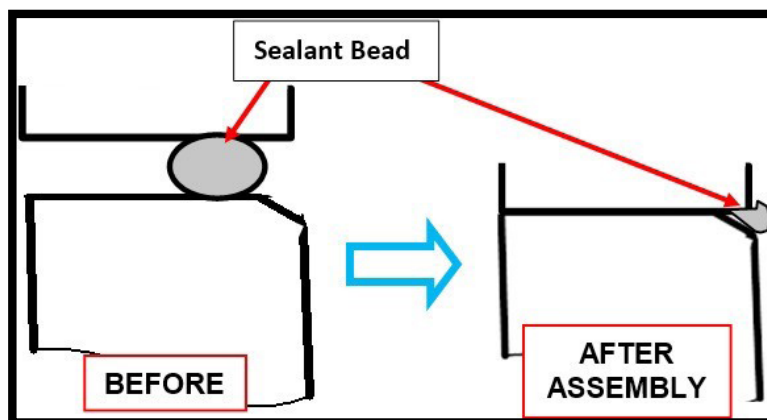
- **CAREFULLY** remove all residual sealant completely from the cover and mating surface of the housing. **DO NOT** use any abrasive or gasket removal / cleaning discs. Use the adhesive side of a piece of duct tape (or equivalent) to pick up any loose pieces of sealant material which may be found in the cavity around the stator support. **DO NOT** use compressed air.

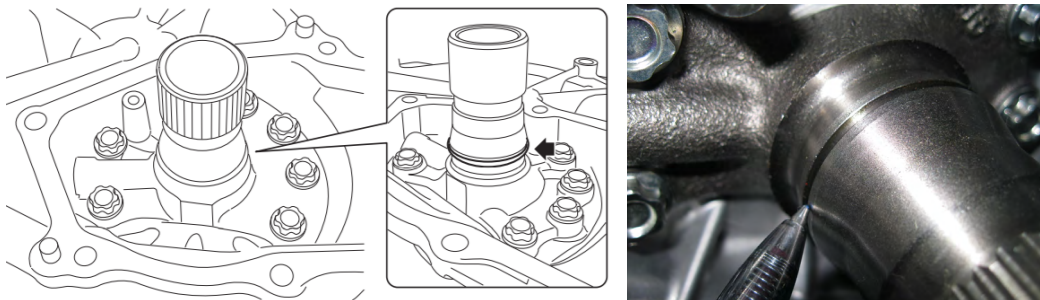
- Inspect both of the machined sealing surfaces closely for irregularities. If necessary, replace the cover following the applicable Service Manual procedures. **The Service Manual uses a black star (★) in the component breakdown illustrations to indicate one-time use parts.**
- **NOTE:** Should the cover need to be replaced, always confirm the new part has the new-style input shaft seal with the additional side lip as described below before installation.
- **IMPORTANT:** Before reassembly, always replace the **ONE TIME USE** plastic sealing ring on the center support and thoroughly lubricate it with CVT fluid.

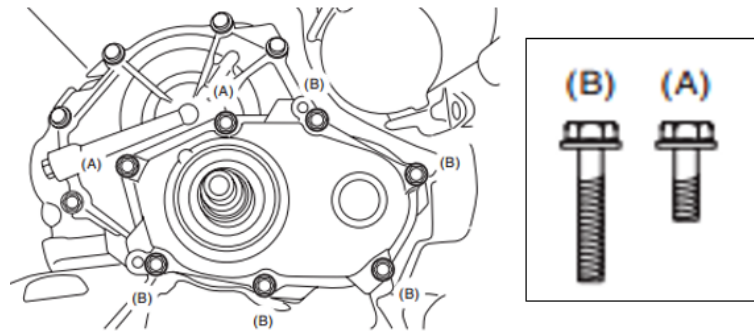
- On the TR690, there are 2 different length bolts for the pump cover. Make sure the proper length bolts (**A** and **B**) are in their respective holes as shown below. Torque to **24 Nm (17.7 ft. lbs)** in a crossing pattern.
