This Service Information Bulletin (Revision 1) replaces SI B41 01 25 **dated February 2025**.

E-Series	Model Description	Production Date
F74	2 Series Gran Coupe	January 9, 2025 – January 15, 2025

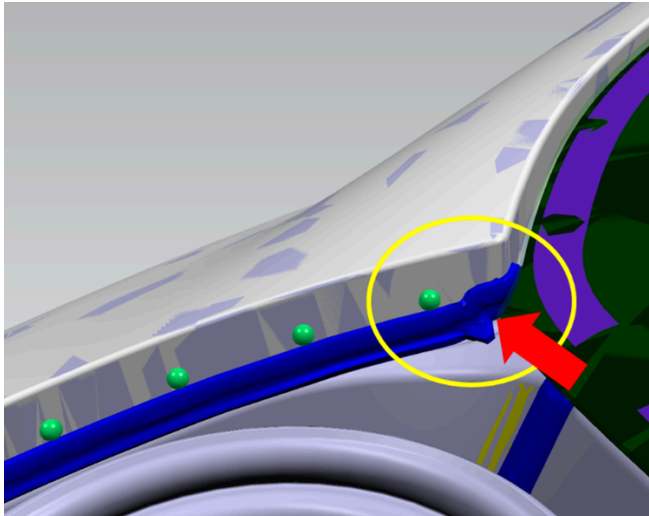
- Check the borescope display to see whether water is entering the vehicle through the crack/tear.
- Submit a **TSARA info only case** titled “F74 water channel inspection” with photos of the crack/tear and a video of water **entering/not entering** the vehicle through the crack/tear for further instructions/procedures.
