TECHNICAL SERVICE BULLETIN

2021-2023 Bronco - Soft Top Roof - Headliner Detaching From Soft Top Material

25-2077

10 March
2025

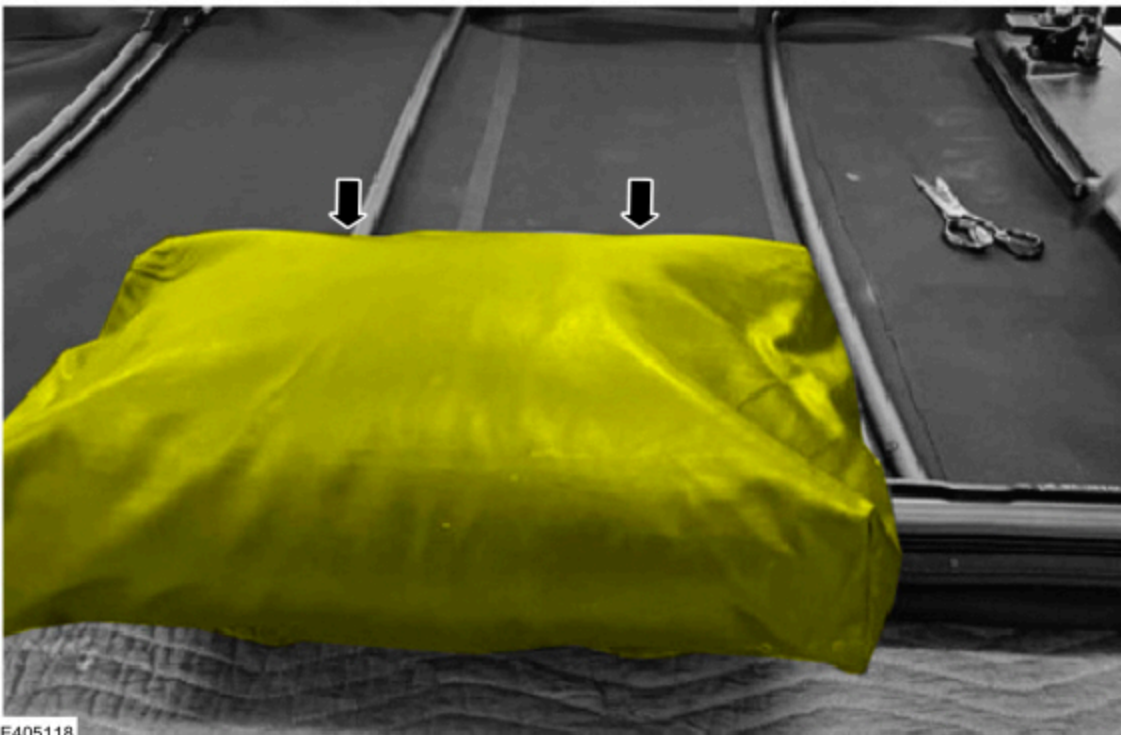
Figure 7 - Sandbag shown on top of frame hinge location. Left side shown, right side similar.

(2). Place a 50 lb. (22.6 kg) sandbag (or similar item) on each the side of the frame to weigh down the raised hinged sections of the frame. This flattens the soft top assembly for easier application. If needed, place a clean cloth underneath the sandbags to prevent the soft top assembly from getting dirty. Refer to Figure 7.
