SIB 51 07 23

UPPER AND LOWER TAILGATE DIAGNOSIS

This Service Information Bulletin (Revision 04) replaces SI B51 07 23 **dated April 2024**.

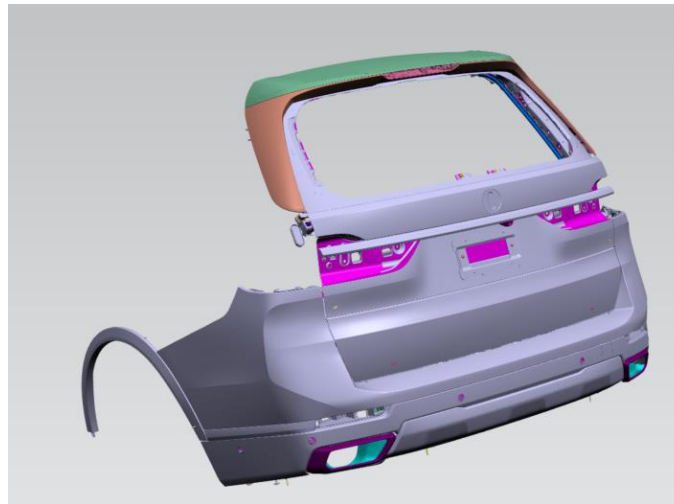
INSTRUCTION FOR LATCH RELEASE

To release the latch manually, the lower tailgate trim will have to be removed/broken. There is a lever that can be pulled directly on the latch to release it.
