GROUP	MODEL
Voluntary Emissions Service	2021-2024MY
Campaign	K5 (DL3a)
	w/1.6L T-GDI
NUMBER	DATE
SC288 (Rev 5, 3/19/2025)	April 2024

# VOLUNTARY EMISSIONS SERVICE CAMPAIGN

FUEL TANK AND/OR PCSV CHECK VALVE INSPECTION/REPLACEMENT + ECU SW UPGRADE (SC288)

This bulletin provides information to inspect the fuel evaporative system and, if necessary, replace the fuel tank and/or the Purge Control Solenoid Valve (PCSV) check valve on certain 2021-2024MY K5 (DL3a) vehicles equipped with a Gamma II 1.6L T-GDI engine, produced from March 27, 2020 through October 17, 2023. This bulletin also provides information to upgrade the ECU software logic. The subject vehicles may experience fuel tank swelling due to an issue with the PCSV check valve, which results in pressurized air to flow into the fuel tank. This may cause the Check Engine Light to illuminate, and in some cases, the engine to run rough, and/or an inability to refuel. These conditions may cause the vehicle to release air pollutant which exceed Federal and California standards.

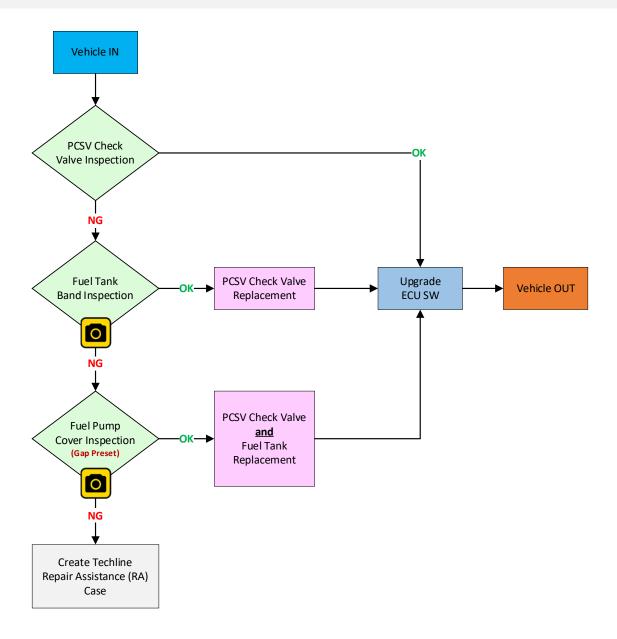
#### Flowchart:

Path 1: Vehicle IN → PCSV Check Valve Inspection (OK) → Upgrade ECU SW → Vehicle OUT

**Path 2:** Vehicle IN  $\rightarrow$  PCSV Check Valve Inspection (NG)  $\rightarrow$  Fuel Tank Band Inspection (OK)  $\rightarrow$  PCSV Check Valve Replacement  $\rightarrow$  Upgrade ECU SW  $\rightarrow$  Vehicle OUT

Path 3: Vehicle IN → PCSV Check Valve Inspection (NG) → Fuel Tank Band Inspection (NG) (attach photo) → Fuel Pump Cover Inspection (OK) → Fuel Tank <u>and</u> PCSV Check Valve Replacement → Upgrade ECU SW → Vehicle OUT

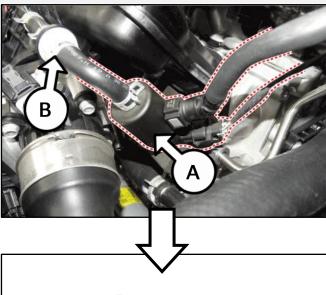
1. Open the hood and locate the Purge Control Solenoid Valve (PCSV) (A).

2. Disconnect the PCSV check valve (B) from the outer hose clamps ends shown.

<u>Note</u>: The <u>new</u> PCSV check valve (B) assembly <u>comes</u> pre-assembled with new hose clamps and vapor hoses.
