Ford Motor Company
PO Box 1904
Dearborn, Michigan 48121

March 7, 2025

SUBJECT: Update Prior to Sale 24U12
Certain 2024 Model Year Ranger Vehicles
Inspect/Replace Restraint Connectors

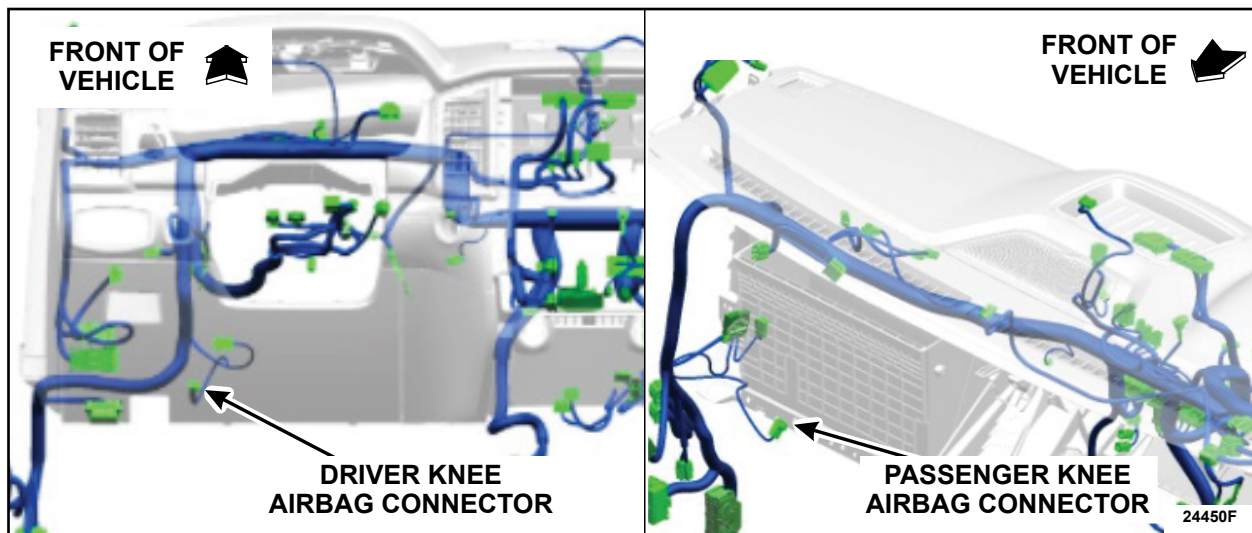
FIGURE 1

1. Depower the Supplemental Restraint System (SRS) system. Follow Workshop Manual (WSM) procedures in Section 501-20B.
2. Disconnect the driver knee airbag and passenger knee airbag electrical connector. See Figure 1.

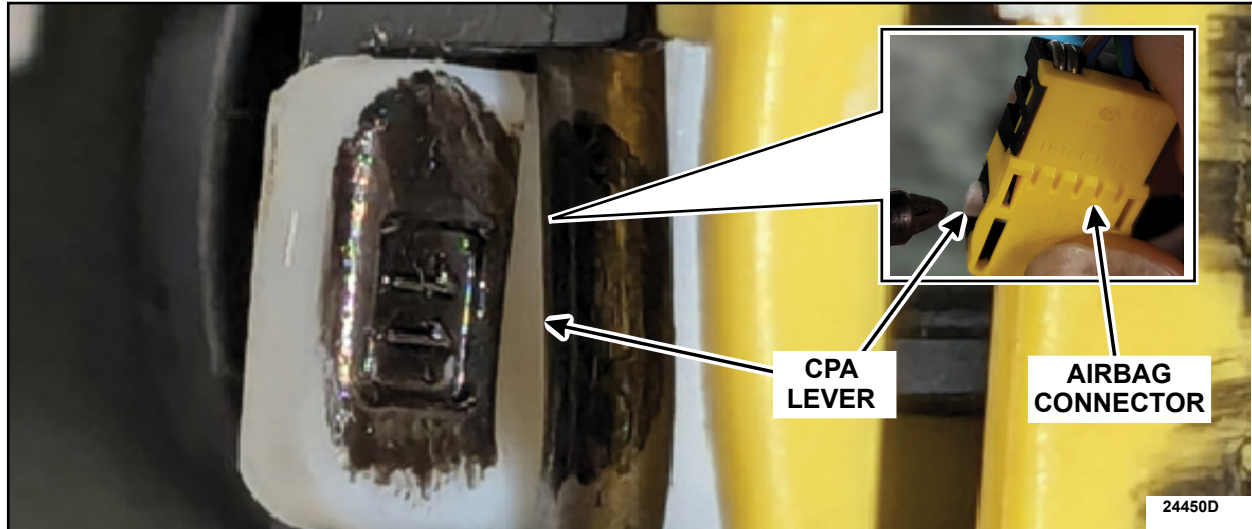
FIGURE 2

5. On the driver knee airbag connector, passenger knee airbag connector and both side curtain airbag electrical connectors carefully mark the Connection Position Assurance (CPA) lever with a black permanent marker. See in Figure 2.

NOTE: Using a permanent marker will make reading the number on the CPA lever easier. Do not use a grease pen or paint marker.

7. If any of the CPA levers have number(s) called out in Step 6, replace that electrical connector pigtail. Follow the repair procedures in Cell 005 of the Wiring Diagrams on Professional Technician System (PTS), using the soldering, butt connectors and shrink tube method.
