Technical Service Bulletin

Topic	55 Tail light collides with rear lid, paint is coming off rear lid below tail light
Market area	United States 444 Volkswagen of America, Inc. (6444)
Brand	Audi
Transaction No.	2071125/2
Level	EH
Status	Released for publishing
Release date	Mar 10, 2025

Q4 e-tron

Q4 Sportback e-tron

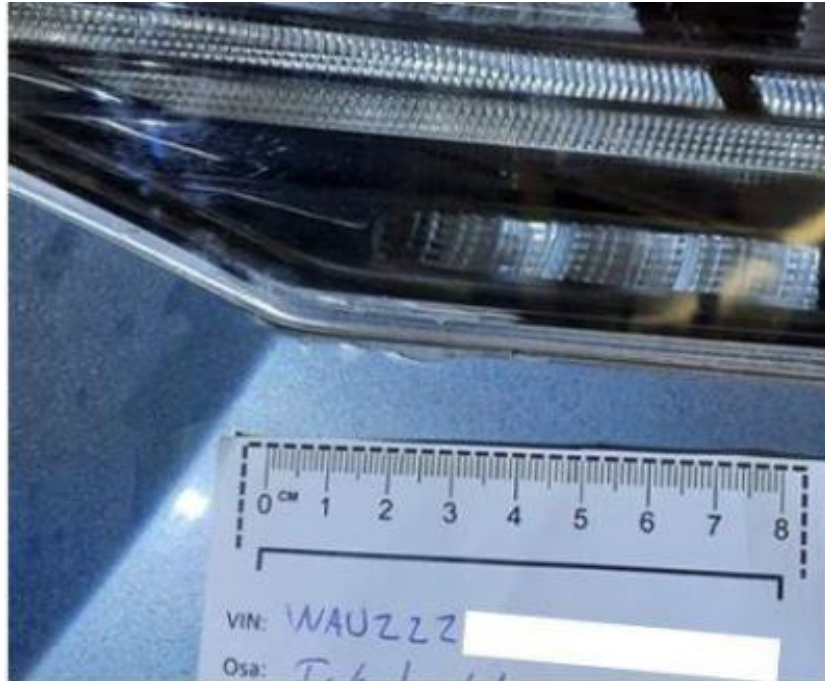
Figure 6. Observe required documentation.

Should be in focus and taken with sufficient light. A high resolution is not necessary.

If appropriate, please mark the location of the problem so that parts analysis has a clear reference to the complaint. Please ensure that the photo documentation does not show any persons and/or face, license plates, or customer data.
