Technical Service Bulletin

Topic	55 Taillight collides with rear lid, paint is coming off rear lid below taillight
Market area	United States 444 Volkswagen of America, Inc. (6444)
Brand	Audi
Transaction No.	2071125/3
Level	EH
Status	Released for publishing
Release date	Mar 18, 2025

Q4 e-tron

Q4 Sportback e-tron

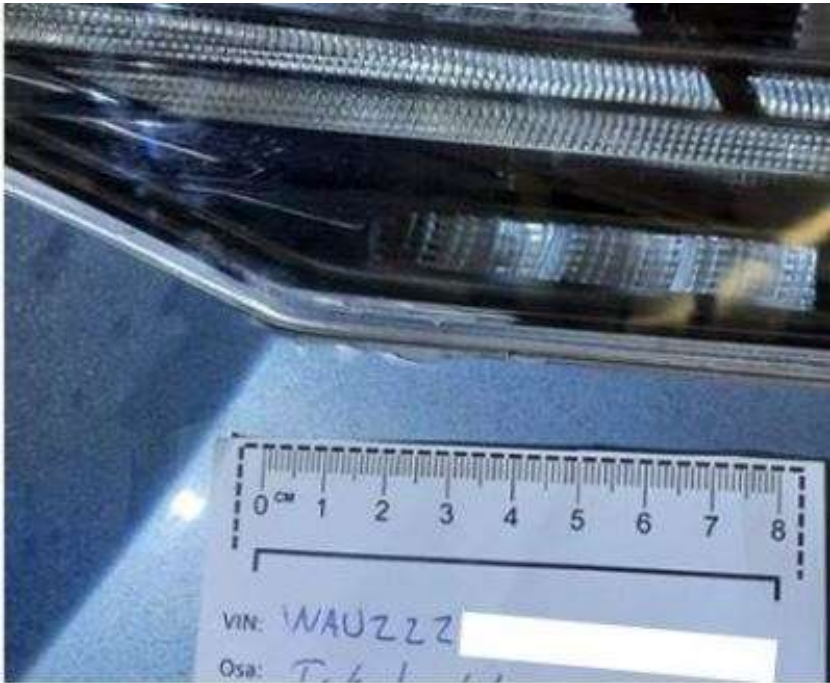
Figure 6. Observe required documentation.

Should be in focus and taken with sufficient light. A high resolution is not necessary.

If appropriate, please mark the location of the problem so that parts analysis has a clear reference to the complaint. Please ensure that the photo documentation does not show any persons and/or face, license plates, or customer data.
