## Technical Service Bulletin

<b>Topic</b>	93 Charging door does not open when button pressed - B1A8FF0, B1A89F0, B1A8AF3, B1A88F3
<b>Market area</b>	United States 444 Volkswagen of America, Inc. (6444)
<b>Brand</b>	Audi
<b>Transaction No.</b>	2071343/2
<b>Level</b>	EH
<b>Status</b>	Released for publishing
<b>Release date</b>	Mar 31, 2025

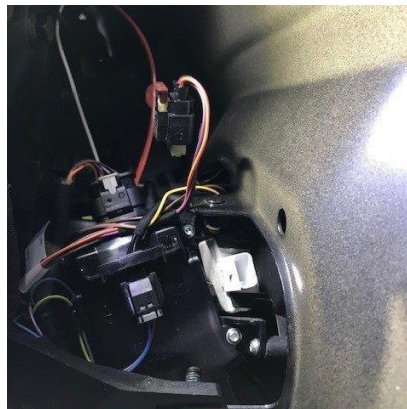
1. Unplug the connector from the charging indicator (Figure 4).  
Check the contacts and connector of the charging indicator(s).

**Figure 4:** The connector has been unplugged.

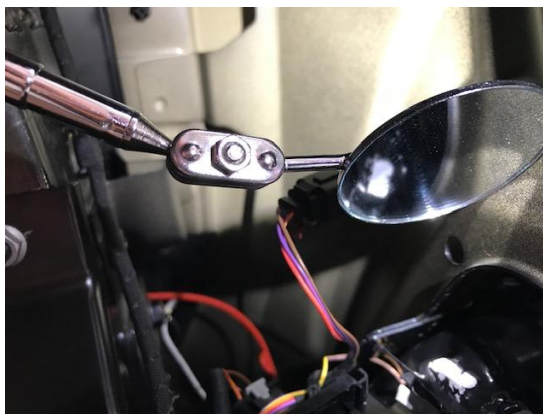
**Figure 6:** Use inspection mirror to carefully examine the charging indicator connector.

3. Check the connector point on the charging indicator for cracks (Figure 1).

If the connector point is cracked or the pins are oxidized (Figure 7), replace the damaged charging door unit as described under the heading **“Removing and installing charging door unit”** below.

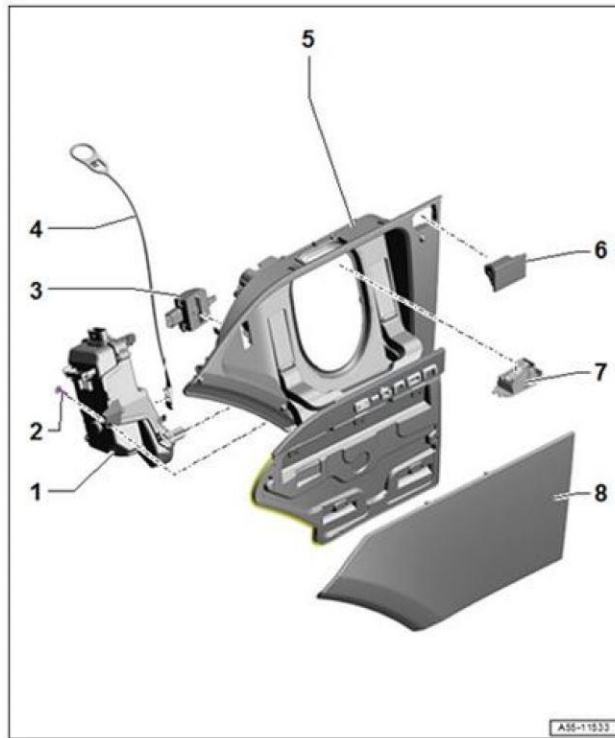
**Figure 9:** Charging door unit (5) must be removed.

1. Remove charging door unit -5- (Figure 9).

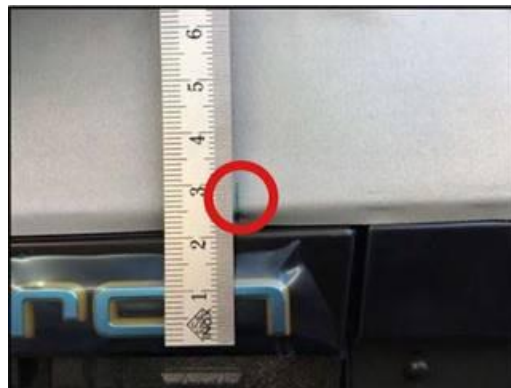
**Figure 10:** Make a vertical mark in the middle of the “n” of the e-tron emblem.

2. Open the charging door, and mask off the upper section of the charging door with adhesive tape (see Figure 12).
3. Close the charging door and mark at the middle of the “n” of the “e-tron” emblem (driver’s side). The mark should be made vertically on the adhesive tape (Figure 10).

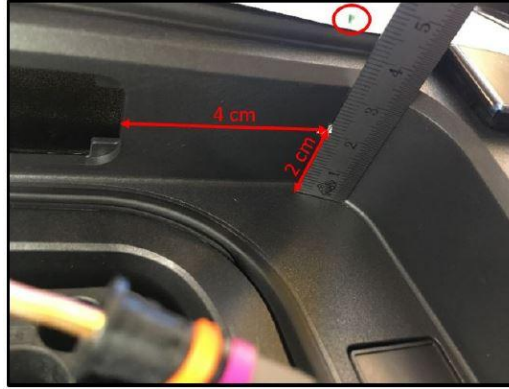
**Figure 11:** The drill mark should be at the same level as the first mark at 2 cm.

4. Open the charging door using the button and make a drill mark at the same level as the first mark, exactly as depicted in Figure 11.

As an alternative to marking at the letter “n” (left side of vehicle) or “e” (right side of vehicle), a dimension of 4 cm (Figure 11) may also be used.

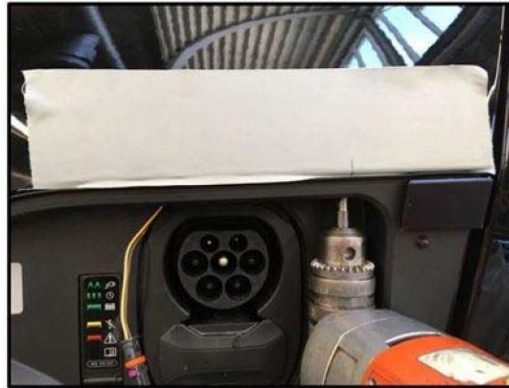
**Figure 12:** Use an angled drill/angle bit to drill to a depth of 15mm at the marked location.

5. Drill through the retaining lug from the inside using an angled drill/angled bit and a short commercially available spot weld drill (diameter approximately 7mm) to a depth of approximately 15 mm at the marked location (Figure 12).

**Remove the drilling residue at the charging socket using a compressed air gun.**

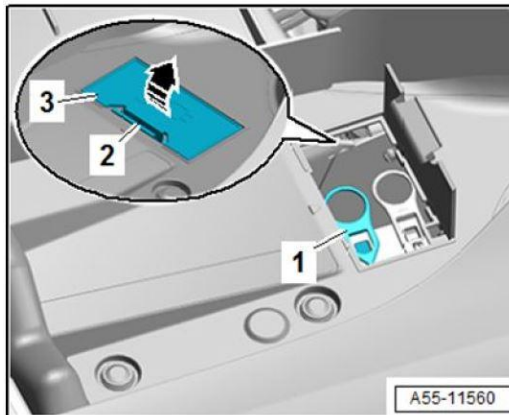
**Figure 13:** The plenum chamber door and manual release cable.

6. Release catch (2) on the plenum chamber and open the cover (3), then move the manual release cable (1) clear (Figure 13).

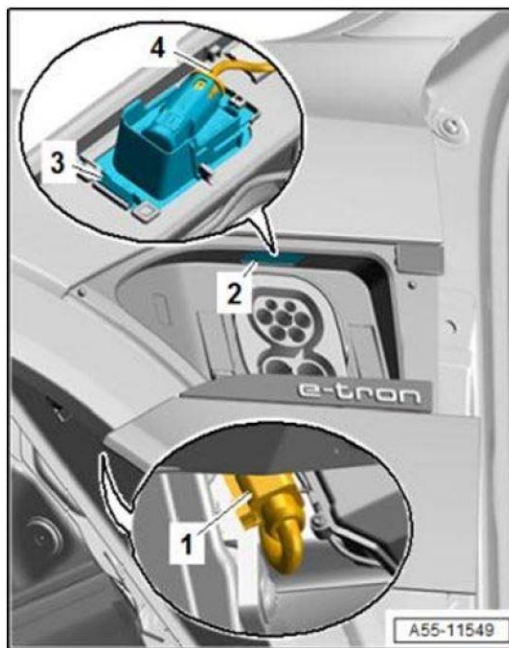
**Figure 14:** Overview of the position of the charging door (installed).

7. Unplug the electrical connector inside of the wheel well (1), release the catch (3), remove the bulb (2), and unplug the electrical connector in the back of the bulb (4) (Figure 14).

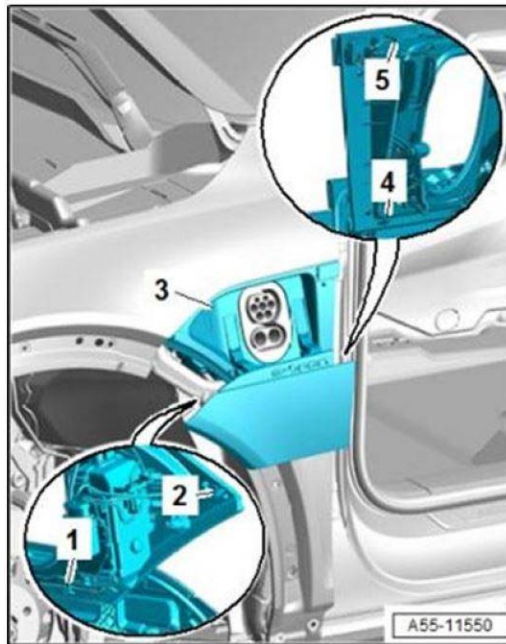
**Figure 16:** Charge door retaining tabs.

8. Use hook 3438 (Figure 15) or a screwdriver to release the remaining catches (1, 2, 3, and 4) (Figure 16).  
Carefully take the charging door unit out of the wing.

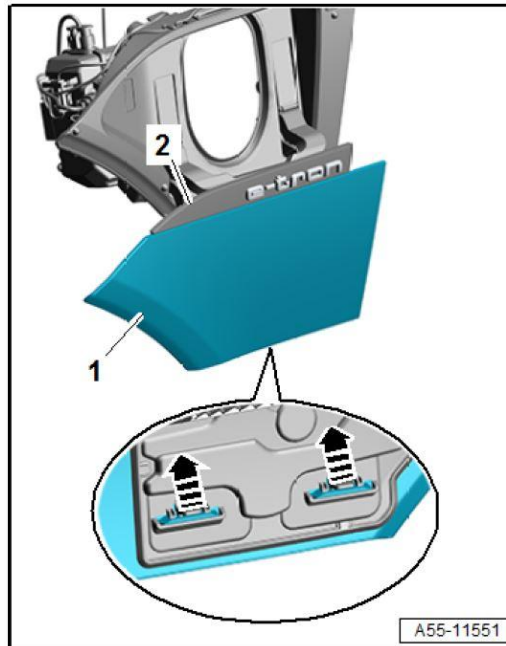
**Figure 17:** Charge door exterior cover.

9. Follow the instructions in Elsa to remove the trim for the charging door unit and install a new unit at *Repair Manual >> Body >> Body Exterior >> 55 Hoods Lids >> Charge Door Unit >> Charge Door Unit Trim, Removing and Installing.*

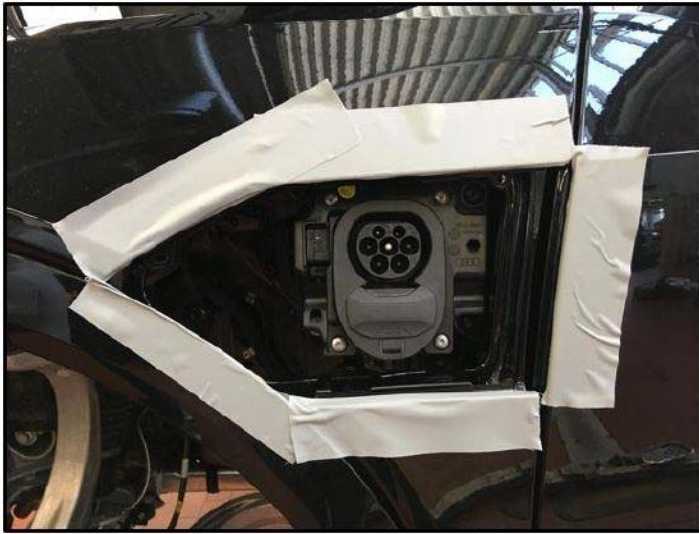
**Figure 18:** Adhesive tape applied around the charging door to protect the paint.

To avoid paintwork damage, mask off the area around the charging door in advance using adhesive tape (Figure 18). The adhesive tape can be removed when the charging door has been installed.

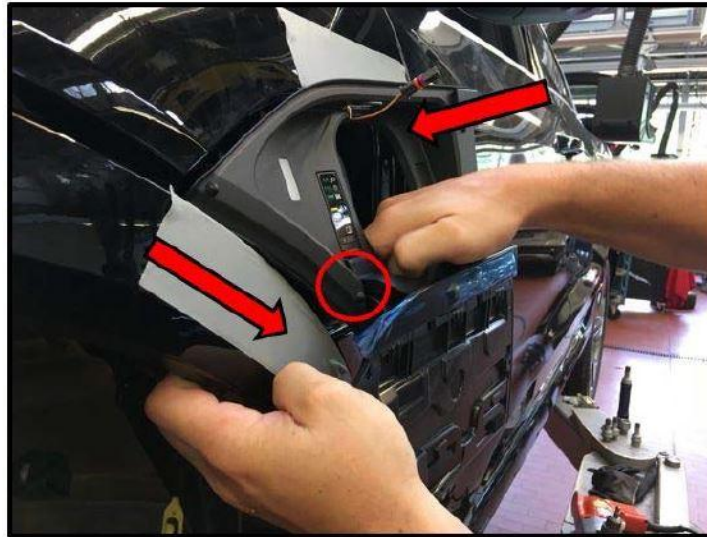
**Figure 19:** Charging door installation.

1. Carefully fit charging door unit, [pressing the wheel arch extension slightly outwards to do so. We recommend inserting the charging door in the area of the red circle first (Figure 19).

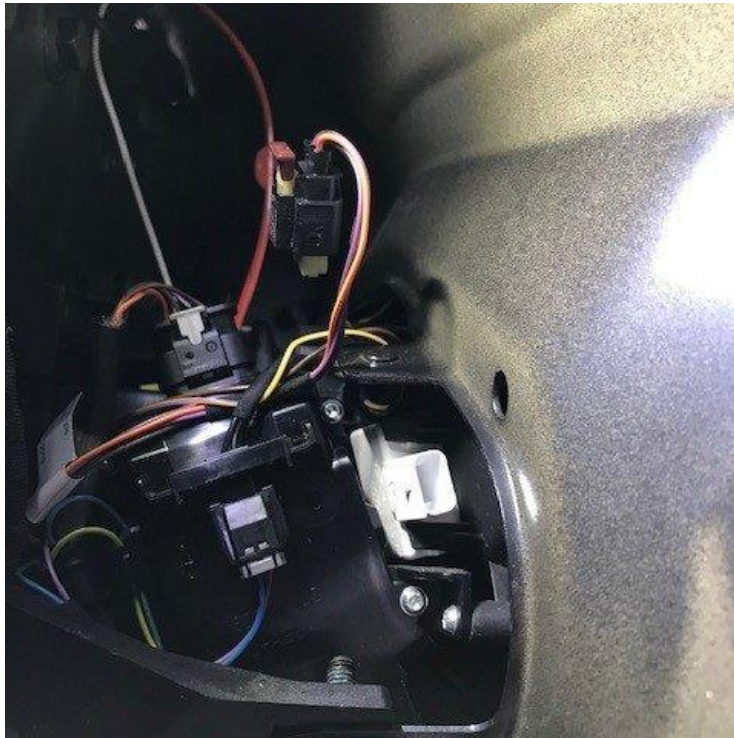
**Figure 20:** The connector is unplugged from the charging indicator.

1. Unplug the connector from the charging indicator (Figure 20).

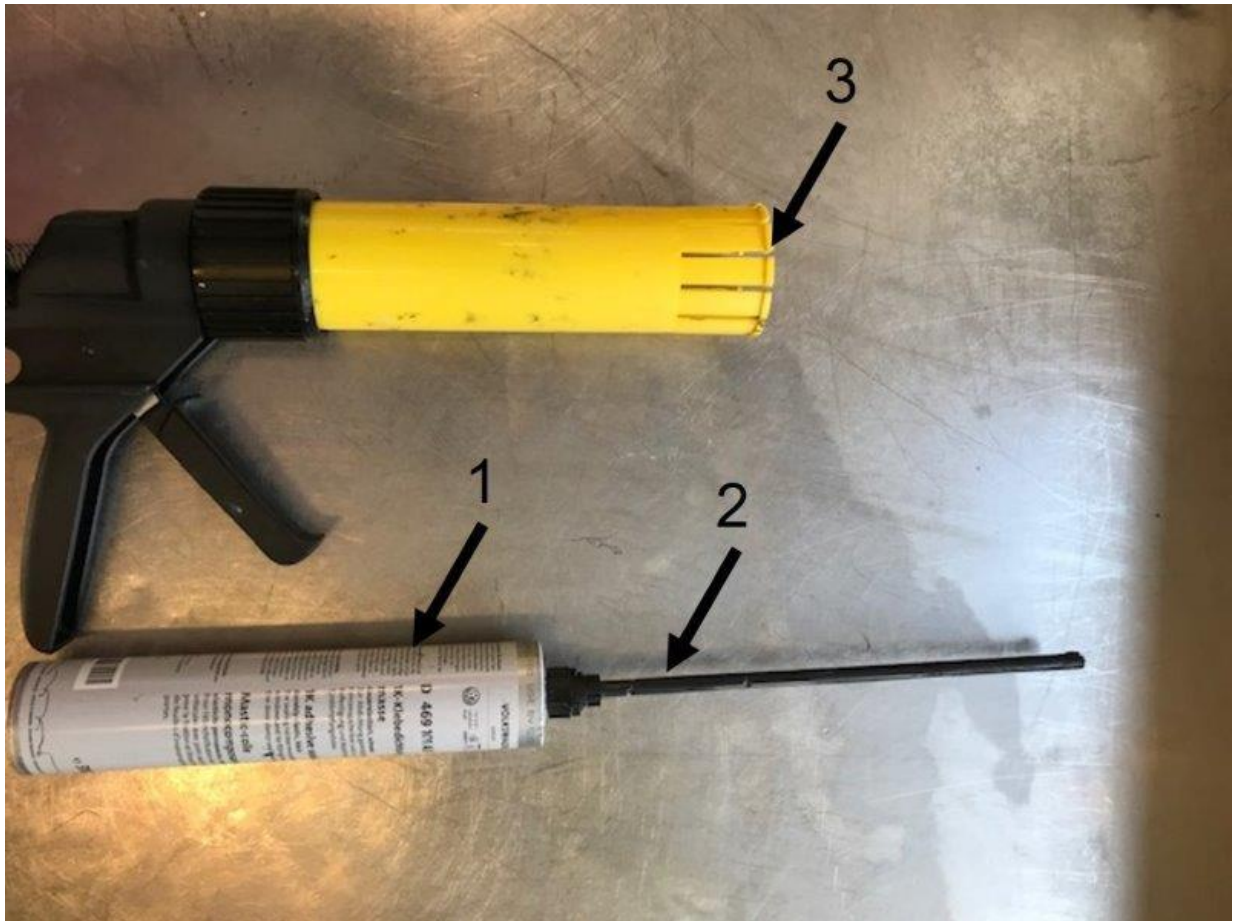
**Figure 21:** Component adhesive sealant and tool.

2. Screw the application hose (2) (order number: ASE33522600000) onto the cartridge of the component adhesive sealant (1) (Part number D 469101A3) (Figure 21).

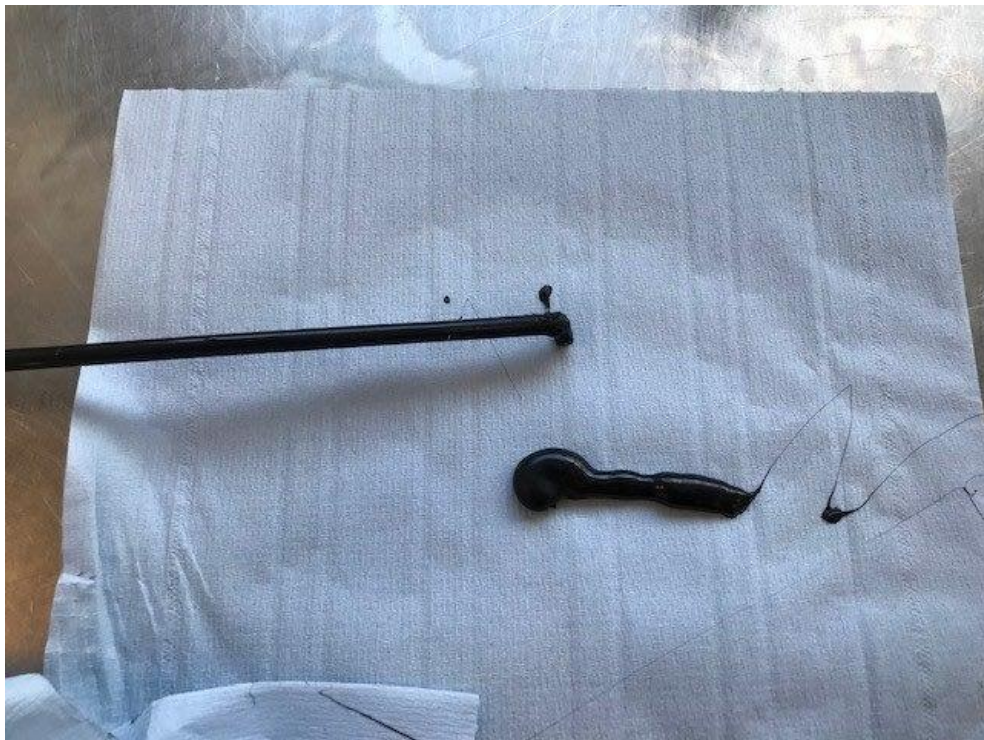
**Figure 22:** Clearing the component adhesive sealant after prolonged storage.

3. In order to ensure that the adhesive sealant has the same consistency at each use after it has not been used for a longer period (several days) use cartridge (3, Figure 21) to press out a sealant bead with a length of approximately 5 cm (Figure 22) before each use of the component adhesive sealant.

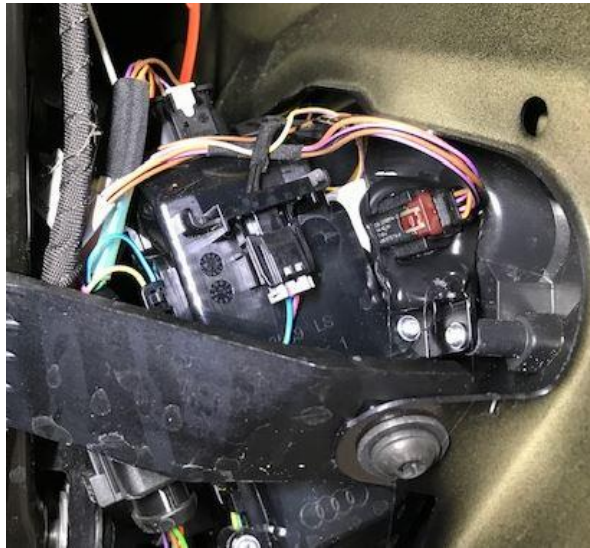
**Figure 24:** The connector should be completely surrounded by the adhesive sealant.

5. Plug the connector into the charging indicator and press it into the adhesive sealant. Press in the release tab on the connector to ensure it is fully engaged.

Plug the connector into the charging indicator. The connector should then be completely surrounded by the adhesive sealant (Figure 24).
