Door Symptom - Noise Complaints from the Door Trim Panel Area: Observe Documentation Specifications (SY 68/22)

Model Line: **Macan (XAB)**

Model Year: **As of 2024**

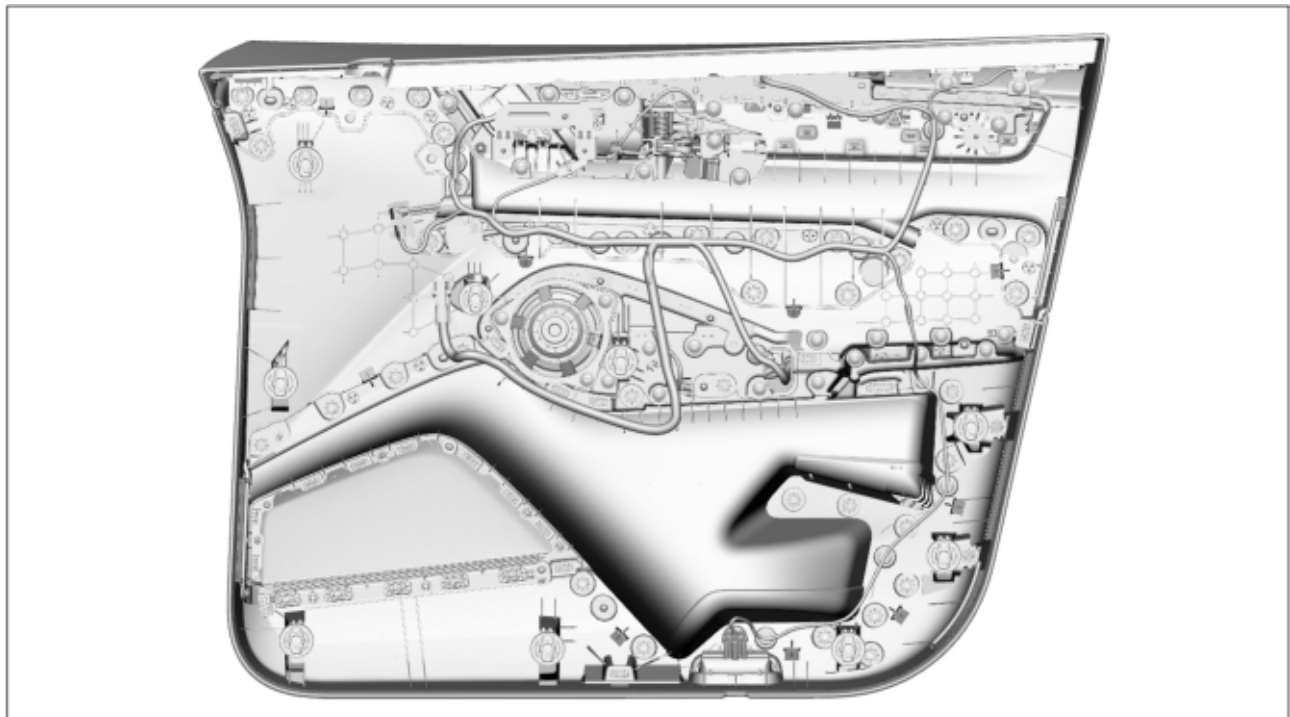
Appendix xy: Loose cable for door trim panel

- Electric line in the door trim panel loose. Electric line secured with a tie-wrap. For exact fault location, see Appendix xy ⇒ *Appendix xy: Loose cable for door trim panel*
