Announcement Of Future Addition To Exchange Order Type

Coolant Leak & Engine Overheating Issue - MY 2021 - 2025 - Jeep Wrangler (JL), Jeep Grand Cherokee (WL), Jeep Compass (MP), Dodge Hornet (GG)/ Alfa Romeo Tonale (GC)

2025 Warranty Bulletin Highlights

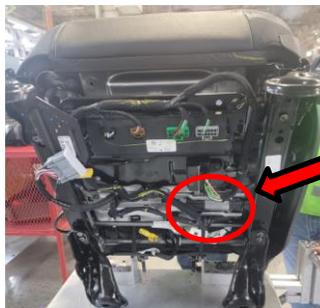
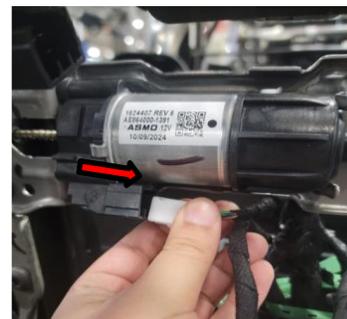
Step 5. Remove the fore/aft wire harness motor connector from the fore/aft motor (back right of the seat adjuster). Push on the tab to remove the motor wire harness connector from the motor. Leave disconnected for 10 seconds.

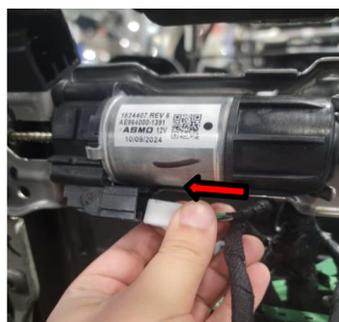
Step 6. Reconnect the fore/aft wire harness motor connector to the fore/aft motor. Push / Pull / Push the connector with fingers to ensure the wire harness connector is fully seated to the fore/aft motor connector.

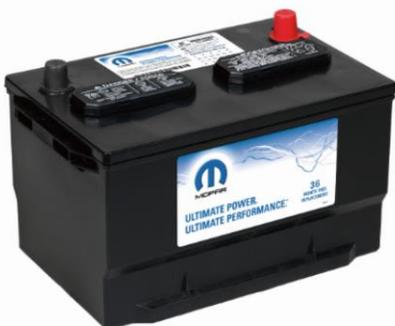
When a 12-Volt battery is completely discharged on a FCA US, LLC PHEV or BEV vehicle, we should be using the procedure found in Service Library related to the 12-Volt battery charging. Unless this procedure is properly followed, a good battery may be needlessly replaced. Charging the battery depends on the battery temperature, and a good, depleted battery accepts charge at a higher rate when the battery temperature is over 32 degrees Fahrenheit. Here are some quick points related to charging a 12-Volt battery.

1. Measure the battery voltage at the battery posts with a voltmeter, to be an accurate with the measurement. We consider a battery below 10-Volts to be extremely discharged.
2. Disconnect and isolate the negative battery cable. If equipped with an intelligent Battery Service (IBS), disconnect the Intelligent Battery Sensor connector FIRST before disconnecting the negative battery cable.
3. Battery charger will vary in the amount of voltage and current provided. The amount of time required for a battery to accept varies.

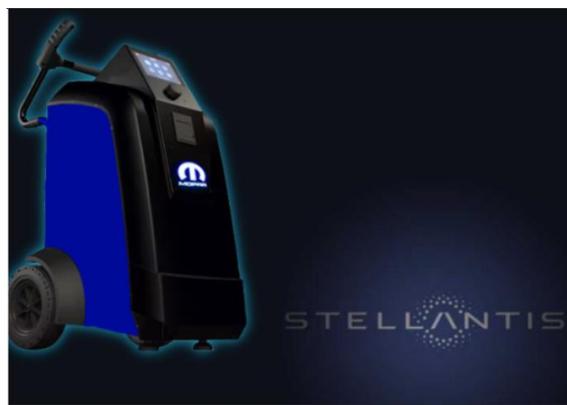
Charging the 12-Volt batteries that have been completely discharged on the PHEV/BEV vehicles, are very dependent on the ground cable being disconnected, if it is not done this way, we can cause damage to the Integrated Dual Charge Module (IDCM) which can result in premature replacement of the Integrated Dual Charge Module.

This is an extremely crucial step when charging any battery, but with PHEV/BEV vehicles, this can result in a very costly replacement of the Integrated Dual Charge Module. Technicians that are charging 12-Volt batteries that have been drained on PHEV/BEV vehicles, need to be aware of this and ensure that they are following the procedure in Service Library.

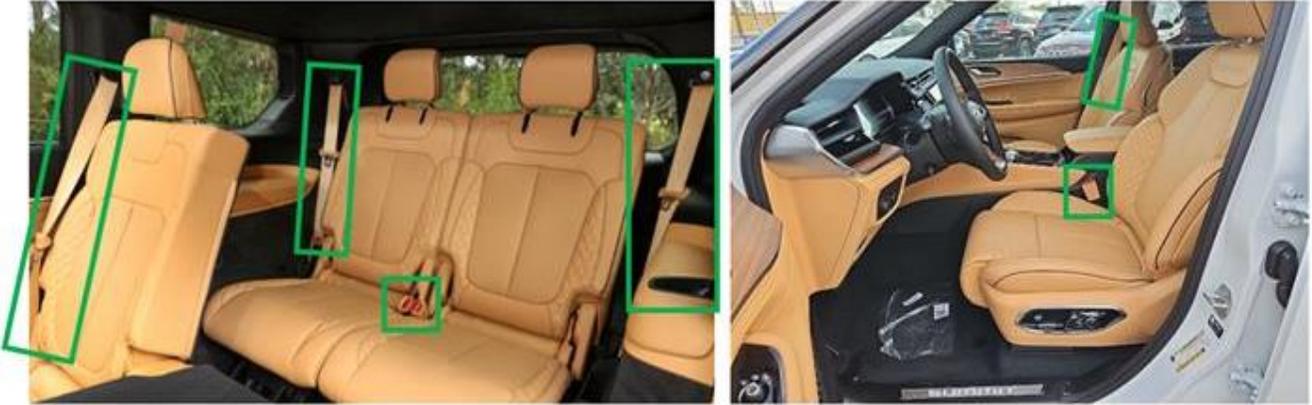
Before:

0403XX) will have seat belts and buckles of Global Black (TX7) color in place of Tupelo (WT5). See before/after picture examples below.
