Coolant Leak & Engine Overheating Issue - MY 2021 - 2025 - Jeep Wrangler (JL), Jeep Grand Cherokee (WL), Jeep Compass (MP), Dodge Hornet (GG)/ Alfa Romeo Tonale (GC)

FCA CARIBBEAN WARRANTY OPERATIONS NEWSLETTER

VOLUME 11, ISSUE 4

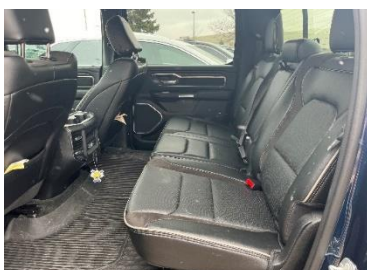
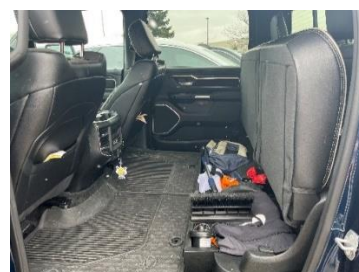
Step 1. Open 2nd row door and function rear seat cushions up to stowed position.

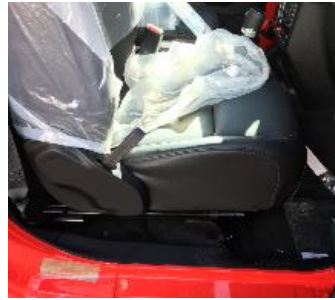
Step 2. Adjust the driver front seat to the full up position. Use switches on the side shield to move power seat fully up.

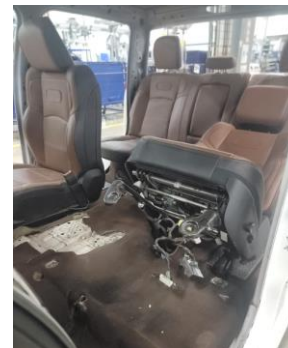
Step 4. Lay the seat down so it's laying on its back so the underside of the seat is easily accessible.

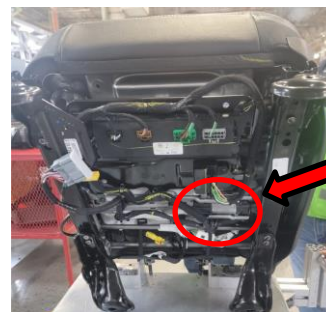
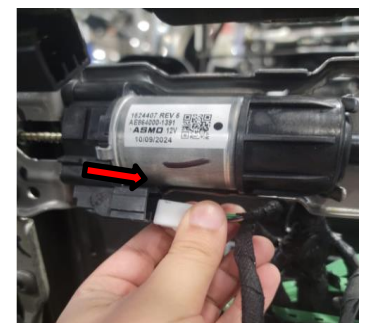
Step 5. Remove the fore/aft wire harness motor connector from the fore/aft motor (back right of the seat adjuster). Push on the tab to remove the motor wire harness connector from the motor. Leave disconnected for 10 seconds.

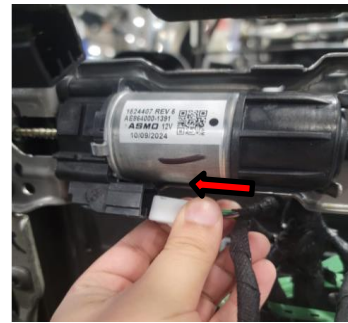
Step 6. Reconnect the fore/aft wire harness motor connector to the fore/aft motor. Push / Pull / Push the connector with fingers to ensure the wire harness connector is fully seated to the fore/aft motor connector.

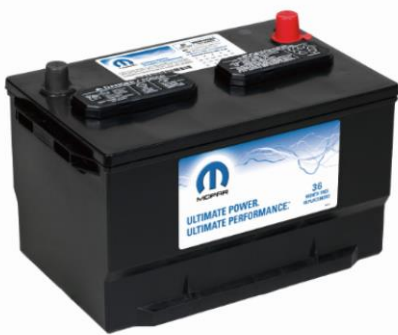
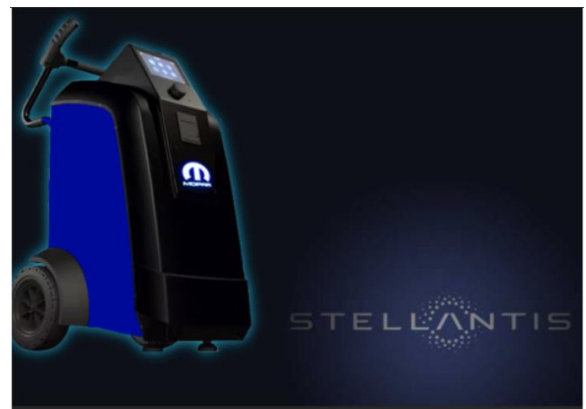
Charging the 12-Volt batteries that have been completely discharged on the PHEV/BEV vehicles, are very dependent on the ground cable being disconnected, if it is not done this

way, we can cause damage to the Integrated Dual Charge Module (IDCM) which can result in premature replacement of the Integrated Dual Charge Module.

This is an extremely crucial step when charging any battery, but with PHEV/BEV vehicles, this can result in a very costly replacement of the Integrated Dual Charge Module. Technicians that are charging 12-Volt batteries that have been drained on PHEV/BEV vehicles, need to be aware of this and ensure that they are following the procedure in Service Library.
