SIB 72 01 25

2025-04-09

## G1x/G3x FALSE ALERT RF SEAT OCCUPIED W BELT UNBUCKLED- EXTENDED LTD WARRANTY

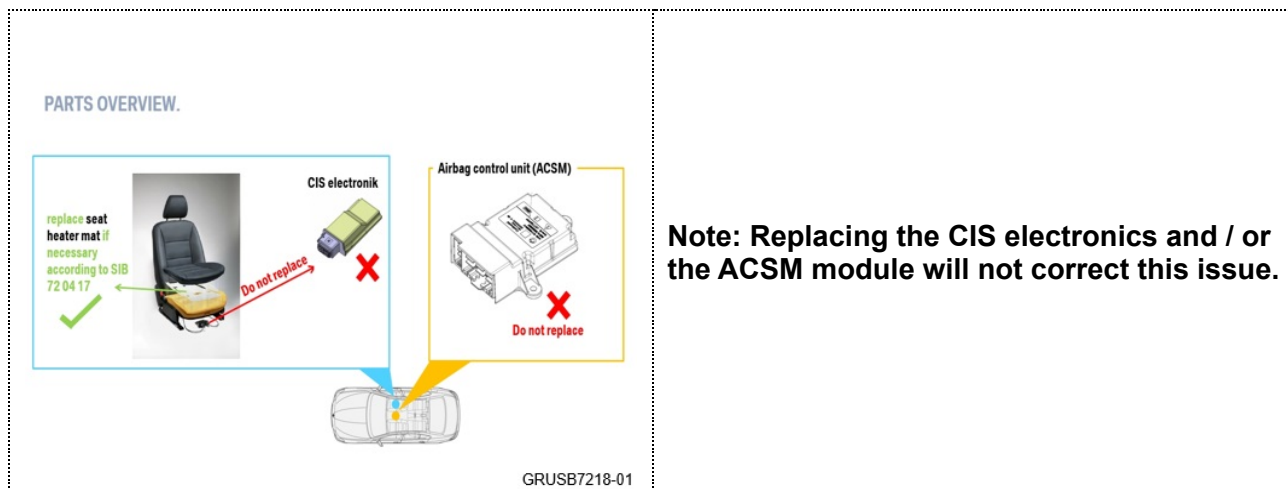
If there are no obvious moisture/stains, the next step is to check the vehicle's installed seat heater/CIS mat sensor part number and its revision index number against a corresponding matrix.

The matrix will help you determine if the installation of the seat CIS mat wiring repair kit is required to address an inadequate shielding condition with the seat occupancy CIS mat's connection wiring.
