## STAR ONLINE PUBLICATION

**Case Number:** S2523000033

**Symptom/Vehicle Issue:** Door Window Fitment, Check, And Inspection.

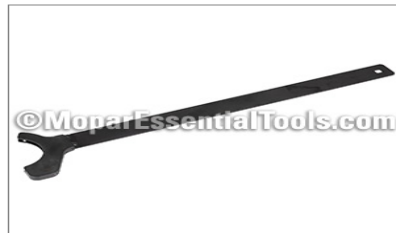
Use this special tool to align the window regulator during service.

1. Suction cup or gloves with grip to keep glass pushed up in position while securing.
2. Glass adjustment wrench: MOPAR PN: 2000032100 special spanner for window adjustment.
