Service Bulletin

Bulletin No.: 23-NA-115

Subject: Ticking, Tapping or Snapping Noise from Engine - 5.5L RPO LT6 Realign Camshaft Caps as Required

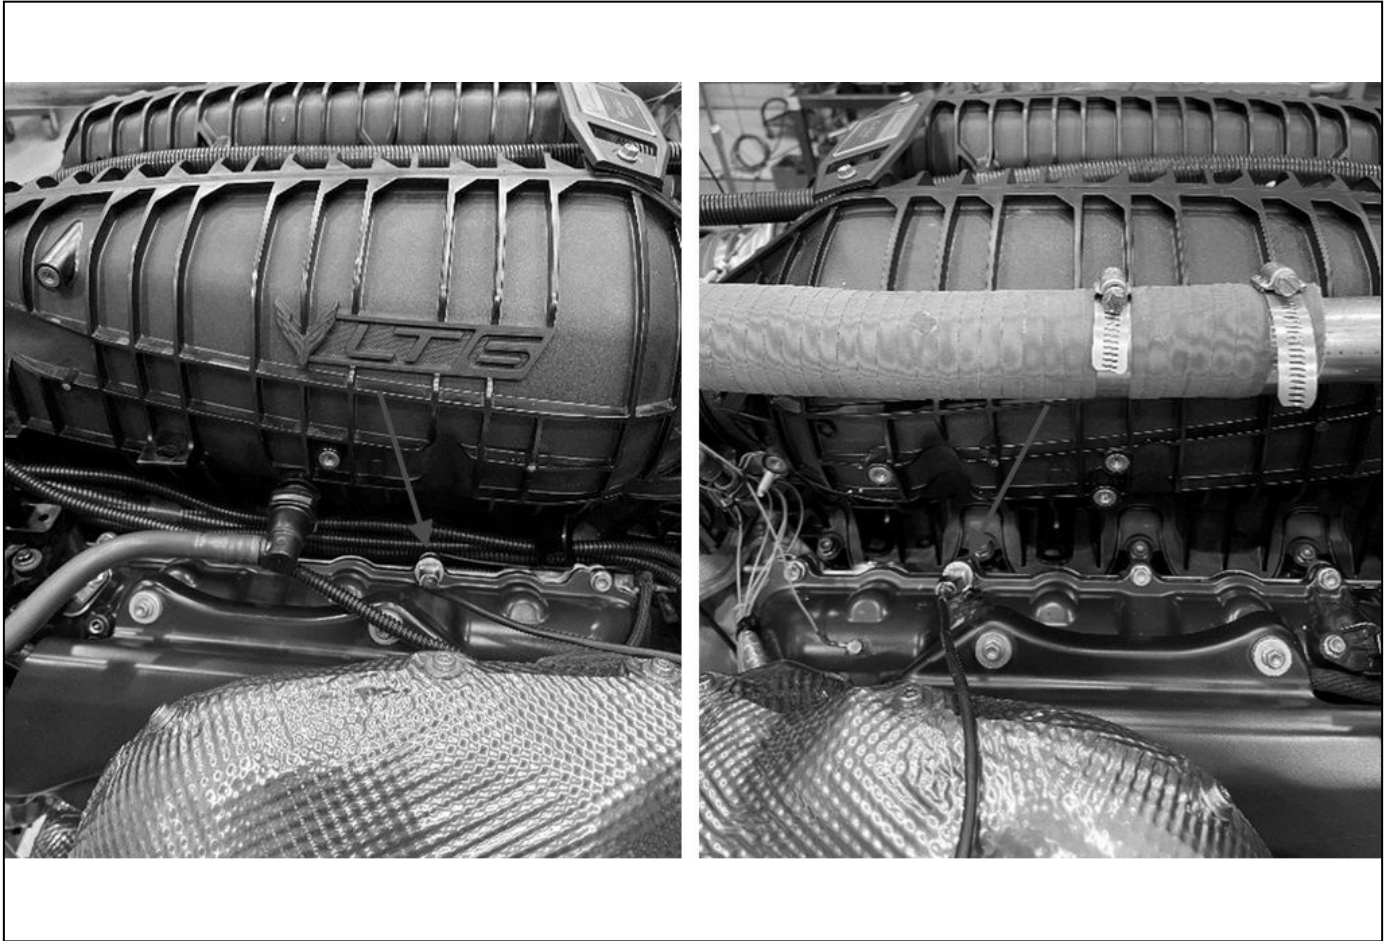
6374742

Follow the directions below to setup the PicoScope to obtain the sound file needed for review.

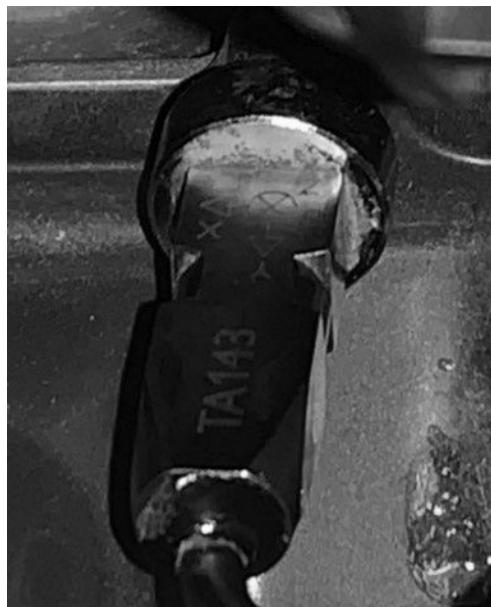
6374737

⇒ With the suspect bank determined, prep/position the accelerometer so the X, Y, Z coordinate system (that's laser etched) is facing upwards before securing to the bolt head. After accelerometer is placed on bolt head, double check to ensure its centered and did not rotate on the bolt head. Doing so will ensure the best results.

Important: Ensure accelerometer coordinates are facing up towards the intake.

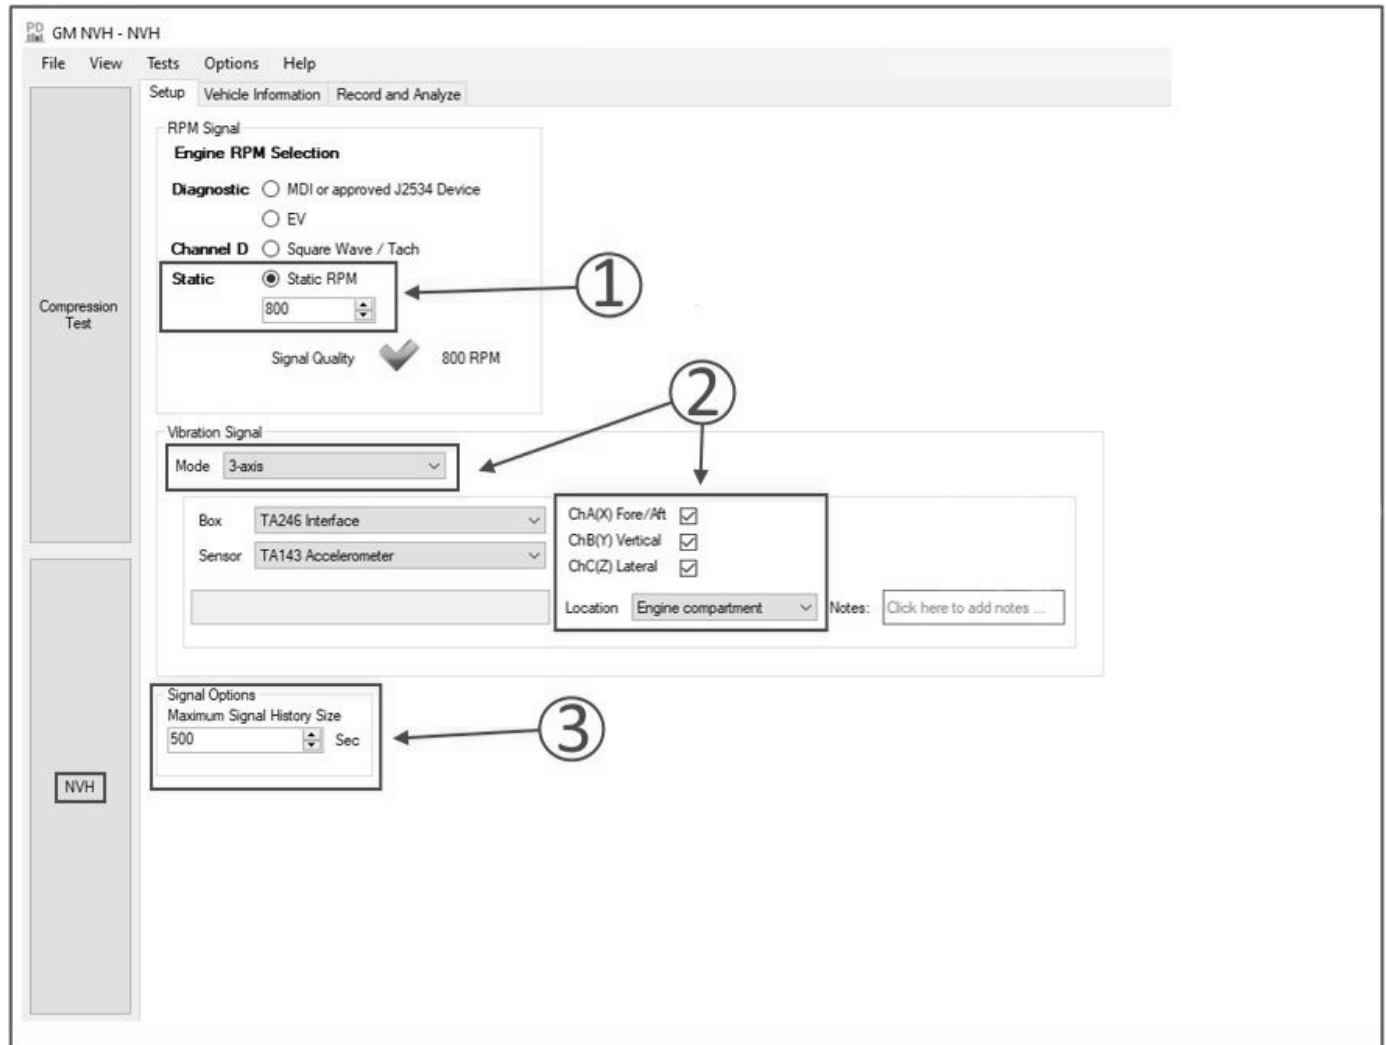
6374911

1. Open the GM NVH software and click on the NVH button.

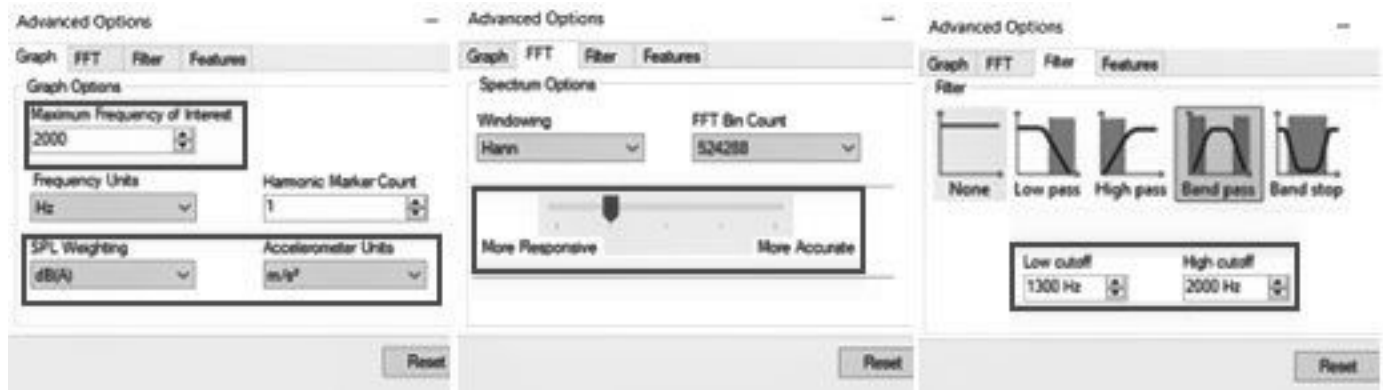
6374914

- Go to options at the top then to advanced options and change the maximum frequency of interest to 2000. Update the SPL Weighting to dB(A) and check that the accelerometer units are (m/s²). Under the FFT tab, change the responsiveness marker to the position shown above. Finally, under the filter tab, add a bandpass filter from 1300 to 2000 Hz.
