Service Bulletin

Bulletin No.: 18-NA-069

Subject: Poor Engine Performance in Extremely Cold Weather Conditions for LFV Engines, Charge Air Cooler Icing - Malfunction Indicator Lamp (MIL) Illuminated - DTC P0299, P0234, P2227 and/or P00C7 Set

Brand:	Model:	Model Year:		VIN:		Engine:	Transmission:
		from	to	from	to		
Chevrolet	Malibu	2016	2025	—	—	1.5L (LFV)	—

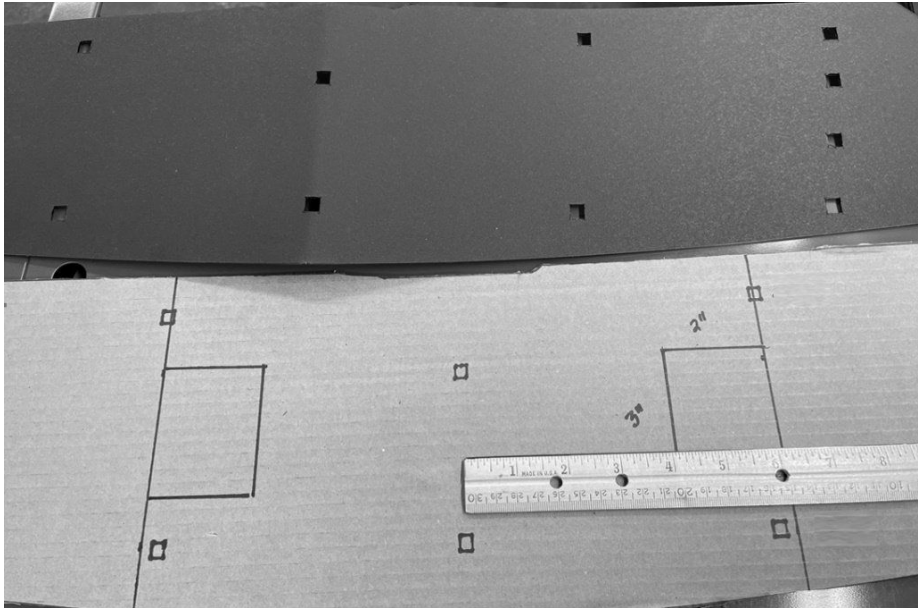
5982680

Front License Plate Mount Grille Cover Modification (2016-2018 Malibu with RPO-VK3)

Important: It is recommended to practice on a piece of cardboard before modifying the plastic grille cover.
