# Service Bulletin

Bulletin No.: 23-NA-151

**Subject: Hybrid/EV Battery Stability, High Priority DTCs, Potential Loss of Isolation, Vehicle Handling and Battery Pack Return Shipping Requirements**

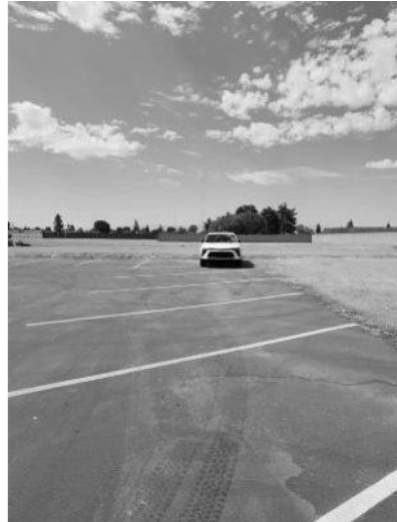
**Figure 4 (Vehicle and Battery Pack Isolation – Passed)**

- 8. Move the vehicle to a stable location outdoors: isolated and away from buildings, vehicles, and foot traffic while waiting direction to diagnose/repair. Recommended distance is 50 feet (15M). Document isolated location via photo (Fig 4 and 5). Refer to 'Neutral Service Mode' in electronic transmission range select service information if required.
- 9. Start a TAC case and upload all photos and your GDS2 session log per Document ID: 6385557 / PIP4902 and reference this bulletin. Additionally, provide any previous diagnosis work performed based on the DTC(s) set or inability to collect the data.

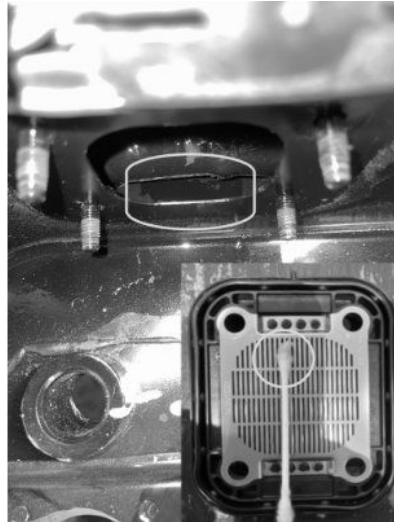
**Figure 13 (Coolant Passage Vacuum Leak Test – Passed)**

- 10.5. Vacuum test the High Voltage Battery coolant circuit for leaks. See Hybrid Battery Pack Coolant Passage Leak Test (Fig 13 and 14). Attach photos to the TAC case.

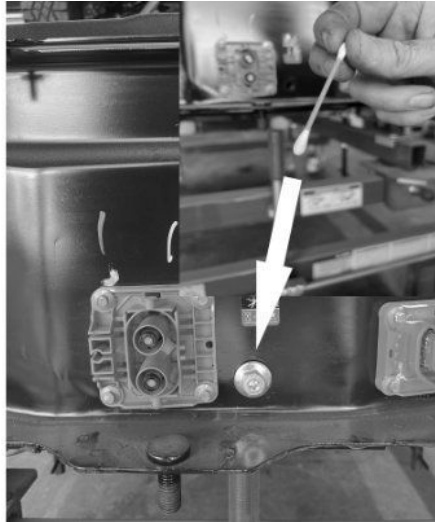
**Figure 14 (Coolant Passage Vacuum Leak Test – Failed)**
