To: **After Sales Official Network**  
Object: **BL4.6 BL Update PN\_47B990100C\_Rev\_0131\_0132**  
Date: **04/04/2025**  
Pages: **19**

**Campaign code:**  
L74X-A.11.25

**Campaign name:**  
BL4.6 Update PN\_47B990100C\_Rev\_0131\_0132

**Model:**  
Revuelto

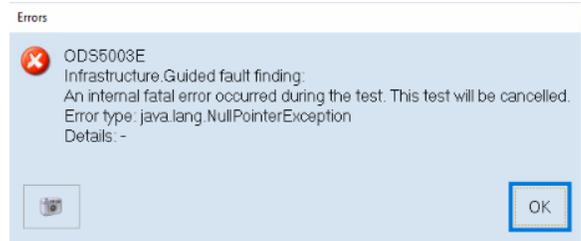
- **ODS5003E** → If the following screen appear please close and repeat the SVM-Code.

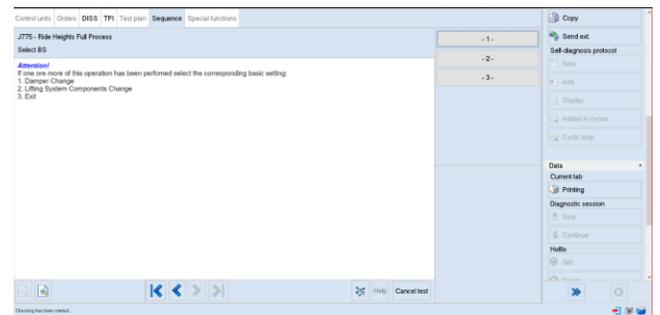
- **ECU0074 → C10C500: Basic setting (deflected) not performed:** please, from the ECU 0074, execute the guided function “74 - Ride hide full process”

Then click on basic setting “2 - Lifting system ” and follow the instructions directly from the O.D.I.S. Service.

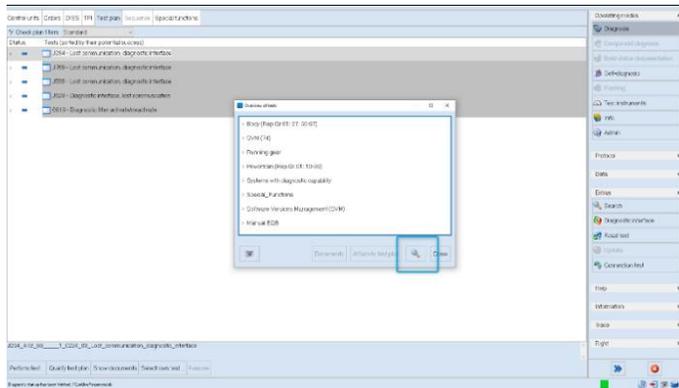
ECU00C5 → U020600: Lost Communication with folding top control module

From the "Test plan" menu. Click on the "Select own test" box and then click on the magnifying glass:
