L74X-
A.05.25

To: After Sales Official Network
Object: BL5.2 BL Update PN_47B990100D_REV0101
Date: 03/04/2025
Pages: 15

Campaign name:
BL5.2 BL Update PN_47B990100D_REV0101

Model:
Revuelto

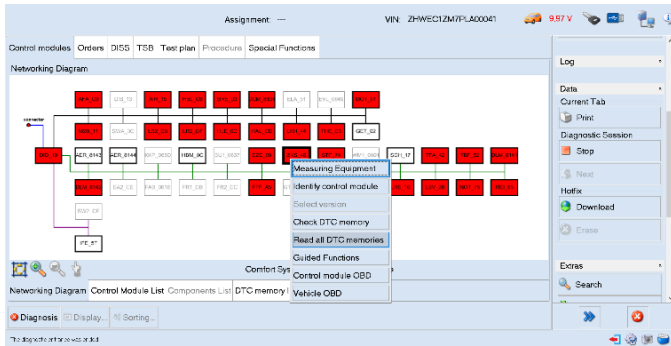
25. Go back to the “Block diagram” card and select “Read all fault memories” from one of the vehicle’s control units to update the display of the faults present after deletion.

IMPORTANT:

Solve any faults still present by performing the functions listed in the “Test plan”. Perform the procedure “IV. Erase fault memory” again until all faults are fully removed from the vehicle’s control units.
