**SIB 72 01 25****G1X/G3X FALSE ALERT RF SEAT OCCUPIED W BELT UNBUCKLED-EXTENDED LIMITED WARRANTY**

2025-05-01

This Service Information bulletin (Revision 01) supersedes SI B72 01 25 **dated April 2025**

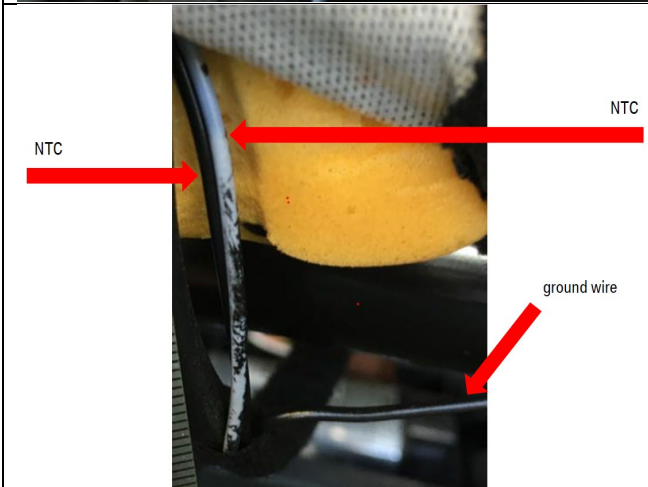
The following cables/cable assemblies are now exposed:

- two NTC cables (negative temperature coefficient lines) for temperature
- Outgoing grounding wire.

THESE WIRES MUST NOT BE CUT!

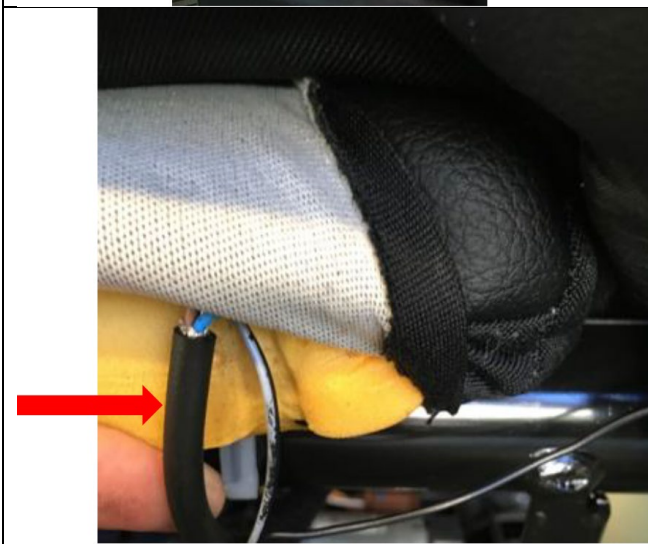
The following cables/cable assemblies are now exposed:

- Cable assembly (4 cables in a rubber jacket) including shielding.

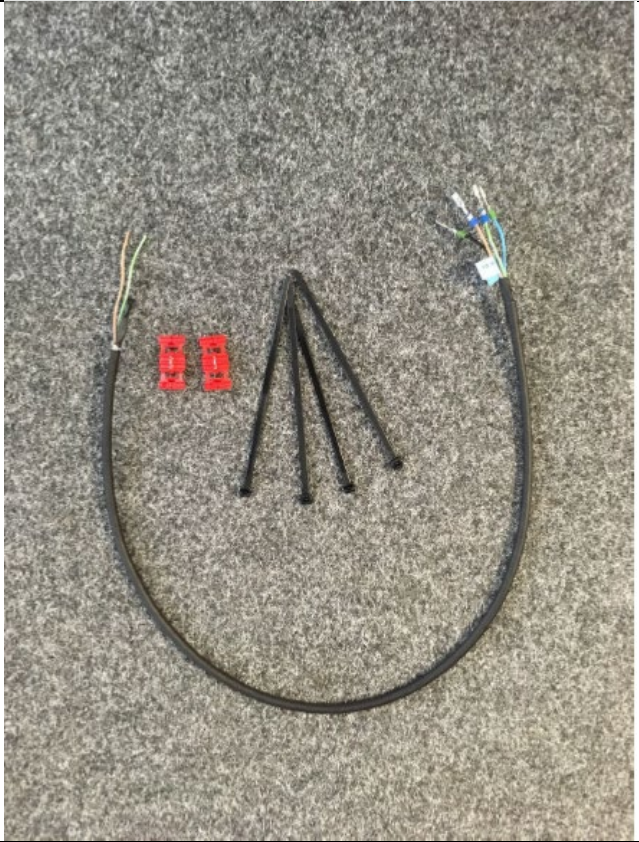
This is the repair kit

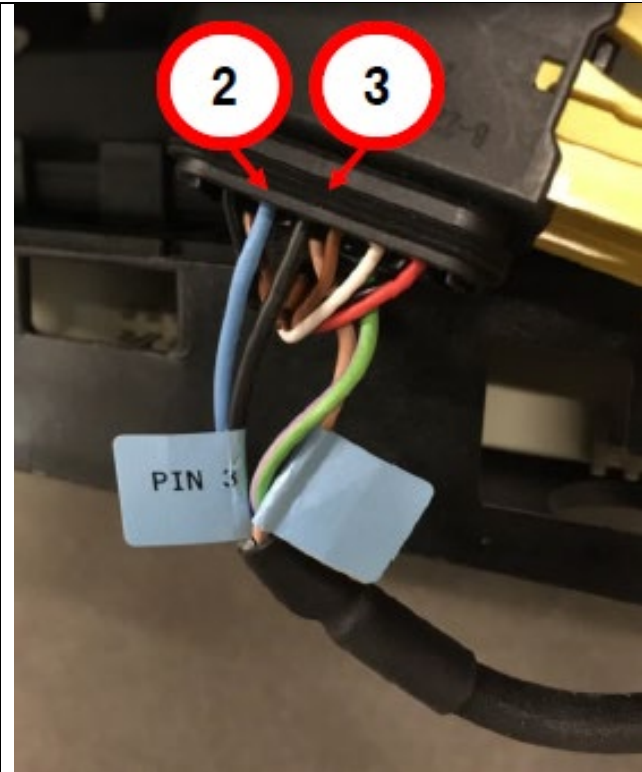
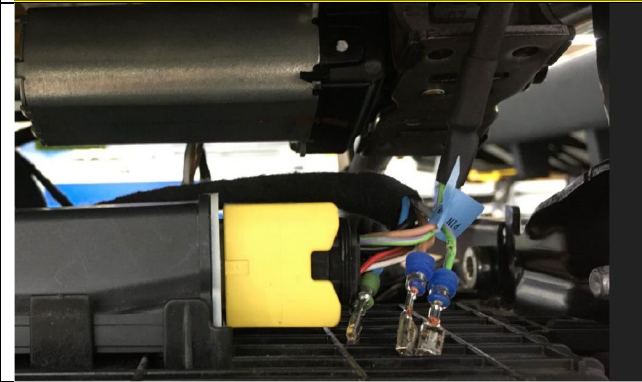
The 4 old cables remain in the wiring harness

To do this, replace one cable with the cable of the matching color, one after the other.

Then plug the connector back into the CIS control unit.
