## Load Compartment Cover Noises

| Topic number | LI68.50-P-079347 |
| Function group | 68.50 - Curtains, roller blinds, luggage net |
| Validity | BR 254 before production date 09.12.2024 |

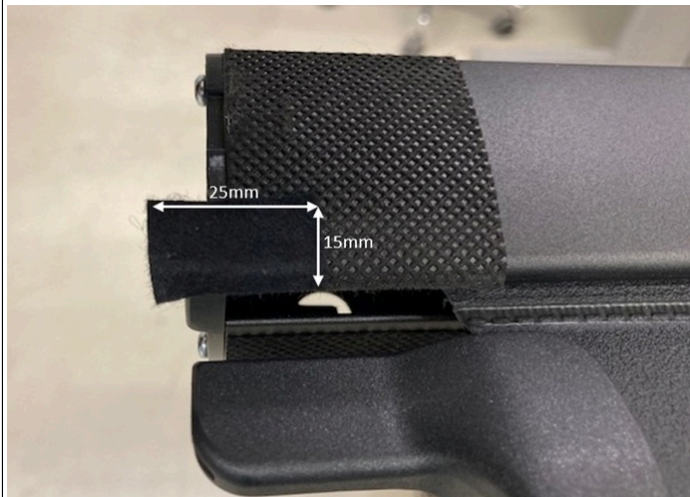
| Attachments | |
|---|---|
| <a href="#">Filz 1.jpg</a><br> | |

Aluminum cassette scrapes on the inside of the end cap. The contact point causes creaking noises.

Cut 2 felt strips to required size of 25 mm/15 mm/1 mm (length/width/height).

Glue a piece of felt (see attachment) to each top corner in the direction of the roller blind outlet (left and right side).
