Diagnostic Sheet

MC20 – Side Door Anomalies

DATE: MAY 30, 2025

MODELS: M240 MC20 and MC20 Cielo (All MY).

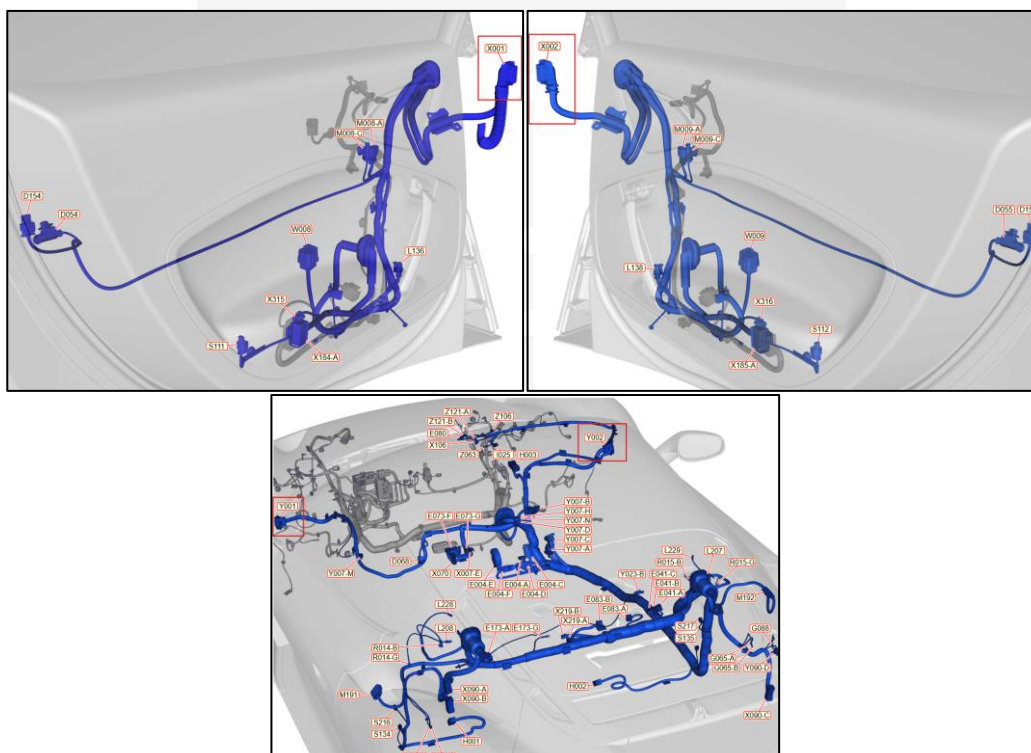
CONCERN: Electrical anomalies related to door services such as speakers, lighting, window lifters, rearview mirrors, door opening and closing, curtain airbags or internal door pressure sensor, communication anomalies on LIN Buses 3 and 4 diagnosed by BCM due to possible oxidation of the door connector(s) X/Y001 and/or X/Y002.

To correctly diagnosis and repair, it is necessary to access connectors X/Y001 and/or X/Y002 following the steps below:
