S-Series™

**2.0 Telematics Control Unit (TCU)
Upgrade - T17 to T27**

Date: May 1, 2025
Bulletin Name: FDM-SVC-041
Model: Oshkosh S-Series
Units Affected: 2.0 Front Discharge Mixers
VIN 821990 - 827769

This bulletin provides instruction for installing a T27 TCU module in place of a T17 TCU module.

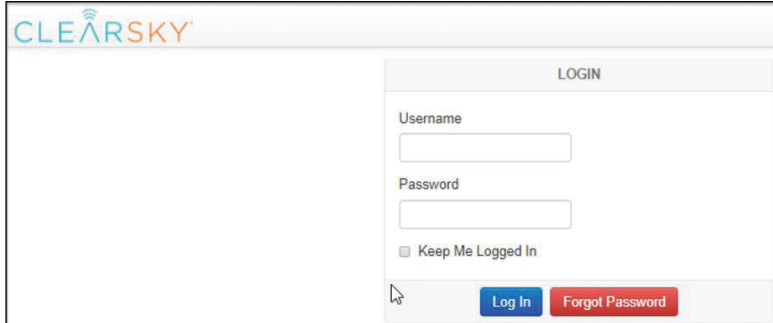
Figure 5

18. Make sure truck is in a location with adequate cellular and GPS service. Truck may need to be outside for adequate service.
19. Turn truck ignition switch to ON position and wait until overhead display shows home screen.
20. Log into ClearSky (<https://clearsky.mcneiluscompanies.com>) See Figure 5. If an account needs to be created contact ClearSky support (clearskysupport@oshkoshcorp.com).

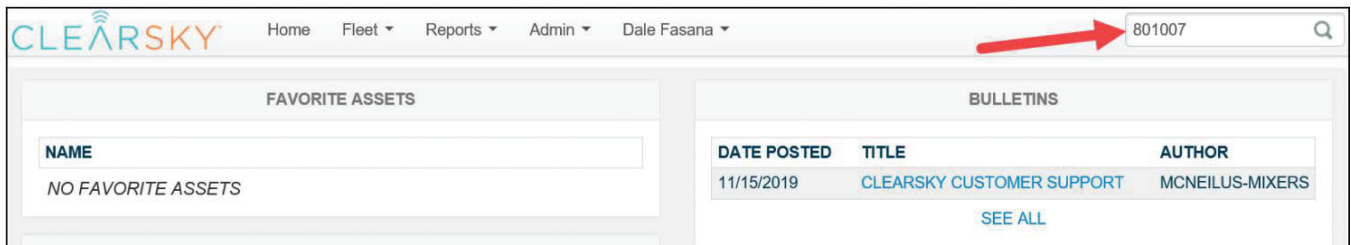
Figure 6

21. Search for truck serial number (last six digits of truck VIN) in ClearSky search window. See Figure 6.

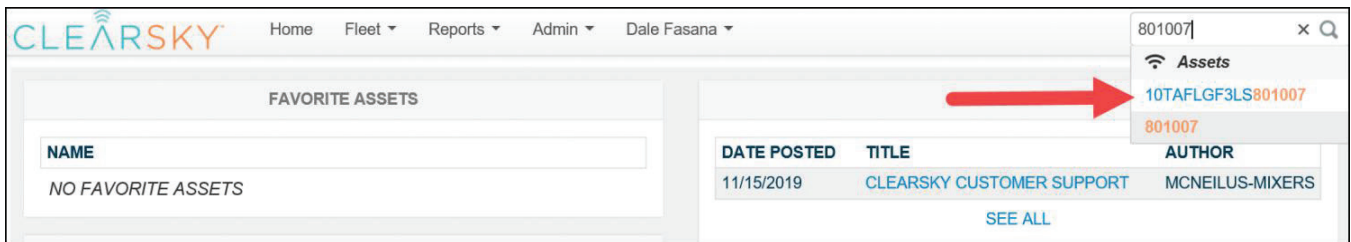
Figure 7

22. Make sure the truck's serial number appears in the search results Assets window and select the truck from the search results. See Figure 7.

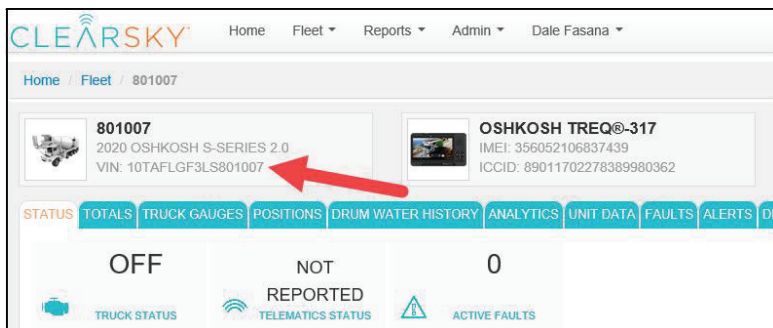
Figure 8

23. Make sure the truck VIN displayed in the information box in the upper left corner of page is correct. See Figure 8.

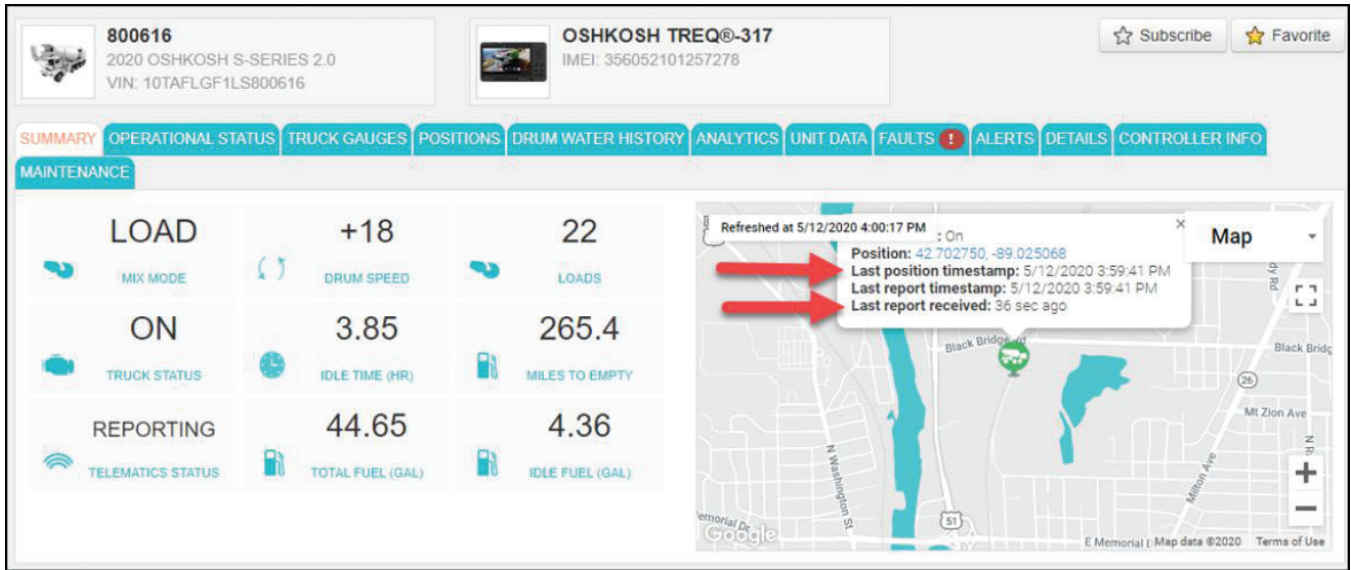
Figure 9

24. Check the GPS by clicking on the SUMMARY tab and making sure the map shows the current location of the truck. The time stamp displayed should be within 2 minutes of the current time. See Figure 9.

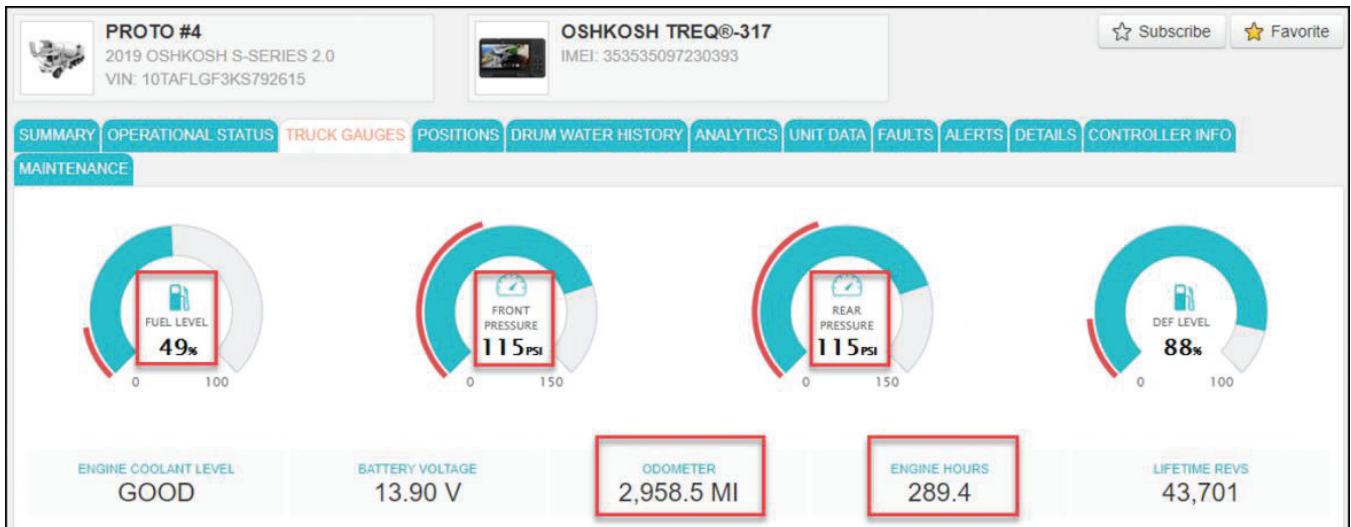
Figure 10

25. Check the ClearSky data by clicking on the TRUCK GAUGES tab and making sure the ClearSky gauges match what is shown on the gauges in the truck. See Figure 10. Gauges include fuel level, front air tank pressure, rear air tank pressure, odometer, and engine hours.
