Technical Service Bulletin

GROUP	NUMBER
CAMPAIGN	25-01-034G
DATE	MODEL(S)
MAY 2025	GV70 (JK1)

SUBJECT: REAR FLOOR PANEL DAMAGE INSPECTION & REPAIR
(SERVICE CAMPAIGN T75G)

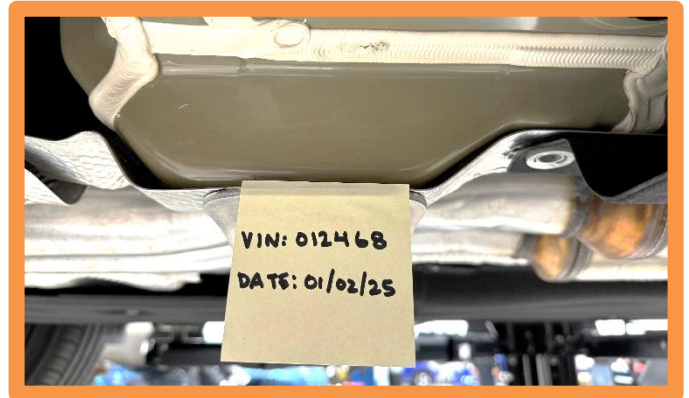
The Digital Documentation photo displays an undamaged area. For damage repair, proceed to the next step.

Using STUI, take a photo of the boxed area with the last 6 digits of the VIN and the date of repair on a piece of paper.
