INSIDE THIS ISSUE:

TECH TALK - VOLUME 286
MAY/JUNE 2025

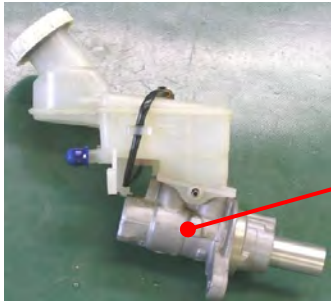
Brake master cylinder

- Using or mixing any brake fluid other than the specified type (including low-quality brake fluid, a different specification) accelerates the wear of the linear solenoid valve inside the brake actuator, potentially decreasing braking performance.
- Pouring brake fluid into the container that still contains engine oil allows residual mineral oil to enter the brake system. This may cause the rubber parts to swell, potentially decreasing braking performance.
