Topic: McLaren Artura Ground Fault Detection Diagnosis Guide

Condition: Permanent **Diagnostic Trouble Codes:** P21F14D P21F14C P186909

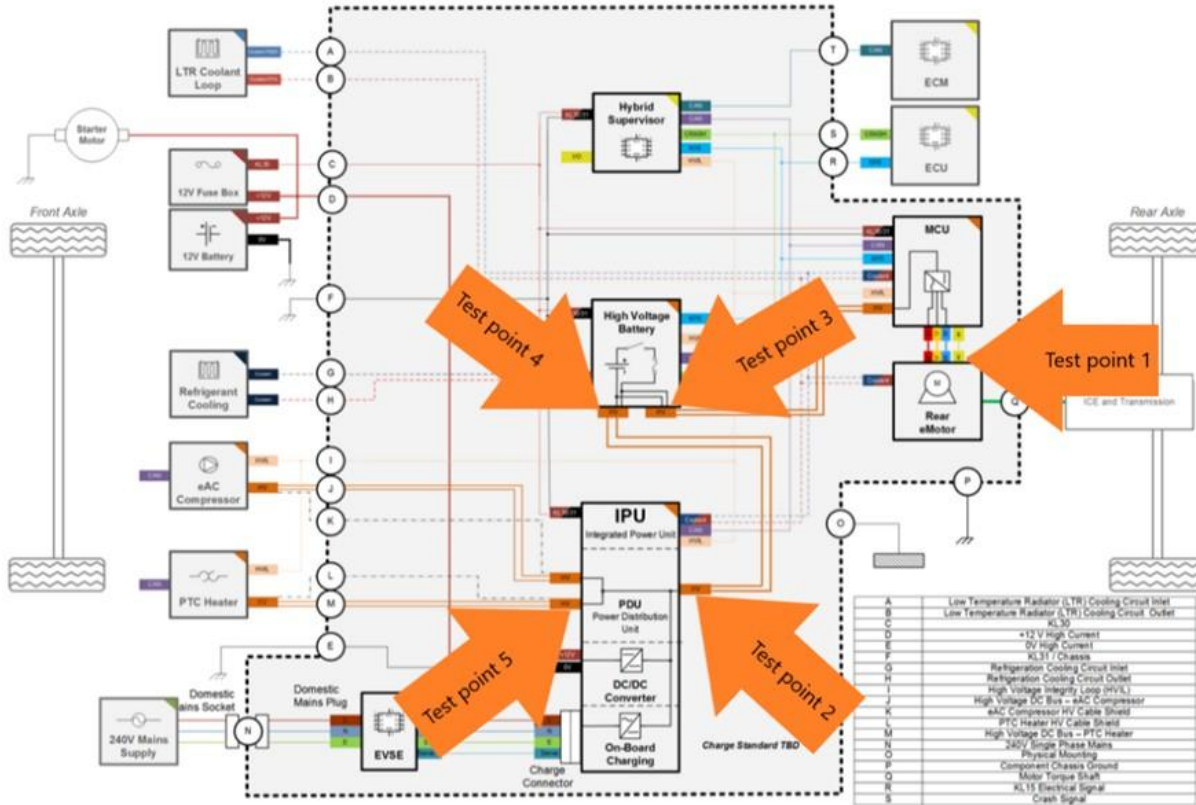
Test Point 1

Phase cables test point - Disconnect phase cable connector and check at each phase on eMotor to ground. Then measure at the phase cable connector (harness side), each phase to ground.
