Service Bulletin

Bulletin No.: 23-NA-115

Subject: Ticking, Tapping or Snapping Noise from Engine - 5.5L RPO LT6 Realign Camshaft Caps as Required

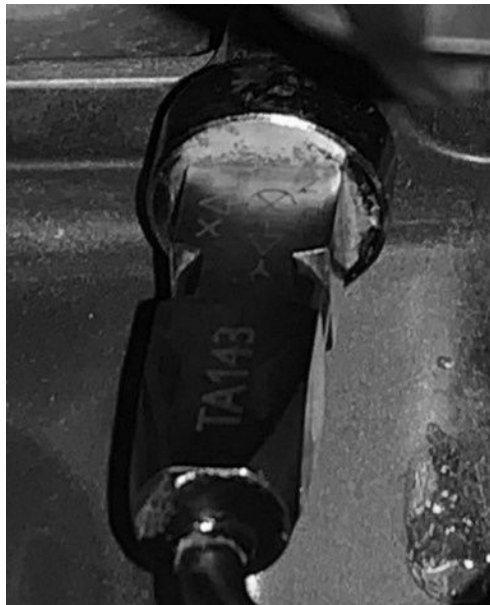
6374737

⇒ With the suspect bank determined, prep/position the accelerometer so the X, Y, Z coordinate system (that's laser etched) is facing upwards before securing to the bolt head. After accelerometer is placed on bolt head, double check to ensure its centered and did not rotate on the bolt head. Doing so will ensure the best results.

Important: Ensure accelerometer coordinates are facing up towards the intake.
