SIB 72 01 25

2025-06-10

G1X/G3X FALSE ALERT RF SEAT OCCUPIED W BELT UNBUCKLED-EXTENDED LIMITED WARRANTY

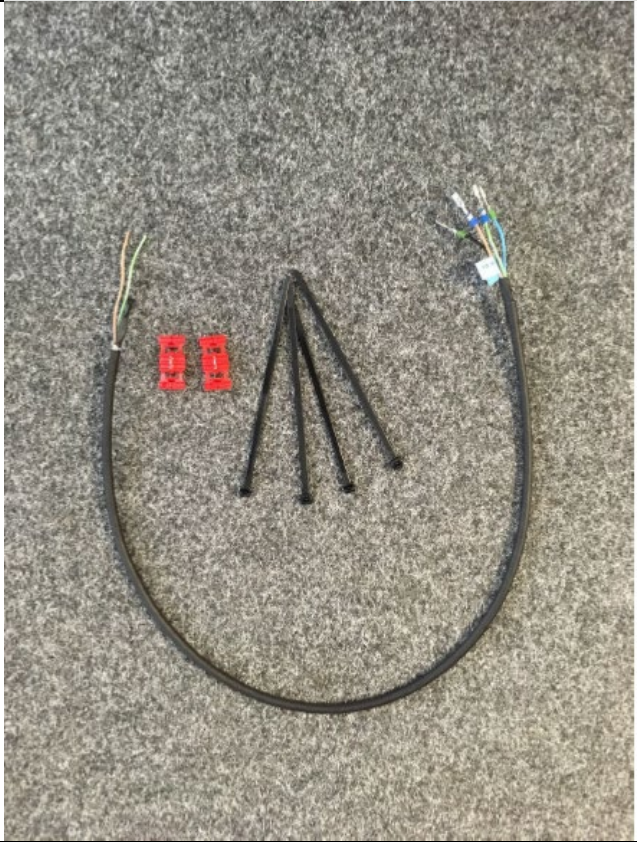
There are 4 wires in the cut cable assembly, but only 2 of which are needed (brown and green/purple).

The other two cables (blue and a cable Without a colored jacket) are no longer needed and can be cut off.

This is the repair kit
