## Entry Step Ignition Lockout

<b>Bulletin Type:</b>	TSB	<b>Publication Date:</b>	June 2025
<b>Bulletin #(s):</b>	25-012	<b>Make(s):</b>	Jayco & Entegra Coach
<b>Job Code(s):</b>	9803632	<b>Model(s):</b>	Condor (23S) Granite Ridge (23S)
<b>Flat Rate(s):</b>	9803632 1.0 HR Entry Step Ignition Repair	<b>Model Year(s):</b>	2025 - 2026

<b>Incident:</b>	Entry Step Ignition Lockout not connected.
<b>Affected Units:</b>	2025 Jayco Granite Ridge & 2025 - 2026 Entegra Coach Condor
<b>Parts Kit: 25-012JM</b>	Parts Kit #: 25-012JM
	1 - CONNECTOR,SPLICE 12-24GA 3 WIRE CLR PLSTC WAGO MFR# 221-413
	1 - FUSE,10AMP ATC/ATO-10 SPADE (Jayco Part #0052231)
	4 - TIE,CA 14.00" BLK
	1 - HOLDER,FUSE IN-LINE 24"
<b>Misc. Tools &amp; Supplies:</b>	3-Way Wagos Wire Cutters Torque Wrench with E12 Torx Socket
<b>Parts Return Information:</b>	N/A

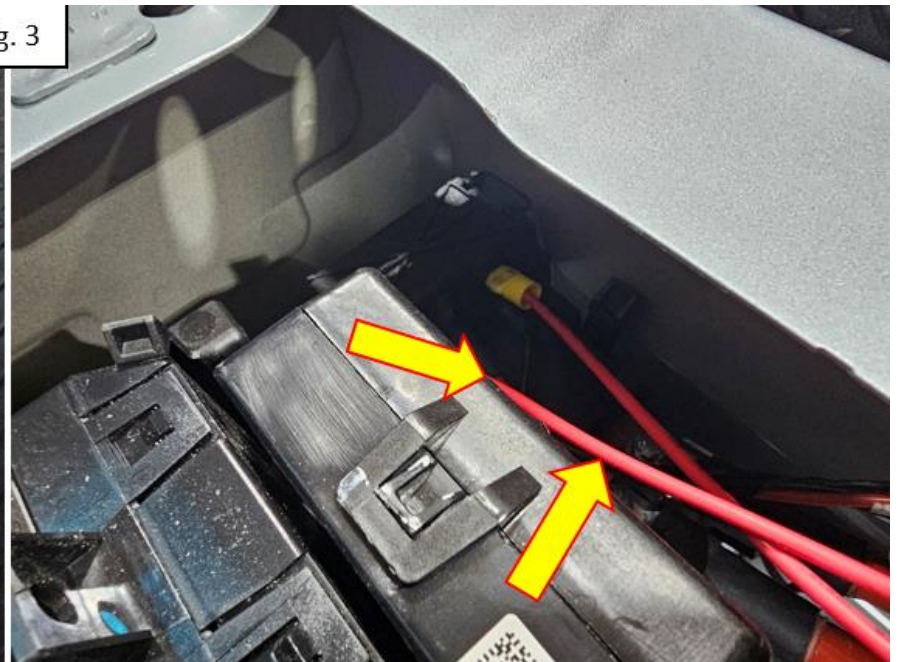
Fig. 3

2. Locate the 16AWG Yellow wire under the driver side seat base. (Figure 2)
3. Locate the red wire under the driver side seat base with the inline fuse (10A) and blue terminal ring. The wire needed, will be on the left-hand side. (Figure 3)
