**HYUNDAI**
Technical Service Bulletin

GROUP	NUMBER
ENGINE MECHANICAL	25-EM-005H
DATE	MODEL(S)
JUNE 2025	SANTA CRUZ (NXT)

SUBJECT: INTEGRATED THERMAL MANAGEMENT (ITM)
REPLACEMENT & ECU SOFTWARE UPDATE – DTC P218100

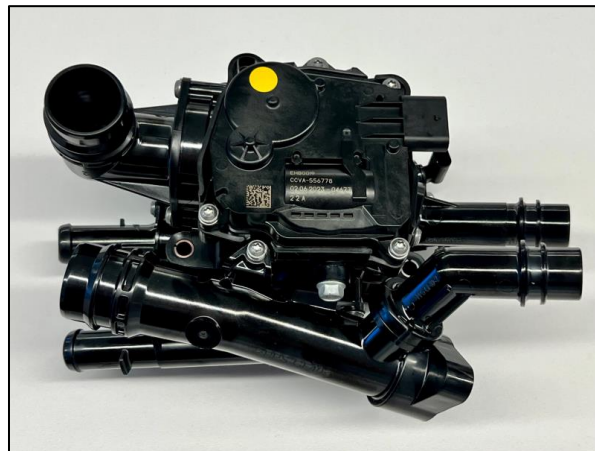
Description: Certain 2022-2023MY Santa Cruz (NXT) vehicles may exhibit a warning lamp illumination for a diagnostic trouble code P218100 that is related to the Integrated Thermal Management Module (ITM). Follow the service procedure outlined in this bulletin to replace the ITM with a revised part and update the Engine/Electronic Control Unit (ECU).

- Completion of both ITM replacement using the part listed below and the ECU updates to revise the control logic is required to repair “DTC P218100 - Cooling System Performance”.
- A Prior Approval (PA) is **NOT** required for this repair, regardless if the affected part is outside of the New Vehicle Limited Warranty (5 years/60,000 miles).
