SERVICE BULLETIN

NUMBER: 15-236-18R

DATE: 12/04/18

SUBJECT: Reprogramming File Availability for Optimization of Harman Gen 3.1
 and Gen 3.1α Audio and Navigation Head Units

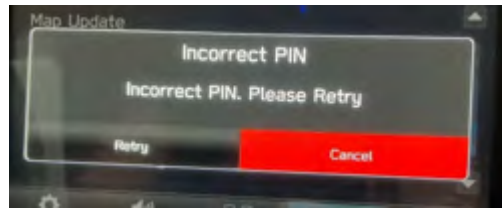
- 7) When an iPhone (CarPlay allowed) is connected using USB, the system moves to CarPlay screen no matter what is set in the <Auto Show Connected Device> menu in Setting. The Setting menu of <Auto Show Connected Device> is applicable only on Android Auto. See **NOTE 3** below.
- 8) Repair Facility POI icons are now shown on the NAVI map display. See **NOTE 4** below.
- 9) Activation Code Not Accepted by Navigation System when updating Map Data

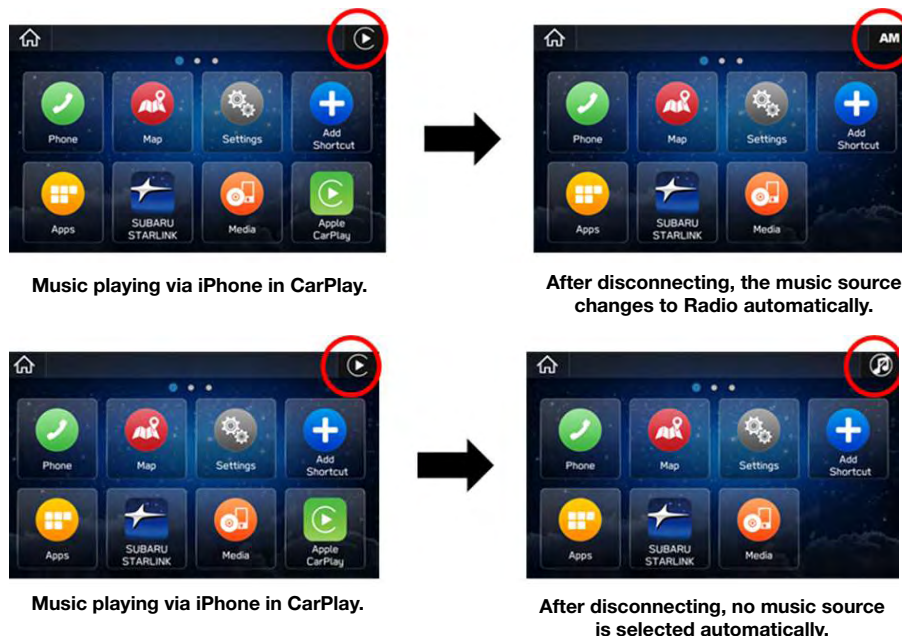
On Ver. 6.0 and before:

If a source of music other than CarPlay has been playing when the iPhone is disconnected, the music source remains same (it is not turned off.)

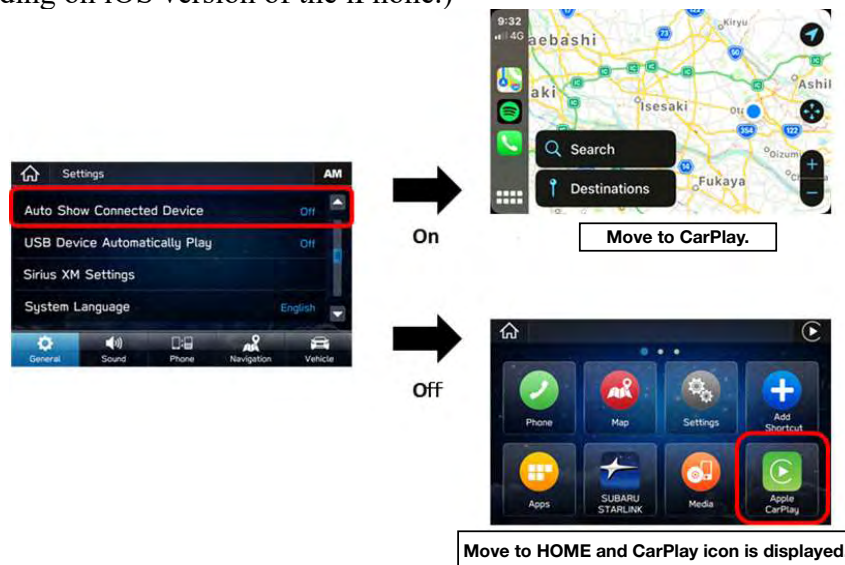
In a case where the iPhone was disconnected while playing music then reconnected while it is playing music, the system moves to CarPlay screen no matter what is set in <Auto Show Connected Device> in Setting (depending on iOS version of the iPhone.)

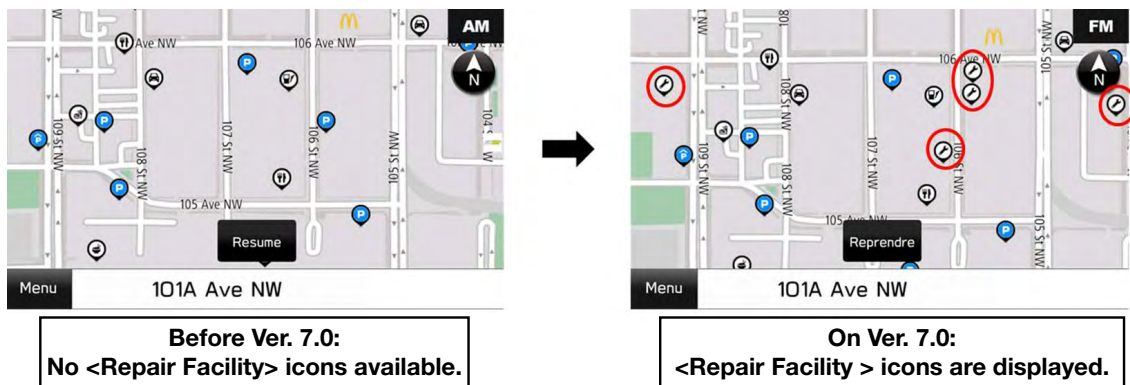
NOTE 4: Displaying Repair Facility POI icons:

<Repair Facility> Icons can be displayed in the NAVI Map.

<Repair Facility> Icons can be turned On or OFF by going to: Settings > Navigation > POI Icons.

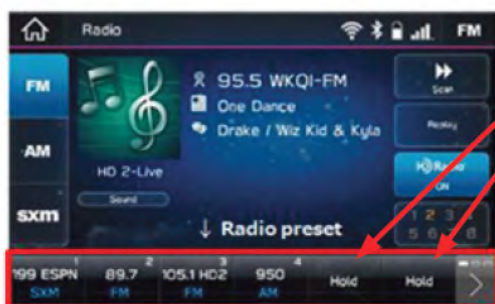
- 1) Station presets are lost. Touch buttons read “Hold”. (Applicable for software versions Rel 4.18.25.50 (or before)). Included in software version Rel_U1.18.38.50.
