**SERVICE BULLETIN**

**APPLICABILITY:** 2025 WRX  
2025 Forester Hybrid

**NUMBER:** 15-326-25  
**DATE:** 06/17/25

**SUBJECT:** FOTA (Firmware Over-The-Air) Reprogramming for DENSO Gen 4.5 Audio Navigation Infotainment Systems via DCM

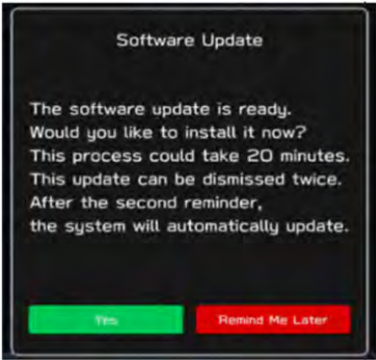
3-2		“The software installation failed. An error occurred during installation. Please contact your retailer.” popup is shown while installing.	An exception error due to hardware malfunction	Installation will resume automatically 24hours later. If same error message again, please perform diagnostic of CCU or update CCU software via USB.
3-3		Selected <Remind Me Later>, but next time IG ON 3.a.i screen is not displayed.

DCM has lost connection to SUBARU server. After downloading was com- pleted, DCM needs to con- nect with SUBARU server, before installing	Assure DCM has strong reception and reliable connection with the server, then turn ignition OFF and ON to repeat the test.
