**PRODUCT CAMPAIGN BULLETIN**

**APPLICABILITY:** 2025 MY Forester (SHEV) **NUMBER:** WRC-25  
**SUBJECT:** Safety Recall and Stop Sale- Insufficiently Tightened Child Seat Anchor Bolts **DATE:** 06/20/25

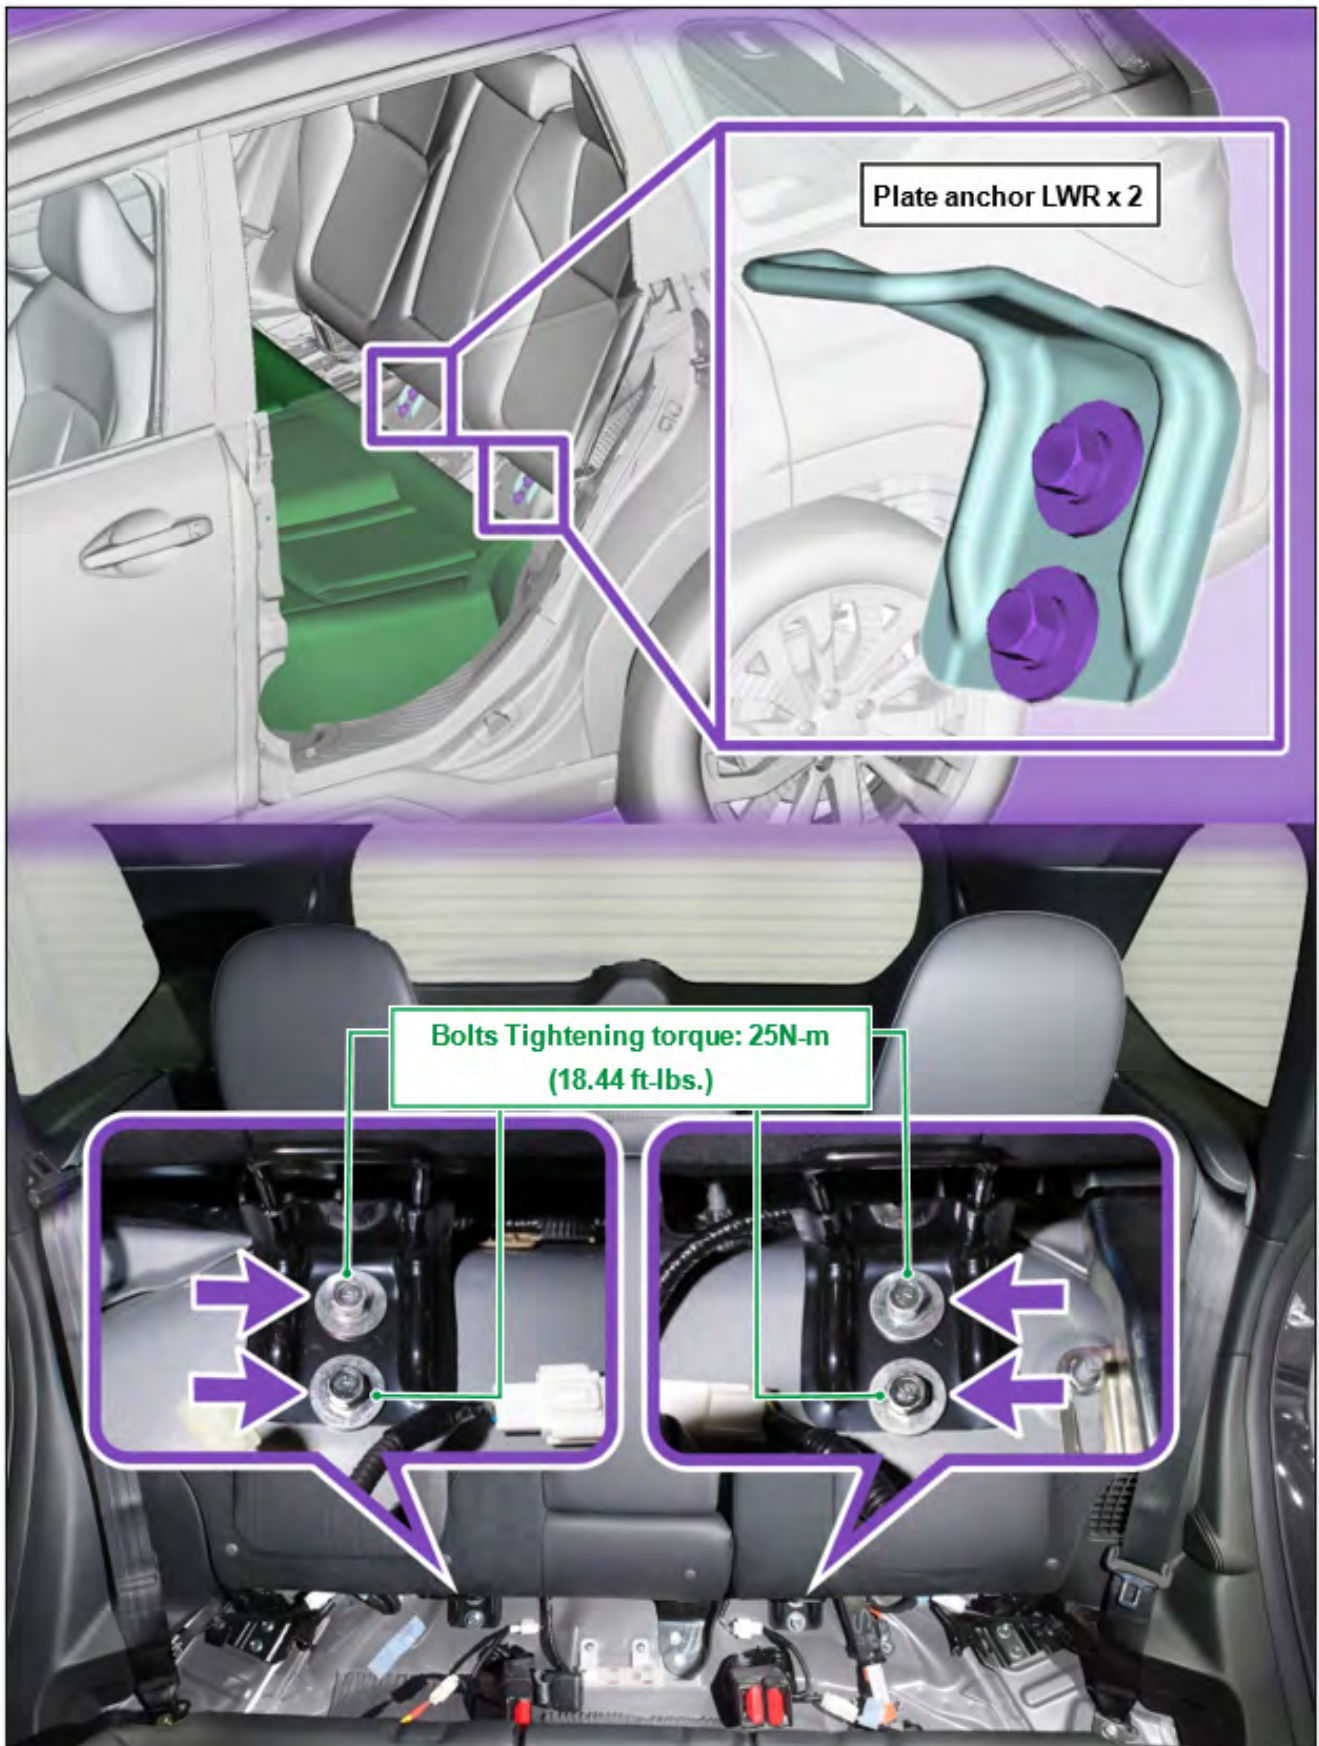
**COMPONENT CONFIGURATION:**

The affected vehicles may have been manufactured with insufficiently tightened child seat anchor bolts. Over time, an affected attachment bolt may become loose, leading to possible separation from the vehicle frame.

For all potentially affected vehicles, Subaru retailers will tighten the child seat anchor bolts to the specified torque at no cost to the customer.
