SERVICE PROGRAM BULLETIN

APPLICABILITY: 2017 MY Forester (turbo) **NUMBER:** WRA-25
 2017 MY WRX **DATE:** 06/27/25

SUBJECT: Rear Catalyst (Center Exhaust Pipe)
 Non-Compliance

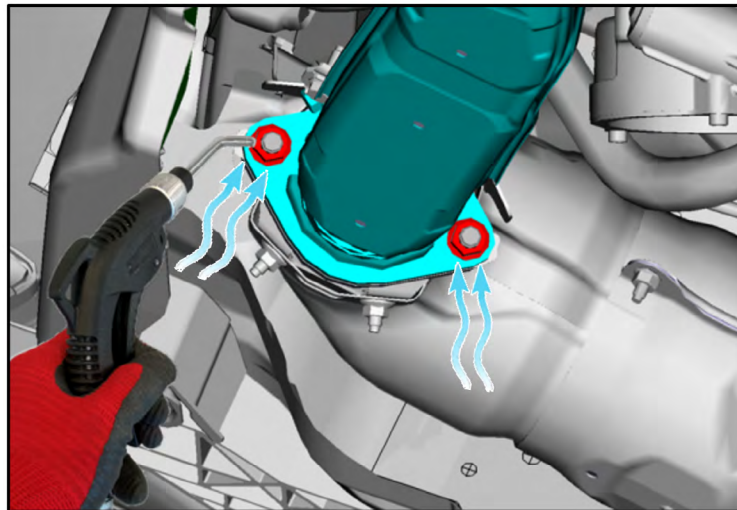
STEP 10: Using an air gun, apply shop air to both nuts for a period of 1 MINUTE to cool.

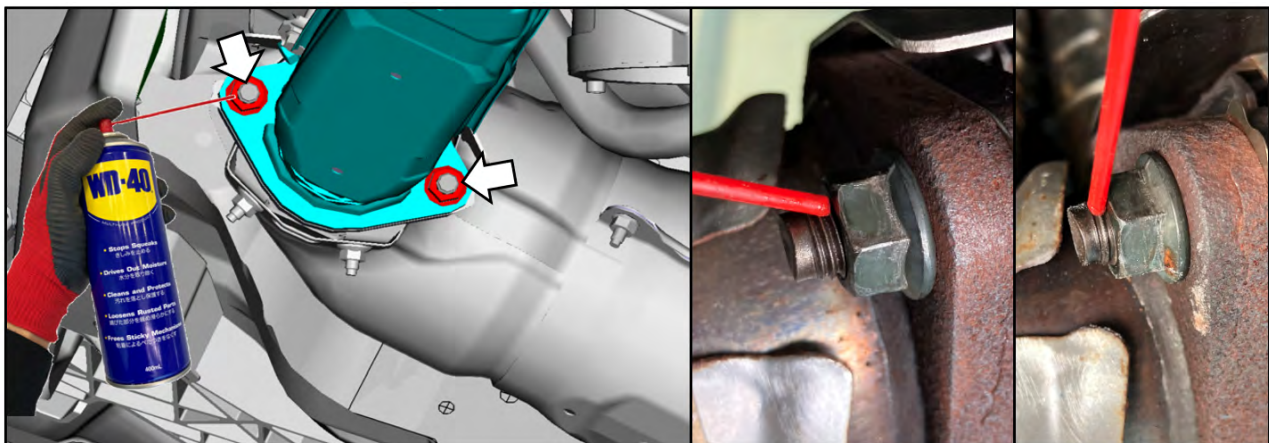
STEP 11: Apply WD-40 lubricant to both the left and right stud/nuts.

CAUTION: If sufficient cooling of the components has not been met, the lubricant will evaporate and not penetrate effectively.

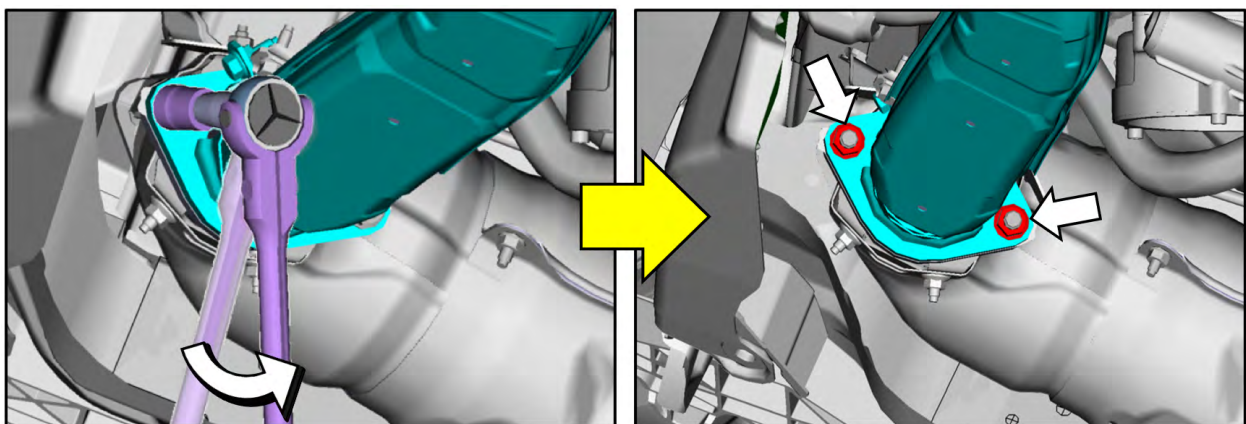
STEP 12: CAREFULLY loosen both nuts.

NOTE: When encountering cases of the nut becoming tight while loosening, slightly turn the nut in the clockwise direction, re-apply WD-40 lubricant, and loosen the nut. **PATIENCE IS KEY!**

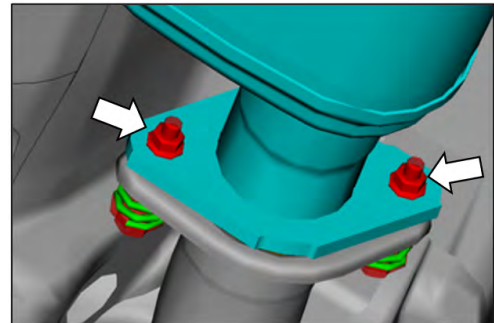
STEP 13: Remove the rear flange mounting bolts and nuts and separate the exhaust.

NOTE: If needed, WD-40 and the wire brush can be used to aid in removal.

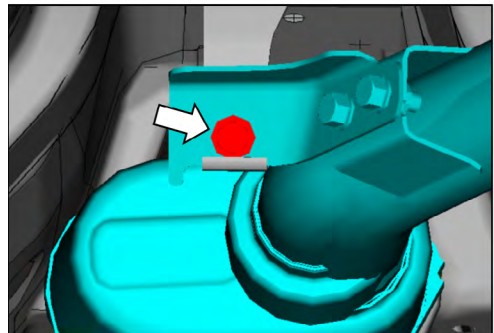
STEP 14: Remove the mounting bolt holding the center pipe to the hanging bracket.

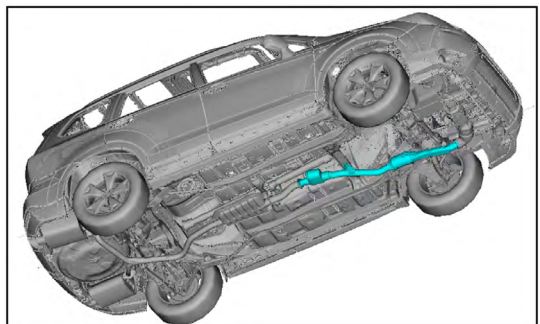
STEP 15: Remove the center exhaust pipe from the vehicle.

IMPORTANT: If excessive stud damage has occurred, refer to the **APPENDIX B** section of this bulletin. Once the additional service procedure is completed, continue to Step 15 below.

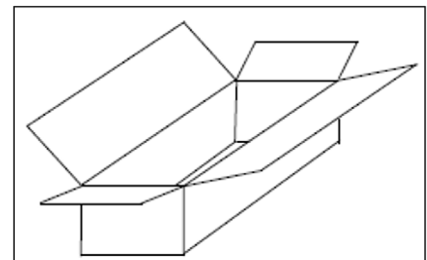
STEP 23: Prepare the catalytic converter for shipment using the 16in x 8in x 8in cardboard box provided with the replacement center exhaust pipe.

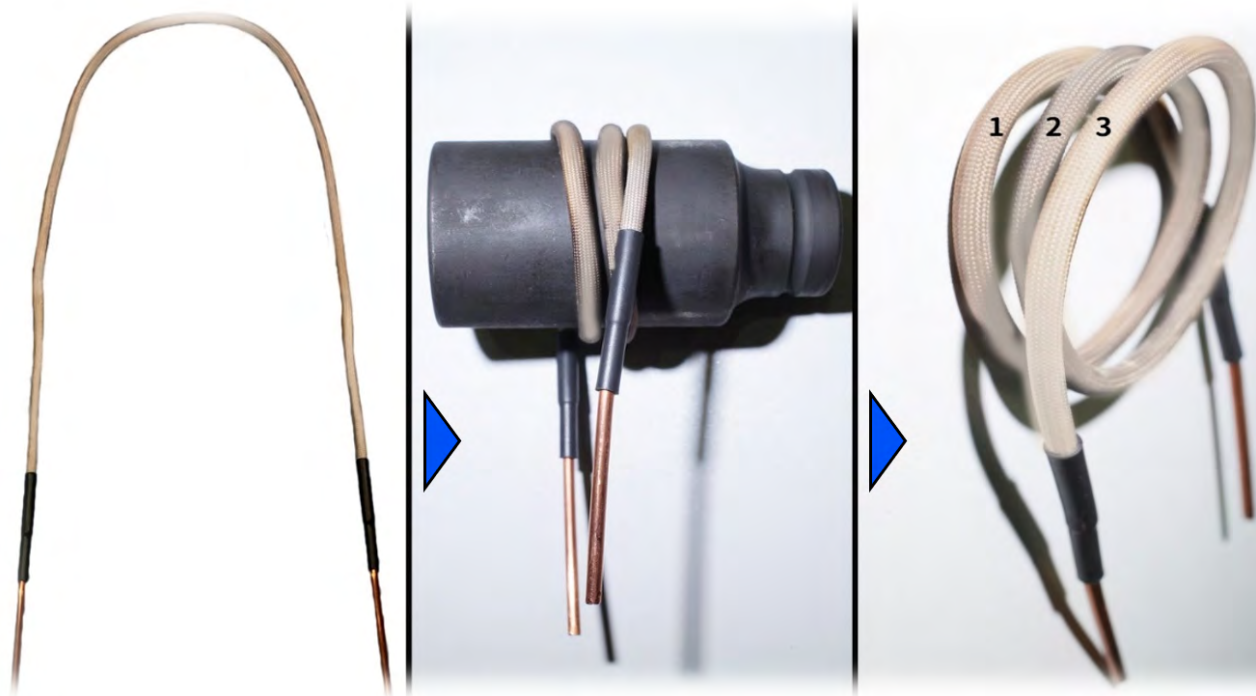
STEP 1: Prepare the coil attachment supplied in the MINI-DUCTOR VENOM tool by winding the coil five rotations around a 27mm socket. This will provide the needed width for the heat application to the exhaust components.

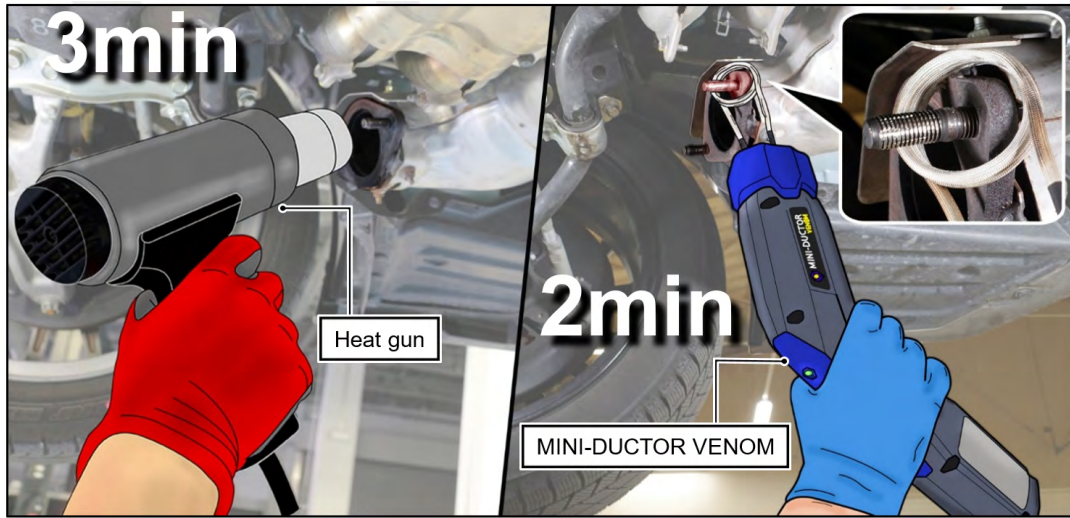
STEP 3: Using a heat gun, apply heat to the flange area for 3 MINUTES. Once completed, apply heat for 2 MINUTES using the MINI-DUCTOR VENOM.

CAUTION: DO NOT exceed heat application with the MINI-DUCTOR VENOM for more than 2 MINUTES.

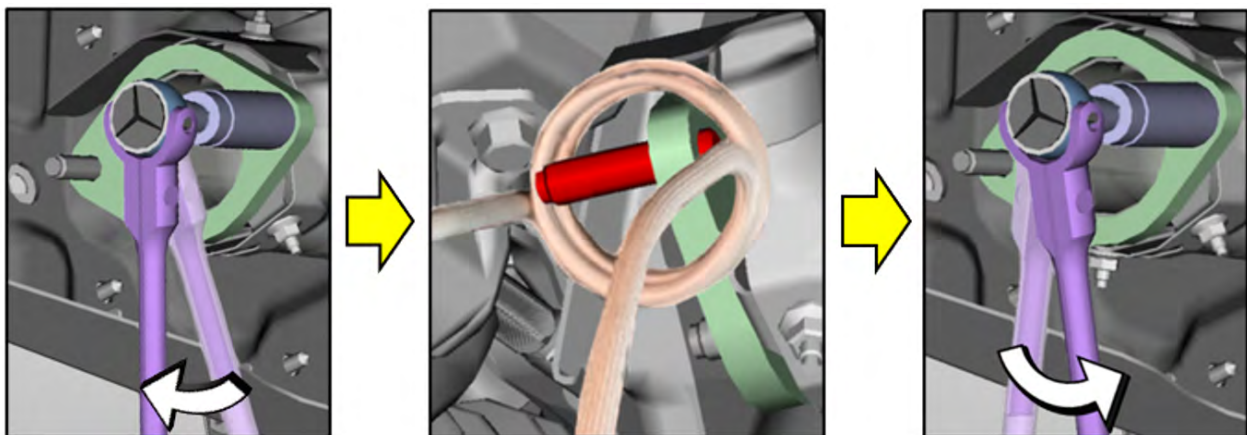
IMPORTANT: When encountering cases of the stud being unable to loosen, slightly tighten the stud, reapply heat, and re-attempt to loosen.

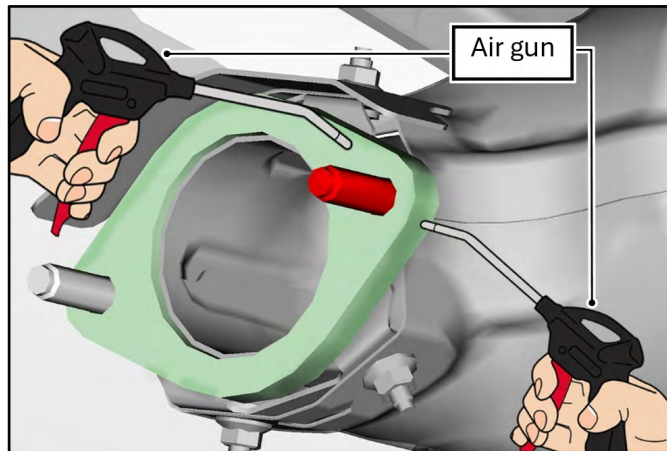
STEP 5: Using an air gun, apply air to the affected area for **1 MINUTE**.

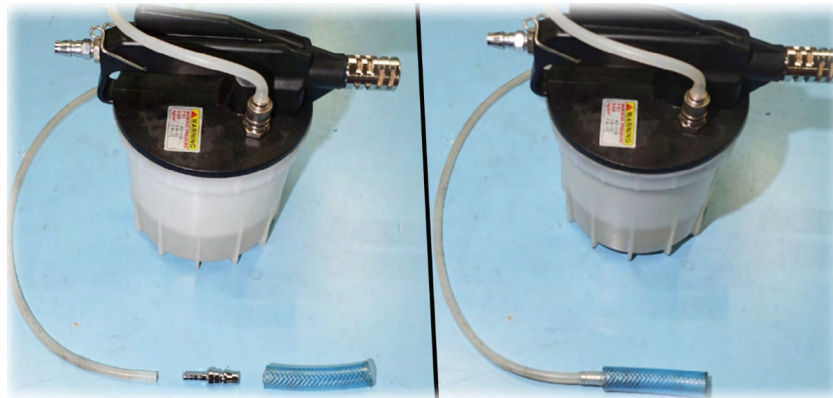
1. Assemble the brake bleed hose tip, air hose nipple, and a hose cut with an outside diameter of 9/16-7/8 (15-21mm) and length of 3 inch (80mm).

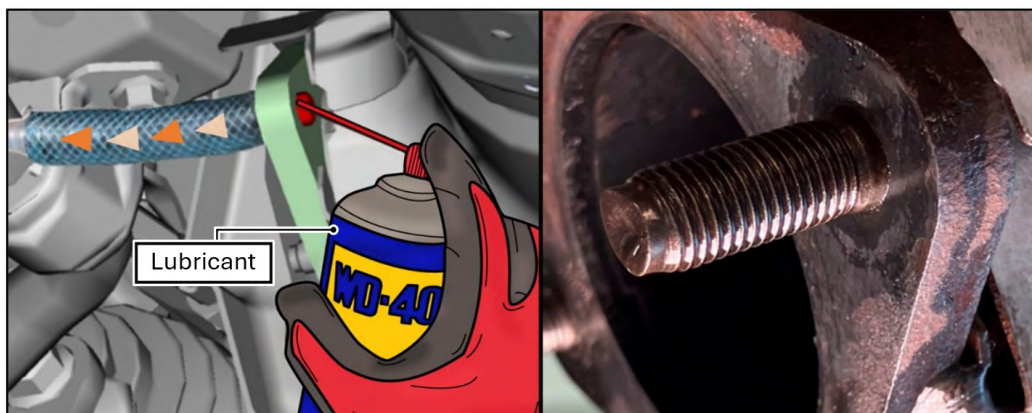
2. Apply vacuum to the affected stud. Maintain flush contact with the hose and flange to ensure sufficient vacuum.
3. Spray the lubricant (WD-40) on the opposite side of the flange to the stud threads. Once the lubricant has fully penetrated the threads, proceed to Step 6:

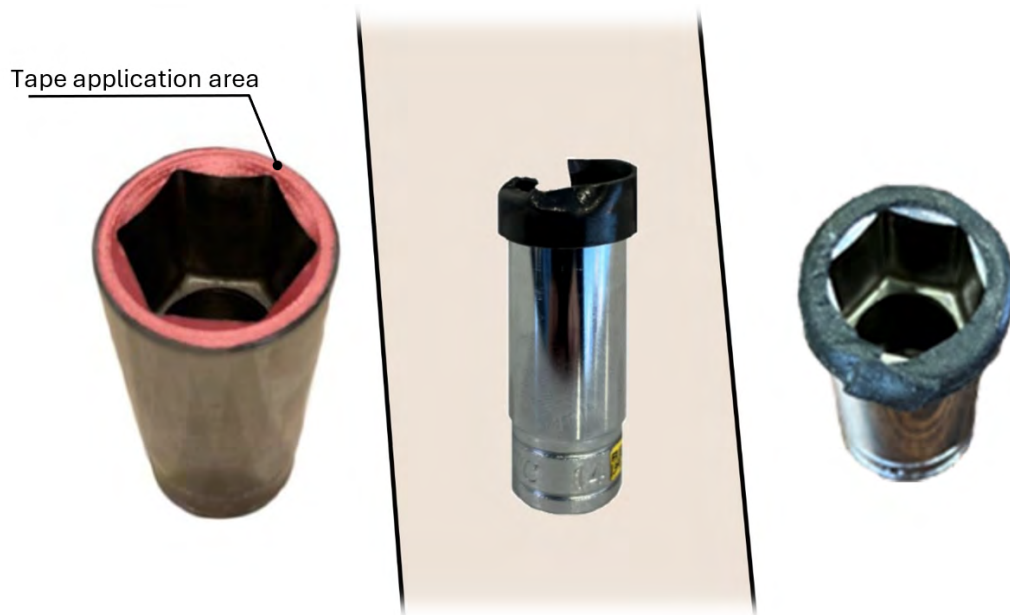
Prepare the socket and tap by applying the tape to face of the socket. Ensure the tape is fully wrapped to ensure a sufficient seal.

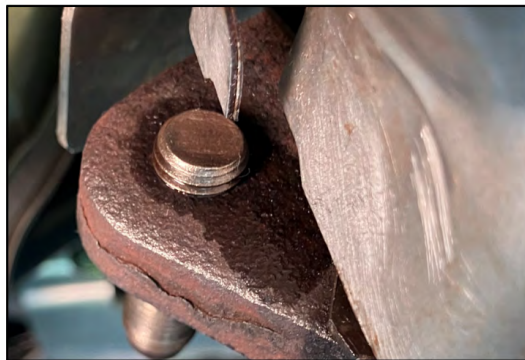
Apply lubrication (WD-40) to the exposed threads on the connection side of the flange.

Install the pre-prepared socket over the stud. Insert the air gun in the back of the socket and close all air gaps with a cloth or rag. While pressing the socket against the flange, Apply air to the socket. This pressure will allow the lubricant to penetrate the threads.

Repeat the lubrication process until lubrication is detected on the opposite side of the flange. Once sufficient lubrication has been confirmed, proceed to Step 6.
