Service Bulletin

Bulletin No.: 24-NA-029

Subject: HUMMER EV Water Leak Diagnostic Tips

Brand:	Model:	Model Year:		VIN:		Engine:	Transmission:
		from	to	from	to		
GMC	HUMMER EV Pickup	2022	2025	-	-	All	All
	HUMMER EV SUV	2024	2025

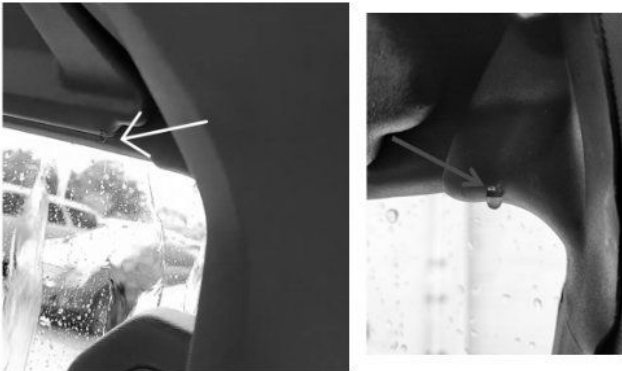
6542288

Condition	Leaks near the top of any of the side windows, weather strips, or sky panel weather strip.
Cause	If any sky panel is out of alignment such as being shifted too far forward or rearward, or too high, this will causing excessive water to enter into the water management system in the weather strips. This causes water to back up over the sealing surfaces creating a leak inside the cabin near the corners of weather strips near the weather strip drain holes.
Correction	Perform top down, side to side, visual inspection of all 4 sky panels installed, with the I-bar installed. If any sky panel appears to be not square in the opening or sitting high – verify the dimensions and adjust as necessary following SI DOC ID 6339878 (pickup) or 6341146 (SUV)

Verify the dimensions and adjust as necessary following SI DOC ID 6339878 (pickup), 6341146 (SUV).
