Front Air Spring Strut Leaking - Yellow or Red Warning Message in Instrument Cluster: Check Plastic Welded Seam on Air Spring Strut (43/25)

Model Line: **Cayenne (9YA / 9YB)**

Model Year: **2023**

Concerns: **Front air spring strut**

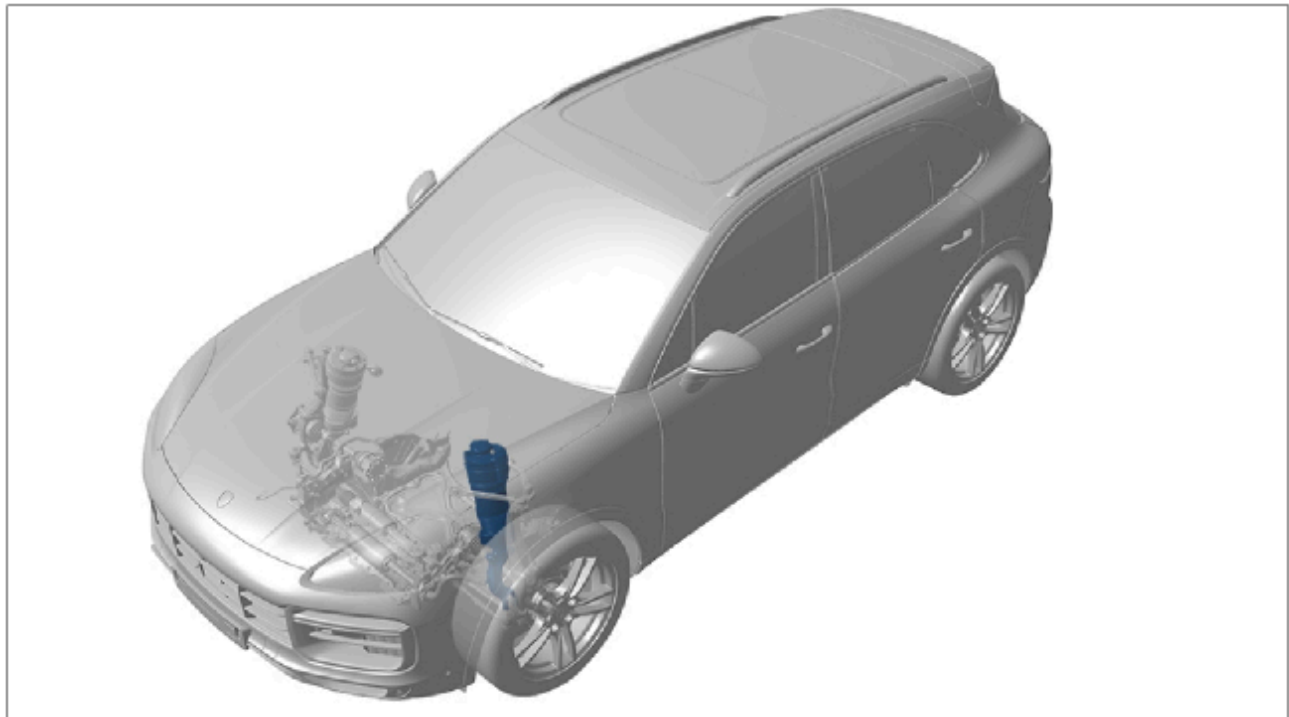
Installation position

Action: If there is a customer complaint, check front air spring struts and, if there is a leak at the plastic welded seam on one of the two air spring struts, replace front air spring struts (left and right) **both once**.

<p><i>Plastic welded seam leaking</i></p>	<p>Front air spring strut is not OK.</p> <p>Replace both front air spring struts (left and right).</p> <p>For procedure, see: ⇒ <i>Workshop Manual '433019A4 Removing and installing front air spring strut'</i></p>
