**Complaint - Cylinder Head Cover Near the Injector Holes Leaking: Subsequent Work on Cylinder Head (180/18)**

Vehicle Type: **Panamera (971/YAA)/Panamera 4 (971/YAA)/Panamera 4S (971/YAA)/Panamera 4 E-Hybrid (971/YAA)/Panamera 4S E-Hybrid (971/YAA)**

Concerns: **Cylinder head cover**

Cause: **Complaint about injector hole leaks**

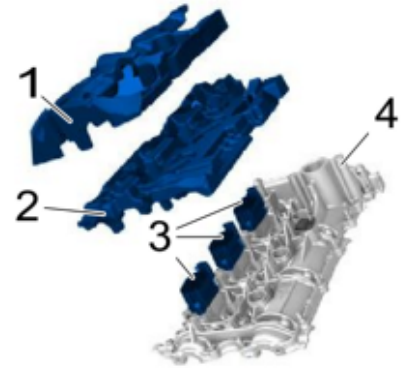
*Cylinder head cover component overview*

- 1** – Insulation on top of cylinder head cover
- 2** – Insulation on bottom of cylinder head cover
- 3** – Solenoid hydraulic valve for valve lift adjustment
- 4** – Cylinder head cover
