Complaint - Cylinder Head Cover Near the Injector Holes Leaking: Subsequent Work on Cylinder Head (180/18)

Vehicle Type: **Cayenne (9YA/9YB)/Cayenne E-Hybrid (9YA/9YB)/Cayenne S (9YA/9YB)/Cayenne S E-Hybrid (9YA/9YB)**

Concerns: **Cylinder head cover**

Cause: **Complaint about injector hole leaks**

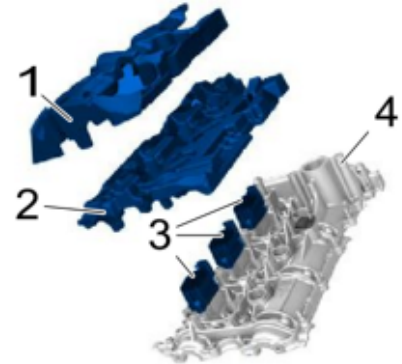
Cylinder head cover component overview

- 1 – Insulation on top of cylinder head cover
- 2 – Insulation on bottom of cylinder head cover
- 3 – Solenoid hydraulic valve for valve lift adjustment
- 4 – Cylinder head cover
